Pacific Gas & Electric Third-Party Line Strike and Fire
San Francisco, California
February 6, 2019

Accident Report

NTSB/PAR-21/02
PB2021-100925

Pipeline Accident Report

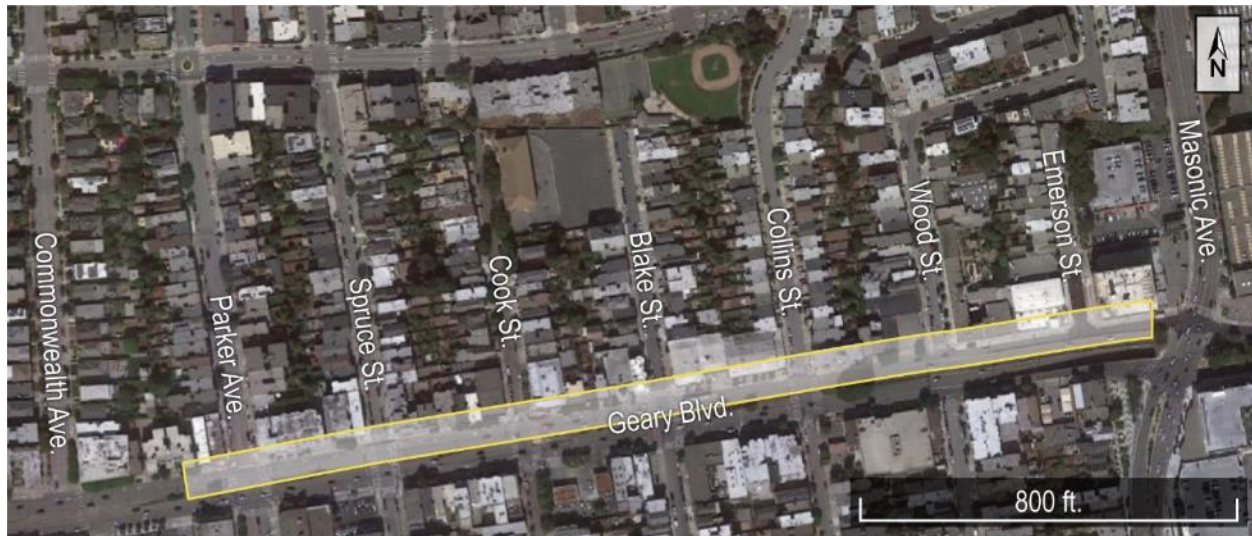
Figure 2 Kilford's project area.

The scope of work called for 1,888 feet of trench excavation and the installation of 3,798 feet of 2-inch high-density polyethylene conduit inside 4-inch polyvinyl chloride piping at a depth of 36 inches. As part of the work, Kilford was responsible for maintaining a minimum of 24 inches of separation from existing utilities and for determining the location and depth of the existing utilities.

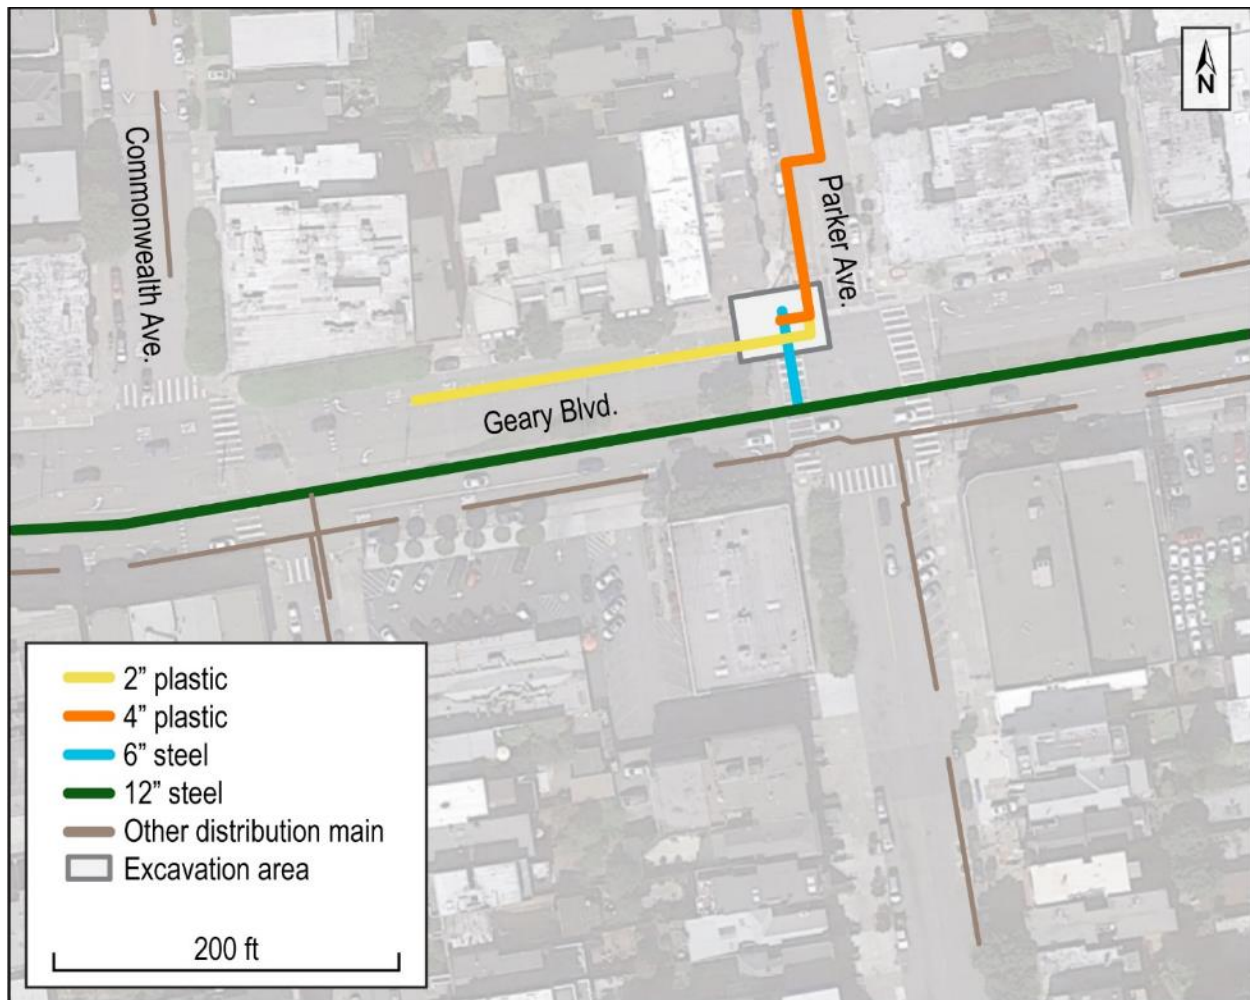
In consultation with the IC, the deputy IC’s GM&C crew, the second crew on site, began work at 1:50 p.m. to excavate the 6-inch steel pipeline in the center of Geary Boulevard. In that area, a 12-inch steel pipeline interconnected with the 6-inch steel pipeline. (See figure 8.) This dig site was chosen based on an old marking for the 6-inch pipeline (date and purpose of marking unknown), which was far enough away from the fire that the deputy IC felt it was safe for his crew to proceed.

Figure 8. Map of location of gas pipelines affected by the accident. (Courtesy of PG&E.)

After the excavation of the 6-inch steel pipeline was already underway, three PG&E locators determined the 12-inch pipeline and, therefore, the 6-inch steel pipeline, were north of the current dig site. Once the “locate crew” recognized the current excavation would not effectively isolate the segment, the excavation was abandoned. A second excavation was started north of the 12-inch pipeline and closer to the fire, with the protection of a water curtain provided by the SFFD.¹³
