Re: Crash of Pilatus PC-12/45 N128CM Report No. NTSB/AAR-11/05 PB2011-910405

**Petition for Reconsideration and Modification of the
National Transportation Safety Board's Findings and
Determination of the Probable Cause for the Crash of
Pilatus PC-12/45 N128CM**

NTSB Report No. NTSB/AAR-11/05 PB2011-910405

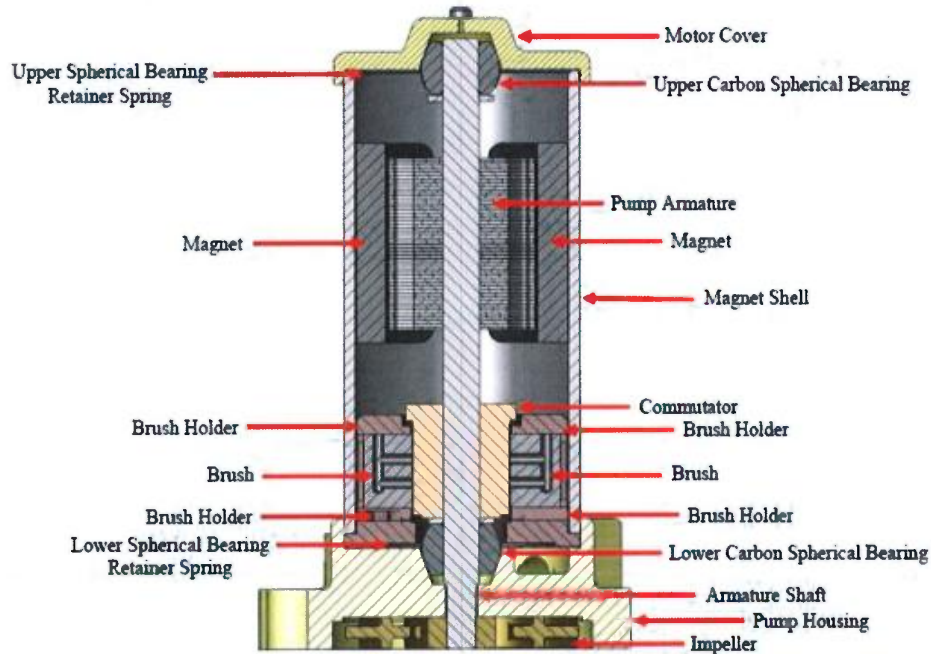
The subject right and left FBPs were installed on the aircraft as new when the aircraft was built by Pilatus in 2001. (Declaration of Richard McSwain ("McSwain Decl.") at ¶¶8-9.) They were manufactured by Crane Co. and were model number RR53710K ("K pump"). (Id.) The K pump is a centrifugal pump powered by a D.C. electric motor. (Id.) The motor in the K pump consists of a rotating armature, which is affixed to an armature shaft oriented vertically in the pump. The armature shaft in the K pump is held in position at the top and just below the commutator by self-aligning bearings, which are made of carbon graphite. If the armature shaft in

the K pump is rotating, the floating impeller, located just below the lower bearing, will also rotate. The image below is a drawing of the K pump⁷.

The pump's carbon brushes are constant-force-spring-loaded, meaning they have constant contact force with the rotating commutator. The commutator in the pump is made of copper, is cylindrical in shape, and is pressed on the armature shaft. The commutator is concentric to, and rotates with, the shaft. As rotation occurs, the constant-force springs maintain brush contact pressure against the commutator. When electrical current is supplied to the pump, the brush assembly provides electricity to the commutator, resulting in rotational torque that causes the armature shaft and floating impeller to rotate. As fuel enters the pump through the inlet, impeller rotation creates fuel flow, thereby providing the fuel flow in the overall system to the aircraft engine.

Confidential internal correspondence between Crane Co. and Pilatus shows that the RR53710K model boost pump ("K pump") was designed to replace the predecessor Crane RR53710B centrifugal boost pump ("B pump") at the request of Pilatus for a "less expensive", *lower quality* pump. (Ex. Y.) The "K" pump was introduced several years after certification of the PC-12 and was not part of the fuel system at the time the plane was first certified by the FAA or for the first seven years of aircraft production. The new "K" pump was redesigned with different balancing properties, different carbon bearings, and a different brush system. Despite these significant changes, the new model K pump never underwent the extensive testing and certification normally performed on Crane pumps.

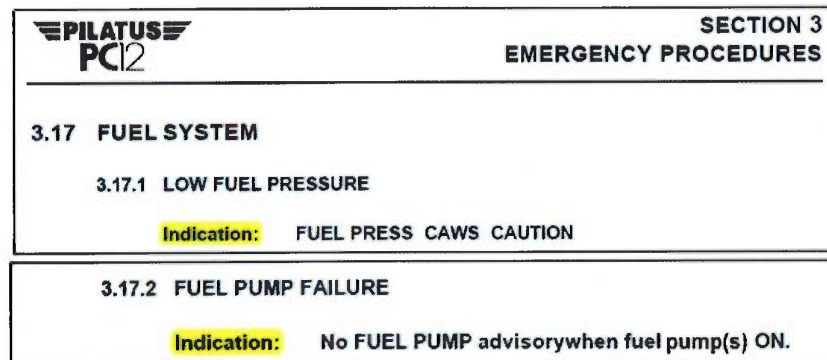
Due to defects in the PC-12 internal computer system and AFM, there were no cautions or warnings to indicate an emergency during the flight. Unsurprisingly, there were also no applicable emergency procedures or instructions delineated in the operative manuals for the situation faced by the pilot.

The PC-12 Aircraft Flight Manual ("AFM") and Quick Reference Handbook ("QRH") contain emergency procedures, each beginning with an "Indication" directing the pilot to the respective procedure, two examples as shown below:

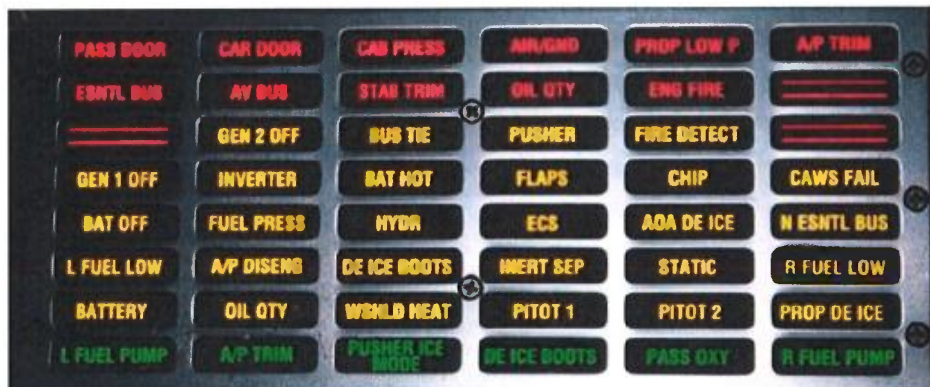
The PC-12 Central Advisory & Warning System ("CAWS") incorporates a panel in the cockpit which illuminates lights and activates "gongs" during certain situations. Some of the Indications in the emergency procedures are the illumination of lights on the CAWS panel. An image of the panel is shown below, taken from page 15 of the NTSB Report.

Each light displayed on this panel can be classified as an “advisory”, “caution” or “warning.” The federal regulations are very specific about what constitutes a “warning” light as differentiated from a “caution” or an “advisory” light. FAR 23.1332 requires that “warning” lights, which are meant to prompt immediate corrective action by the pilot, shall be red in color. As described in the Accident Report, illumination of a red warning light indicates a condition that requires an immediate corrective action by the pilot and it is accompanied by an additional red master WARNING light¹⁰ and an audio message. An amber caution light indicates a condition that requires the pilot’s attention but not an immediate corrective action; it is accompanied by an amber master CAUTION light and an aural gong. And a green advisory light indicates that a system is safely operational. (Report at p. 14-15).
