# CRASH OF PILATUS PC-12/45 N128CM

June 30, 2017 Petition for Reconsideration of the  
NTSB's Findings & Determination of Probable Cause

Supplemental Presentation  
Dated: June 29, 2018

**Re: Crash of Pilatus PC-12/45 N128CM Report No. NTSB/AAR-11/05 PB2011-910405**  
***Supplement to June 2017 NTSB Petition for Reconsideration***

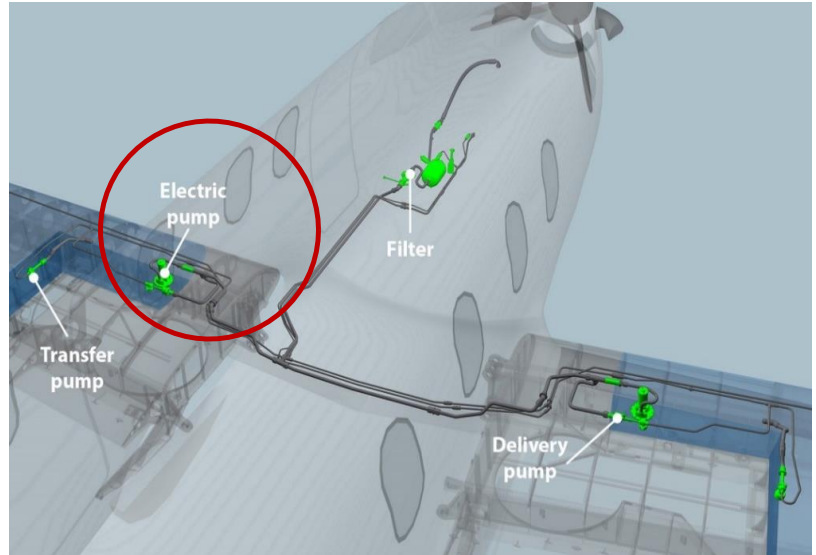
- For over a 30 years, Pilatus knew the fuel system was prone to icing
- The PC-12 fuel system does not meet FAR 23.95(c) specifications and therefore FSII (Prist) is required for all flights operating below 0 degrees
- The fuel filter is incapable of functioning in freezing temperatures without FSII (Prist) and provokes a persistent Low Fuel Pressure condition
- To overcome low fuel pressure, and to avoid creating an imbalance, the aircraft requires Fuel Booster Pumps (FBPs) in each wing's collector tank
- The FBPs are supposed to balance the fuel b/w the left and the right wing fuel tanks when needed

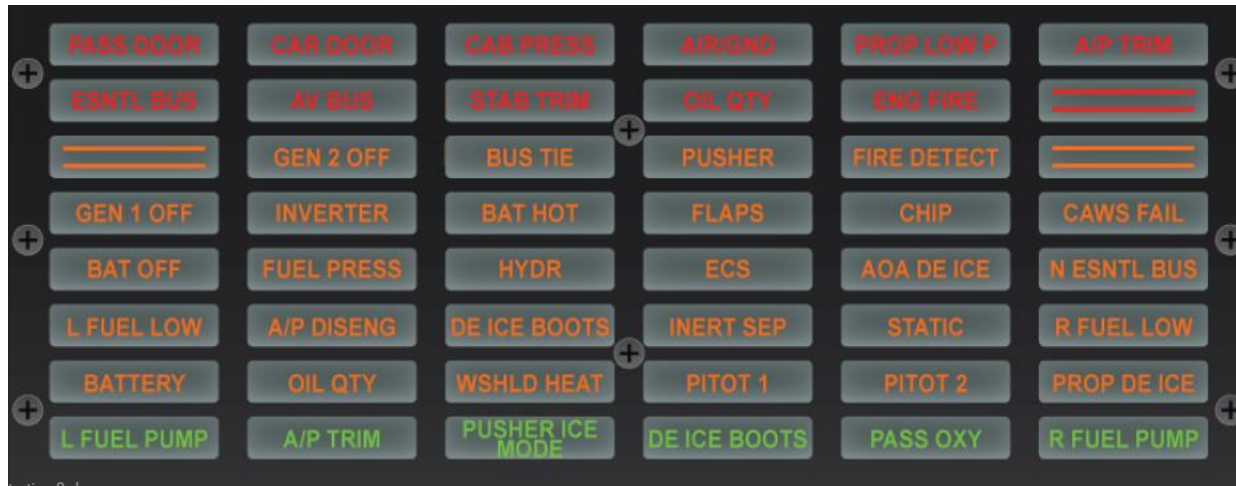
GREEN ADVISORIES which indicate a system is functioning.

Whenever a CAWS red or amber caption illuminates, the MASTER WARNING or CAUTION will illuminate. A voice callout will also be given with all red annunciations and an aural gong will sound with all amber annunciations.

# The PC-12 Low Fuel Pressure light violates FAR 1305

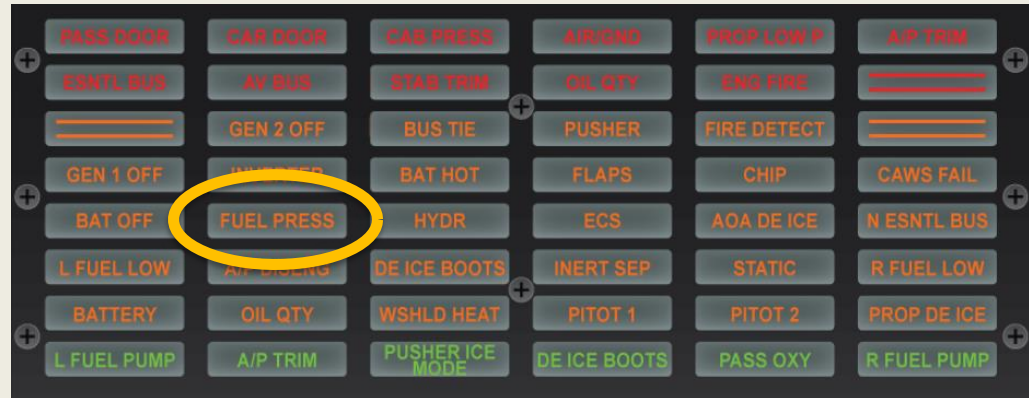
- Blocked Fuel Filter →
  - Low Fuel Pressure Condition →
    - Boost Pumps Activated →
      - Pressure Restored
- Blocked Fuel Filter Continues →
  - Cycle Repeats...

***This cycle occurred 307 times  
without lighting the  
Fuel Pressure warning light***
