Pipeline Investigation Report: NTSB/PIR-22/02

Enbridge Inc. Natural Gas Transmission Pipeline Rupture and Fire

Danville, Kentucky
August 1, 2019

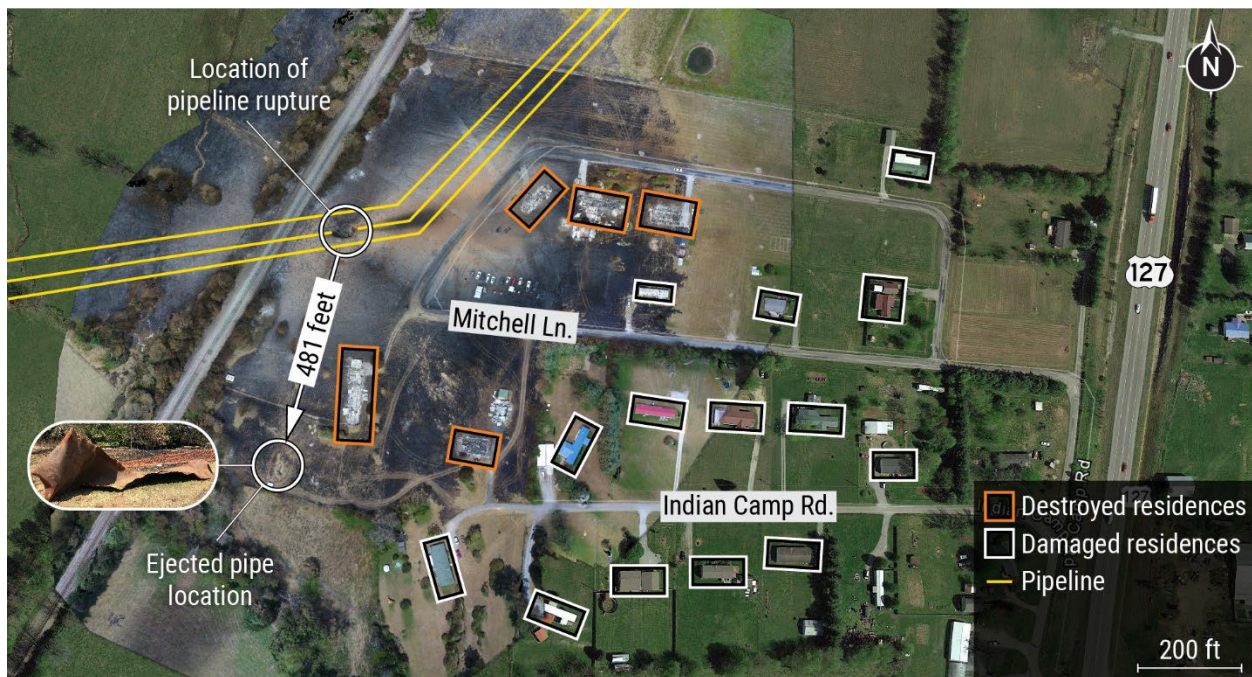
Figure 1. Aerial view of the Indian Camp Subdivision overlaid on Google Earth image.

On August 1, 2019, at 1:23 a.m. local time, a 30-inch-diameter natural gas transmission pipeline, Line 15, owned and operated by Enbridge Inc. (Enbridge), ruptured near Danville, Kentucky.¹ As a result of the rupture, 1 person was fatally injured, 6 people were hospitalized, and over 75 residents were evacuated from the Indian Camp Subdivision, a residential community. The rupture released about 101.5 million cubic feet of natural gas and ejected a 33.2-foot-long section of pipeline that landed about 481 feet southwest of the rupture site. The releasing gas ignited and burned. Five residences in the subdivision were destroyed by fires, and an additional 14 were damaged. (See figure 1.) A nearby railroad track owned and operated by the Norfolk Southern Corporation sustained fire damage.

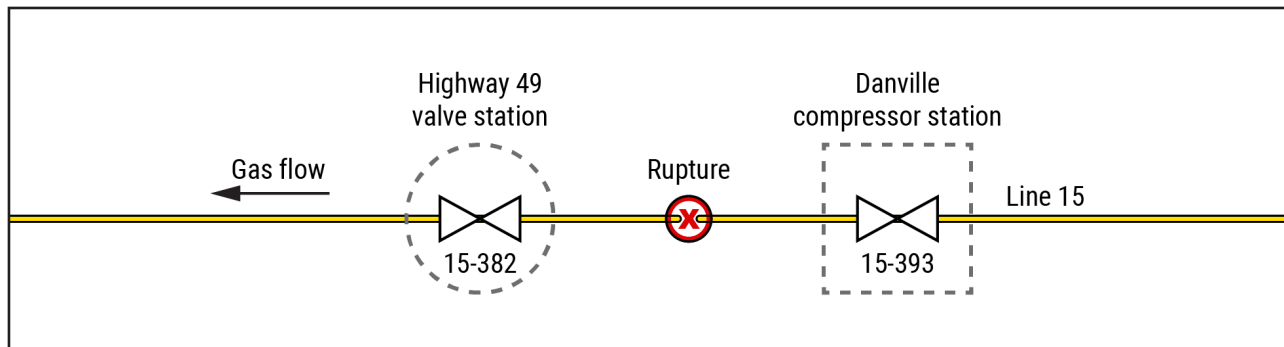
Figure 2. Process flow diagram for pipeline isolation.

To isolate the affected pipeline segment, Enbridge personnel needed to close valves manually at the Danville CS (valve 15-393) and at a valve station located near Highway 49 (valve 15-382). (See figure 2).

from the station, and saw a low-pressure alarm at the CS, he did not act to close the manual valve at the CS until instructed by the area supervisor. The station operator manually closed valve 15-393 at 1:39 a.m., isolating the affected pipeline segment on the north side of the rupture.

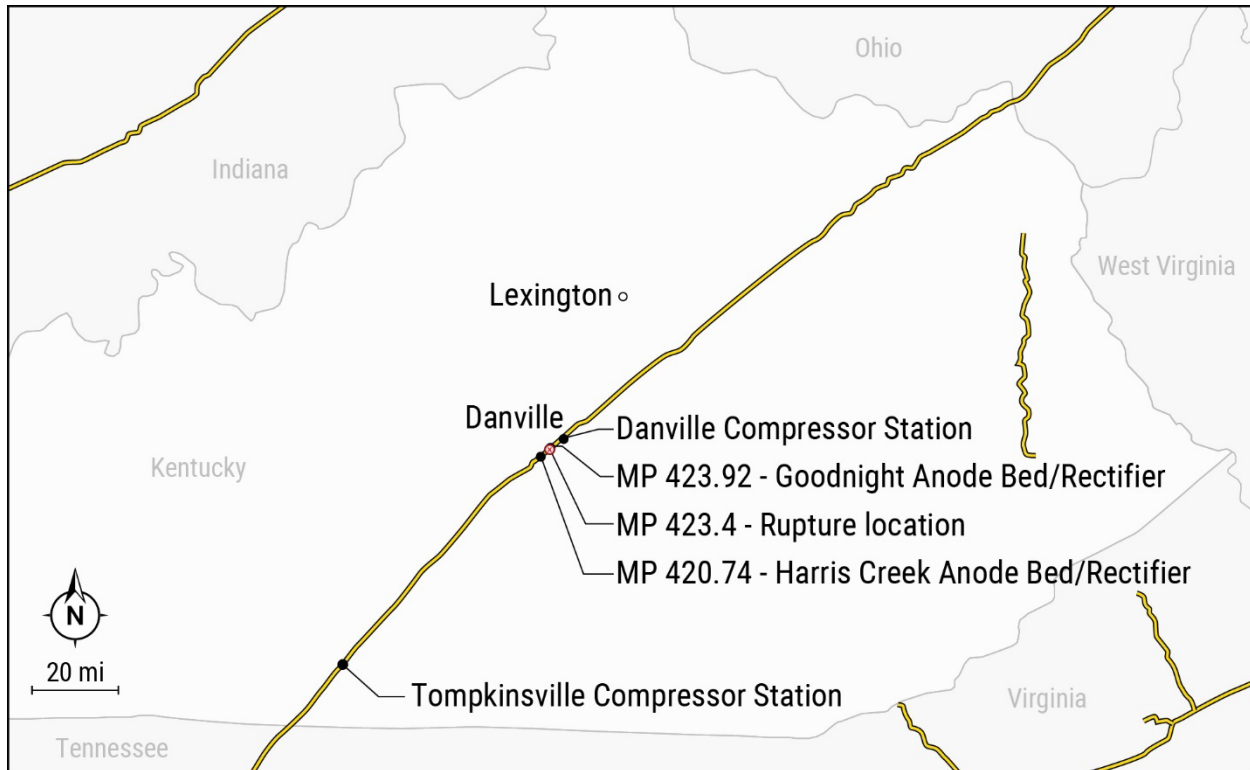
Figure 8. Map of the right of way for Lines 10, 15, and 25.

External corrosion is controlled on Line 15 by impressed-current cathodic protection and design elements such as coating.²⁶ Between the Tompkinsville CS and the Danville CS, there are eight rectifiers. The closest rectifier and anode bed north of the accident site is at Goodnight, and the closest rectifier and anode bed to the south is at Harris Creek.²⁷ (See figure 8.) The soil in this area is primarily shale. The Enbridge corrosion technician told the NTSB that “it takes a lot more [cathodic protection] with shale,” and that shale “does lower the ability for [cathodic protection] to go through the rock.”
