PARTY RESPONSE TO LINE 15 PIPELINE EXPLOSION AND FIRE

Operator: Enbridge Inc./Texas Eastern Transmission, LP

Location: Danville, KY

NTSB No.: PLD19FR002

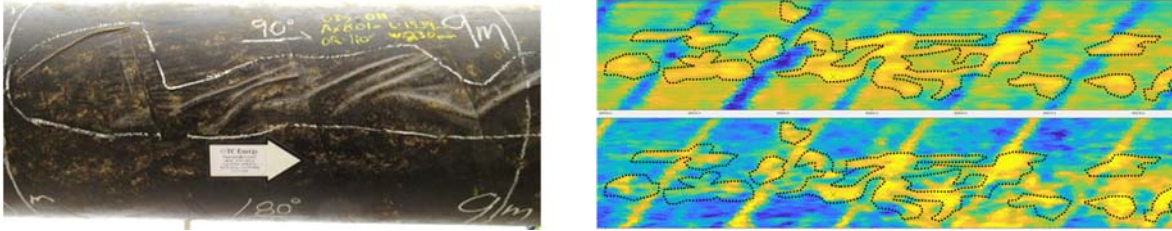
Figure 3 Identification of coating features

Detection of indications of coating disbondment relies on identifying change in the signal attenuation compared to the adjacent area. The relative difference in the tail energy values will depend largely on the external interface, which in turn is affected by the acoustic impedance of the two materials. Whenever there is an energy difference exclusively in the tail energy plot, it is due to coating disbondment or a change in the coating, e.g., a double coating layer.
