KURT LEPPINS
Written Statement

OF ACCIDENT 275AK Aug 5, 2021

1) 2008 ROBINSON / N-775AK
R-44 Serial# 1875

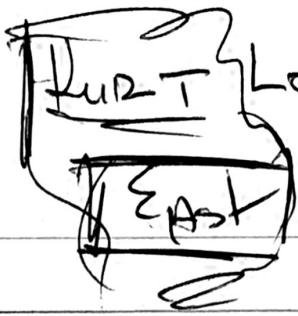
Leppings sketch of
 fire where wreck occurred
 8/5/21

I surveyed field to be sprayed at approx 7:30 AM flying from west to east. The sunrise was low in sky and in my eyes. I did not see any wires crossing field. I spray a couple other fields first then came back to that field approx 8:15 AM. And began spraying from east to west along side paved road. I heard a bang and instantly was in the corn field down. I exited helicopter immediately after unbuckling the seat belt. The road was on south side of field and there were power lines on south side road and after getting out of heli I observed one line crossing field from south to north, and one line tangled in helicopter. I was about 150-200 yds to west of line in the corn field. The road to south was a high point and field slope downhill to north. The power line pole in the field was near north edge of field and it did not go to any buildings. It went down hill further to the north, off into a valley. (See attached sketches)
