National Transportation Safety Board

DCA22FM001

PIPELINE OPERATIONS

Group Chair's Factual Report

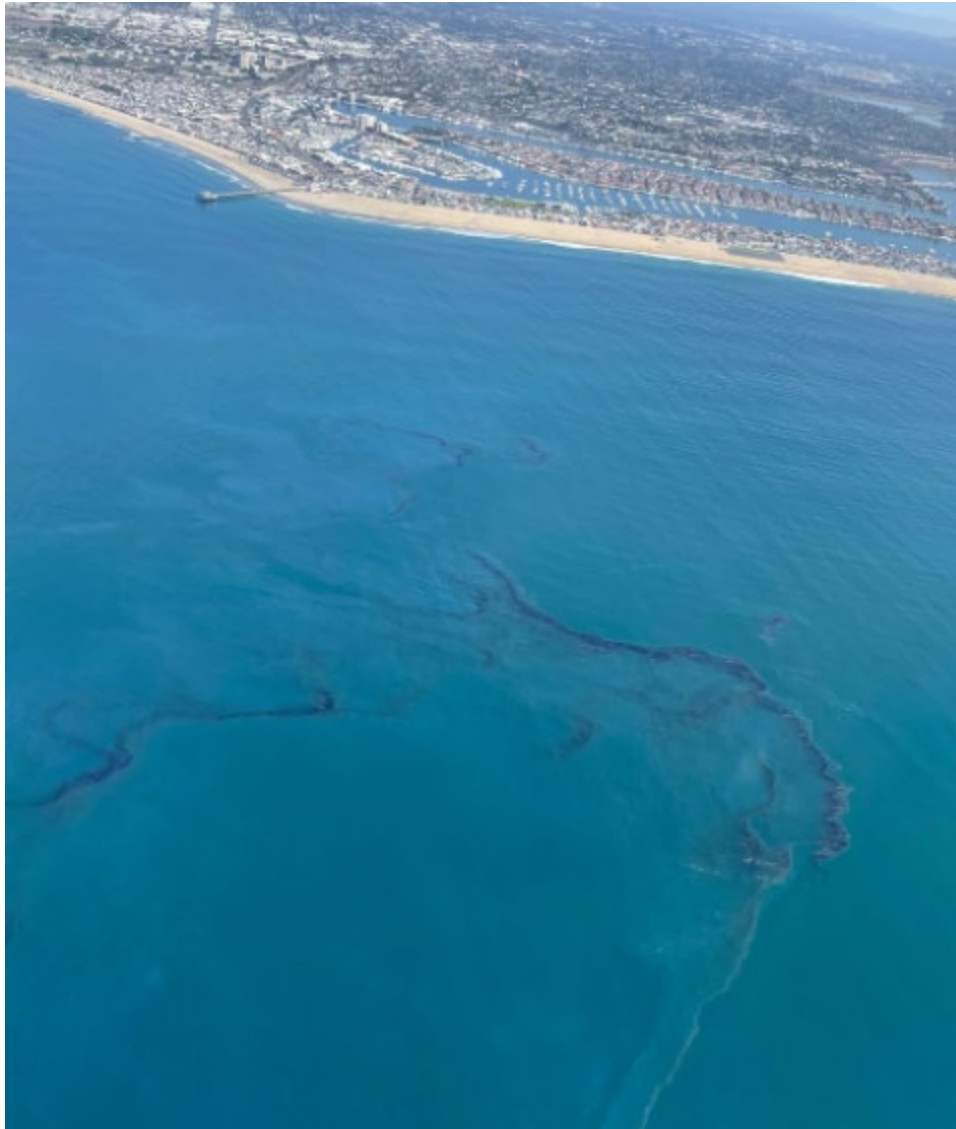
area about 60-foot wide by 1-1/2-miles, located about 4.5 miles south of the *Platform Elly*.³ See the pipeline release location in shown Figure 1.

Figure 1. Crude oil is shown in the Pacific Ocean offshore of Orange County, Oct. 3, 2021. Photograph courtesy of U.S. Coast Guard.

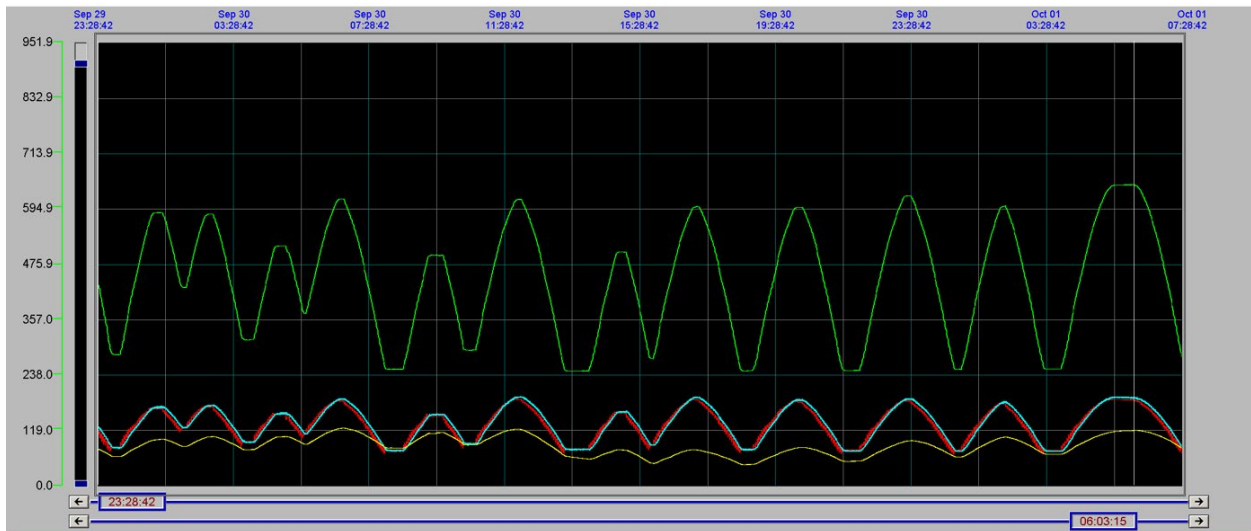
Around 16:00, the dayshift controller observed that the SPBPL mainline pressures on the console indicated normal operating pressure and flow patterns (shown in Figure 5) until 16:05, when the pattern changed from normal behavior as shown in Figure 6. At that time, there was a mainline pipeline pressure spike of 829-psig, which is below the maximum operating pressure of the pipeline, but above the normal operating pressure of the system. Figure 6 shows the pipeline operating flow and pressure changed from normal to erratic patterns.

Figure 5. San Pedro Bay Pipeline Normal Operating flow and pressure. The green line indicated the mainline pipeline pressure, the red line indicates the mainline total flow rate, the blue line indicates the raw flow rate into the pump station, and the yellow line indicates the pipeline inlet pressure.

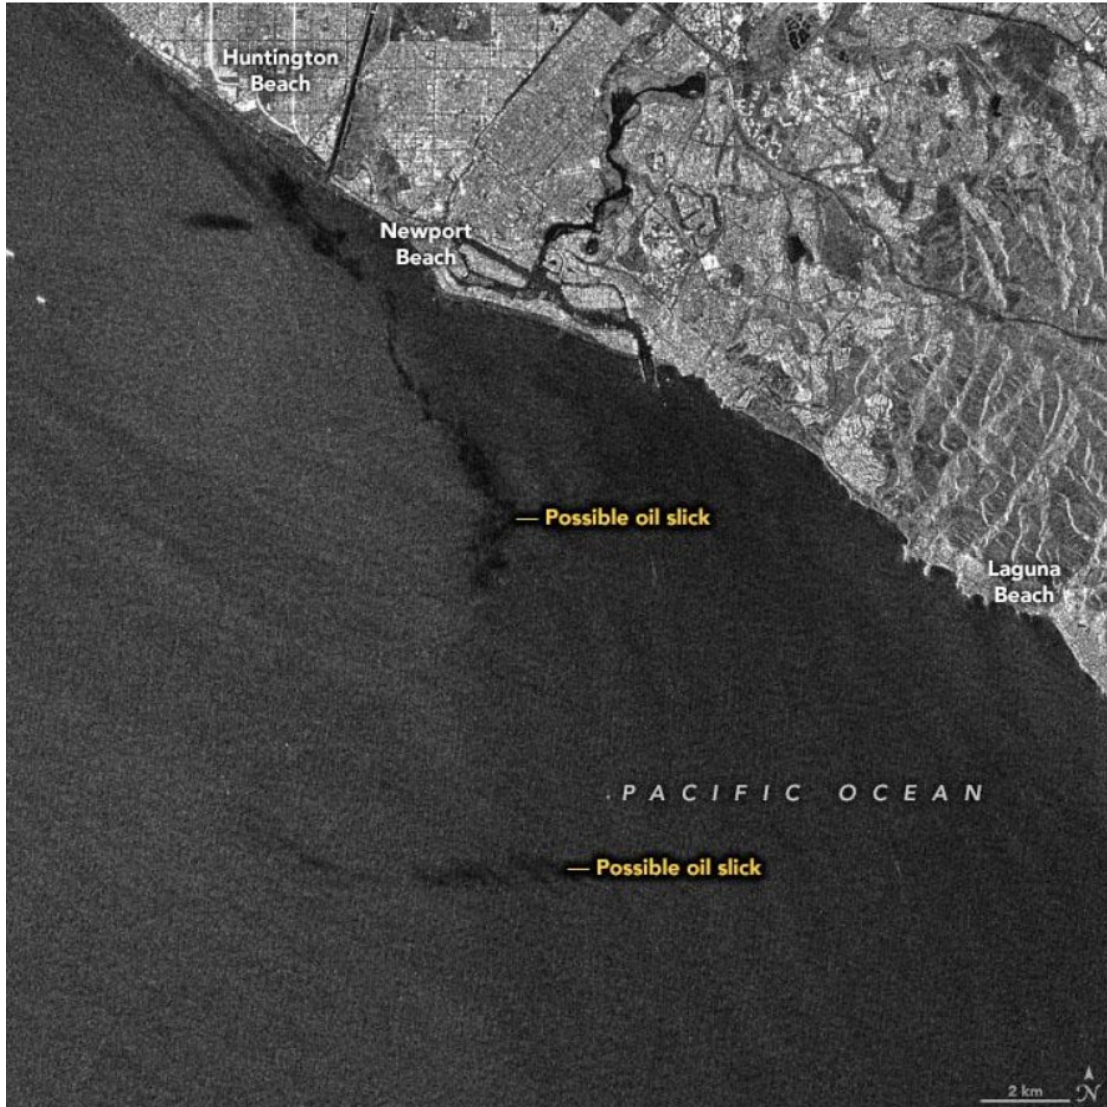
On October 1 at 19:58, the National Oceanic and Atmospheric Administration (NOAA) NOAA/NESDIS/satellite analysis branch observed an oil anomaly on satellite imagery and reported it to the NRC at 01:15 on October 2.²⁰ See Figure 8. NOAA did not characterize this anomaly as oil on water at that time.²¹ At 23:30, a seventh Atmos LDS alarm was activated while the pipeline was running.

Figure 8. Dark areas in this radar image captured by NASA Earth Observatory/Joshua Stevens at 18:49 on Oct. 2, 2021.

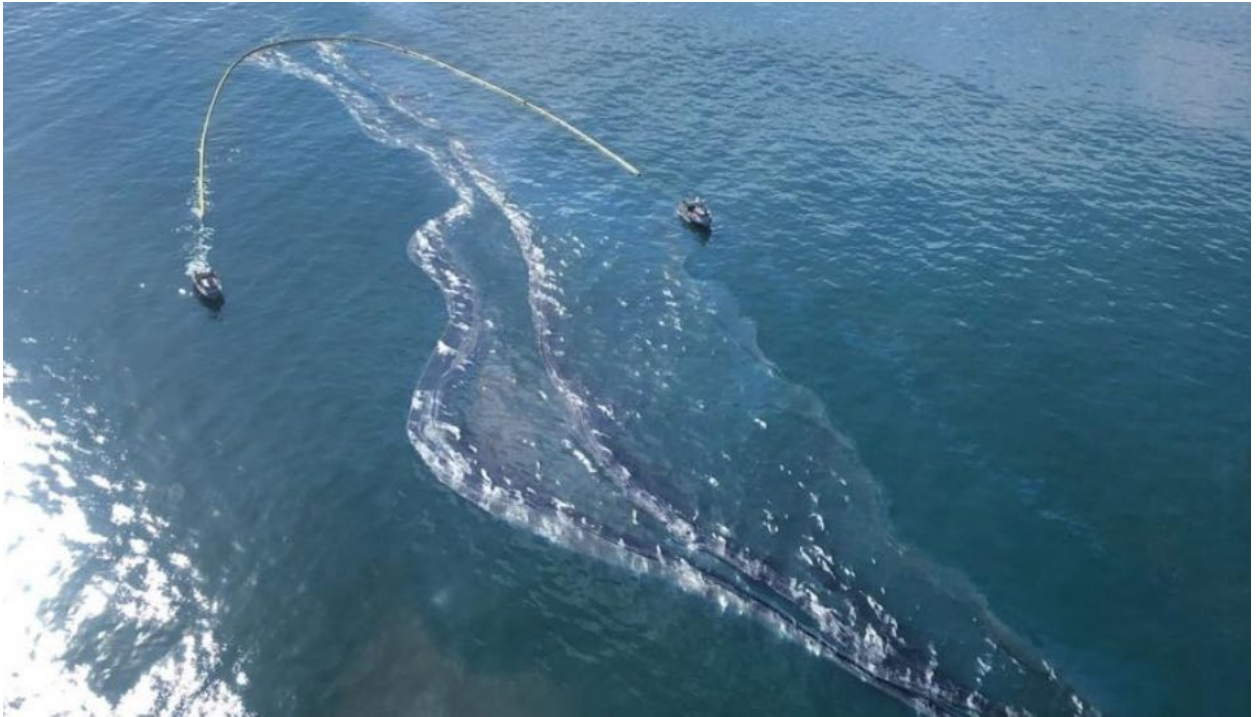
At 06:04, the controller stopped shipping, called out for an additional pipeline right-of-way survey when it was light out, and waited for the results. Sunrise occurred at 06:47. The vessel *Nicholas L* crew started inspecting the pipeline right-of-way at 07:10, starting from *Platform Elly* and traveling toward shore. At 08:09, the vessel crew confirmed there was oil on the water. They estimated a 60-foot-wide x 1 ½ mile long oil sheen that could be seen on the water, located about 4.7 miles from the shoreline. See Figure 9.

Figure 9. The unified command responded to and cleaned the crude oil spill off the California coast. Oil spill removal organization (OSROs) are shown towing skirted oil boom to contain the oil spill. Oct. 3, 2021. Photograph by U.S. Coast Guard.

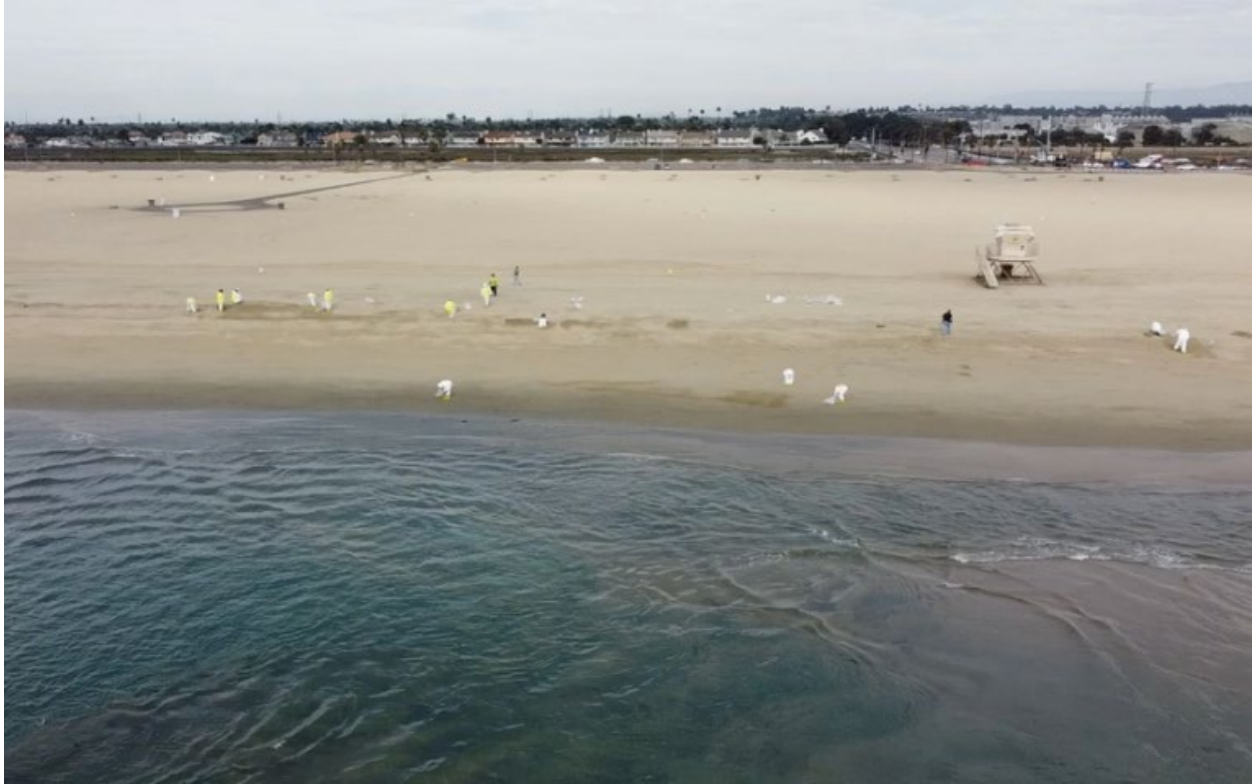
Figure 10. Shoreline crews conduct cleanup operations on Huntington Beach, Calif., October 4, 2021. Photograph courtesy U.S. Coast Guard.

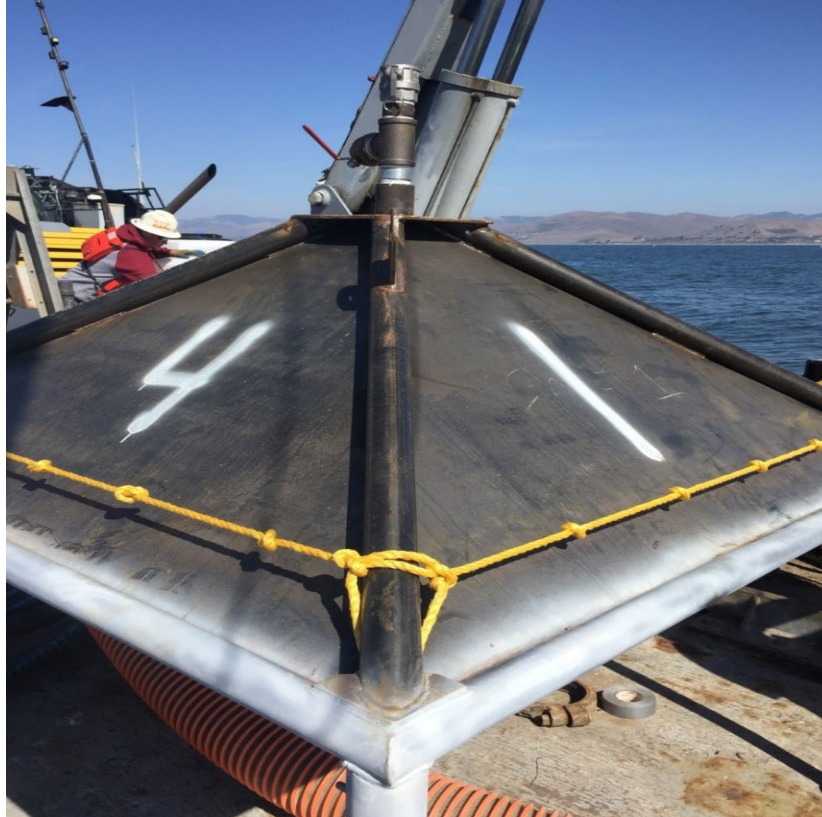
On November 20, 2021, when Beta Offshore divers re-inspected the crack, they found a 30-foot x 70-foot oil sheen on the water. Beta Offshore notified the UC and submitted an updated report to the NRC (Report No. 1322578 and update NRC No. 1322586). The divers inspected the previously applied wrap on the crack area and found small crude oil droplets that had moved around the wrap and were migrating to the surface. They removed the composite wrap and installed an epoxy and wrap over the crack. They then placed a pollution dome, which captures any oil released, over the crack area, as well as a camera for ongoing monitoring 24 hours 7 days per week.³¹ The dome (Figure 19) remained in place until all hydrocarbons were removed from the pipeline and the threat of pollution eliminated.

Figure 19. Pollution Dome Design and Fabricated and Ready for placement with a 53 Barrel Capacity. Photograph by Beta Offshore.
