**NATIONAL TRANSPORTATION SAFETY BOARD
OFFICE OF RAILROAD, PIPELINE, AND HAZARDOUS MATERIALS
INVESTIGATIONS
WASHINGTON, D.C. 20594**

**Pipeline Operations Group
Factual Report**

**Propane Pipeline Strike Near the EPIC Dock, Corpus Christi Ship Channel
Corpus Christi, Texas**

**NTSB# DCA20FM026
(99 Pages)**

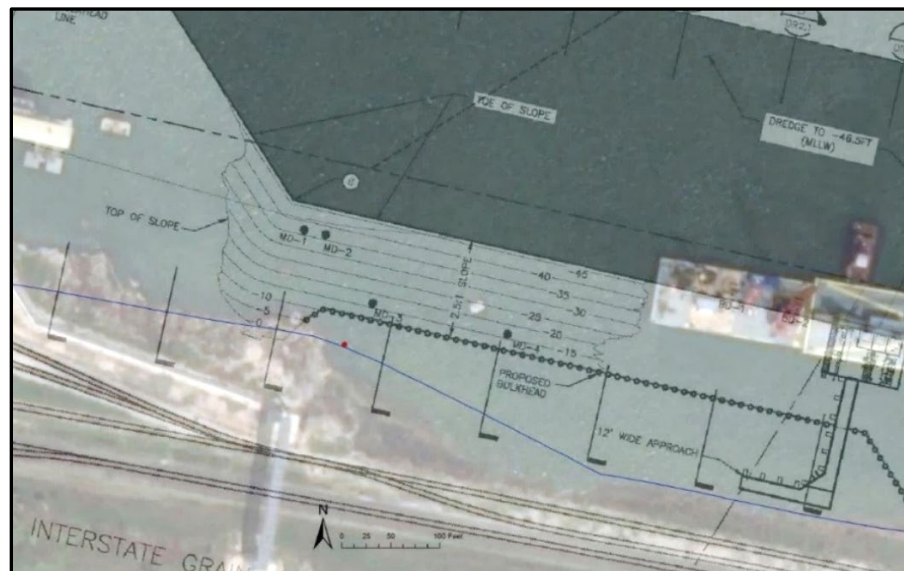
Figure 5. Excerpt of the June 23, 2020 Schneider Engineering revised dredging plan overlaid on Google Earth background, showing the TMI 2018 location of pipeline TX219 and the approximate accident location identified by a red dot.¹¹

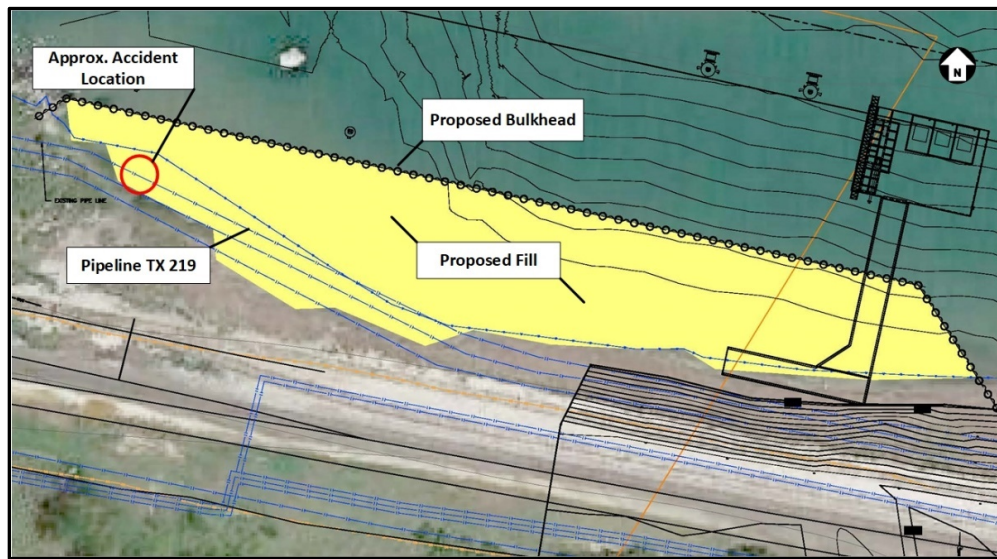
Figure 7. Annotated excerpt of Schneider Engineering & Consultants design and build plan for the EPIC East Dock, April 9, 2020, showing the proposed bulkhead, area to be filled, pipelines, and the approximate accident location. This drawing (without annotations) was included in the EPIC encroachment request to Enterprise Products on June 8, 2020.

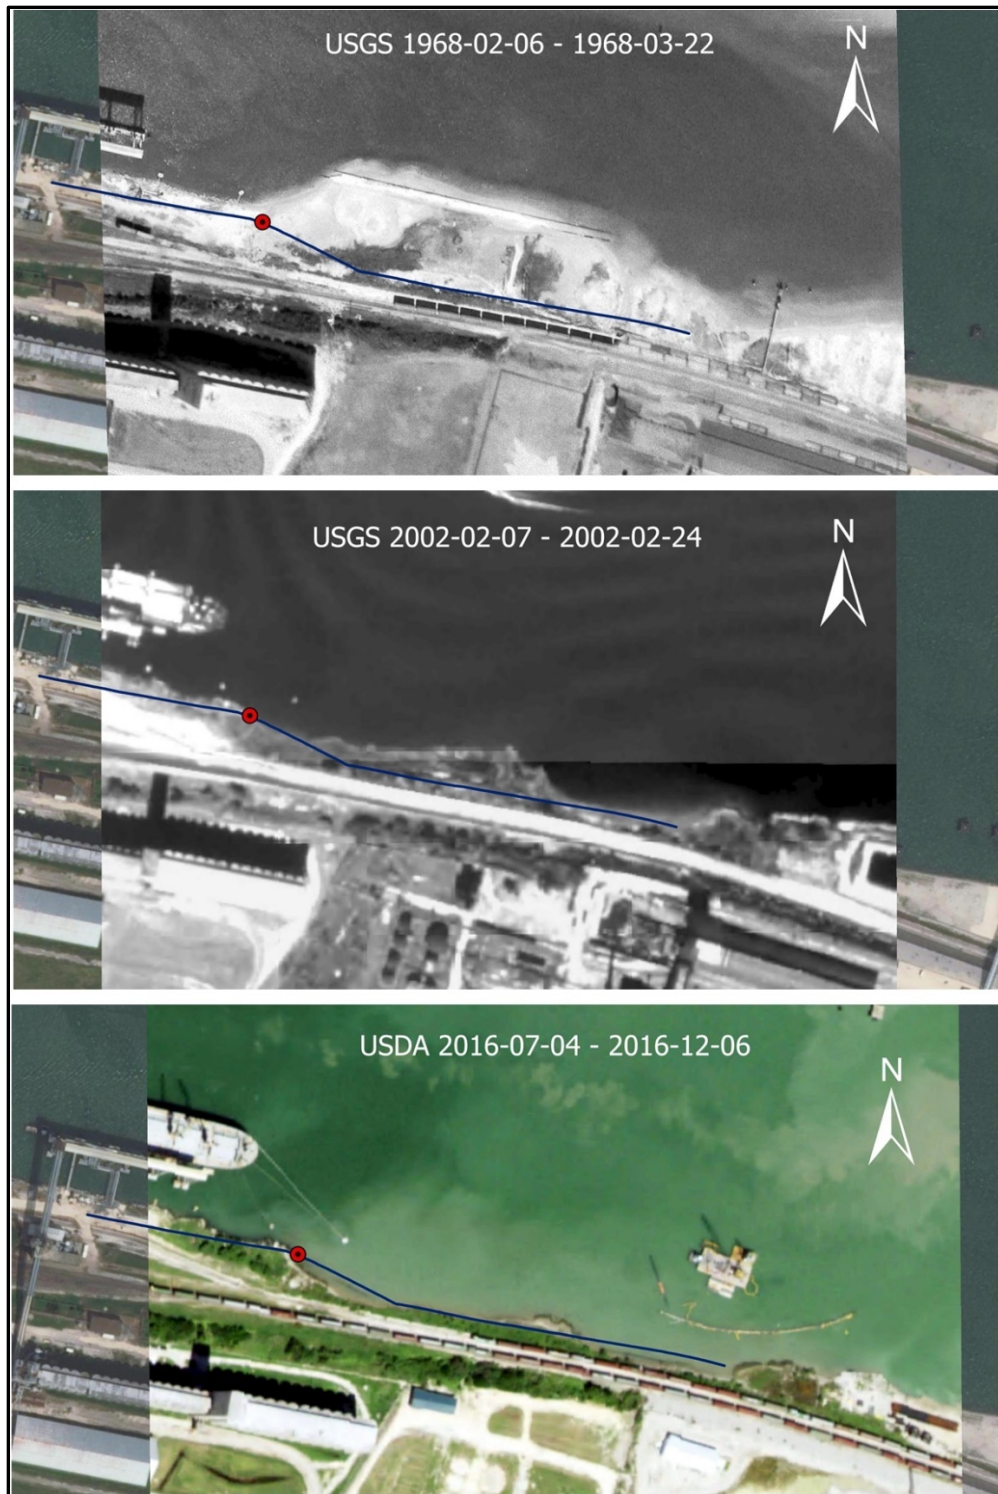
The breached segment of pipe had become situated within the waterway from years of progressive land loss near the EPIC Dock project area (Figure 12). The length of the pipeline TX219 segment traversing the waterway at the accident location was about 265 feet.⁴³

Figure 12, EPIC East Dock project area, 1968 (year the pipeline was installed), 2002, and 2016, showing the extent of land loss since its construction. USDA and USGS photographs overlaid on Google Earth image. The blue line indicates the location of pipeline TX219 (TMI Solutions, 2018) and the approximate accident location is indicated by the red circle.

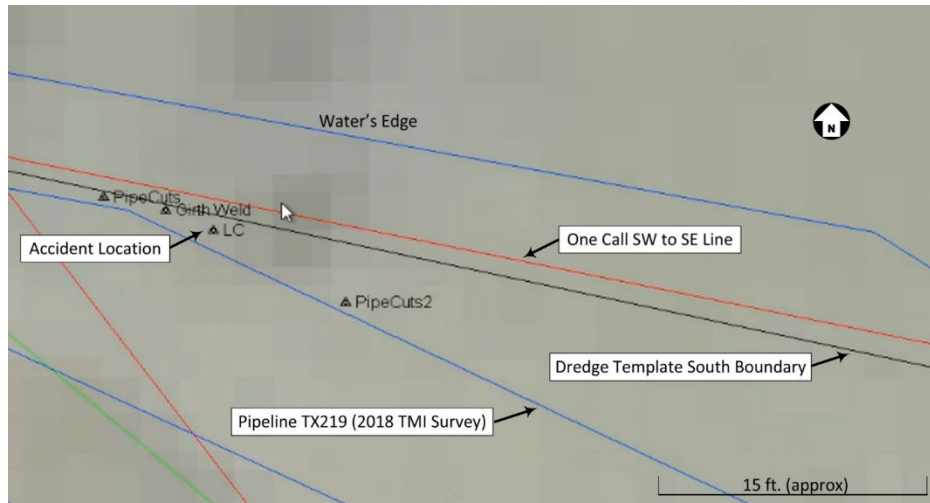
Figure 14. Plot in the HYPACK 2018 module of the Orion Group June 23, 2020 One-Call notification coordinates that were used to draw a southeast to south west line (red line), the Orion Group dredge template south boundary (black line), and pipeline TX219 location determined by the TMI Solutions LLC, December 28, 2018 utilities survey (blue line). The Enterprise Products pipe cut location survey and the accident location are also shown for reference. Courtesy HYPACK, a Xylem brand with NTSB annotations and approximate scale.

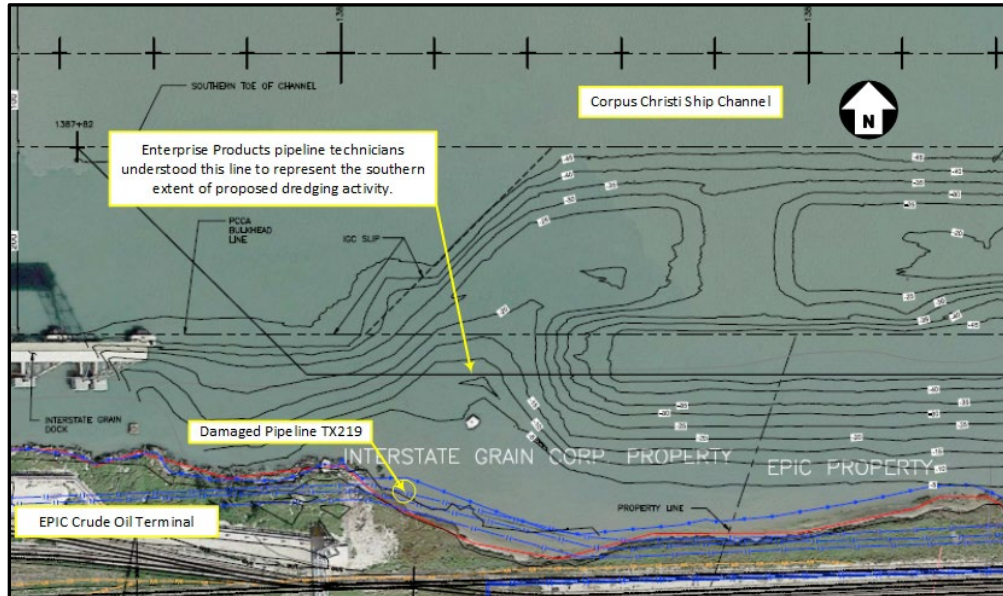
The Enterprise gas pipeline technician further stated that based upon the Orion project engineer’s June 29, 2020 email and as a result of his discussion with the Orion project engineer, he understood the southern boundary line of the prismatic area on the plan (identified by the yellow arrow in Figure 15) was supposed to represent the closest location that dredging was to occur near the Enterprise pipelines. The pipeline technicians did not use the plans Orion supplied to calculate the distance between the pipeline and what they understood to be the

Figure 15. Annotated excerpt of the Schneider Engineering EPIC Marine Terminal dredging construction plan the Orion Group project engineer emailed to the Enterprise Products gas pipeline technician on June 29, 2020. Annotations indicate the Enterprise Products pipeline technician's understanding of the southern boundary of the dredging project and the location of propane pipeline TX219 (yellow arrows). The approximate location of the pipeline damage is indicated by the yellow circle.

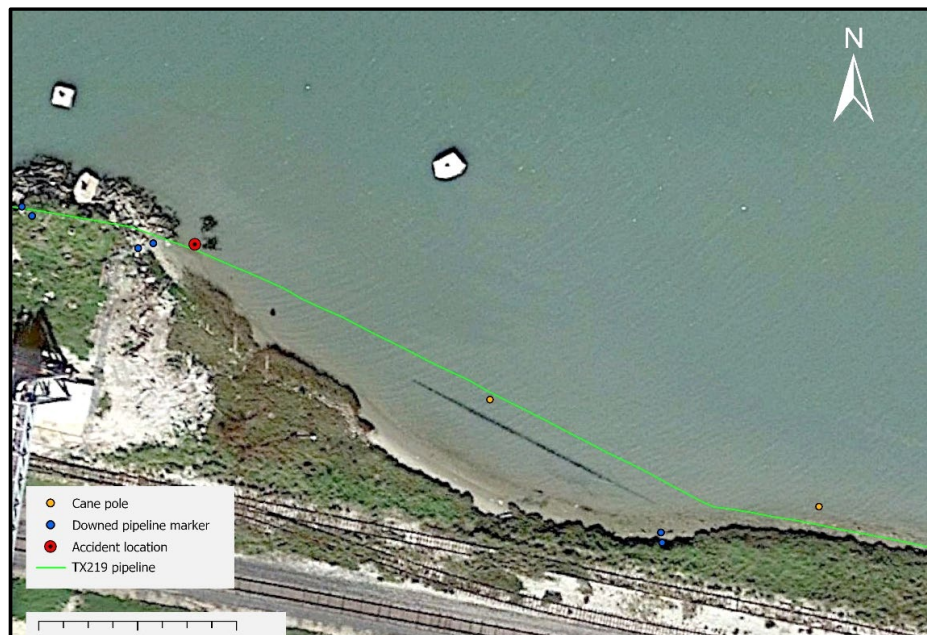
Figure 20. Post-accident September 30, 2020, Enterprise Products pipeline TX219 KML, temporary and permanent pipeline marker survey locations, and accident location projected on Maxar Technologies, Google Earth imagery of January 31, 2020. Cane pole GPS 2289 was located between the 10-inch non-Enterprise pipeline, which is partially visible as a dark line parallel to pipeline TX219 (green line).

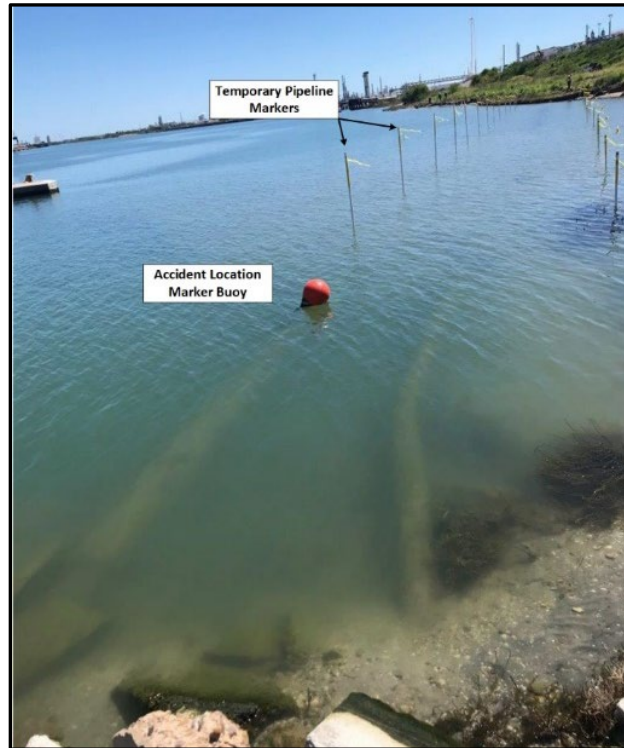
Figure 21. Temporary PVC pole pipeline marking for post-accident pipeline evidence recovery operations. The accident location is marked with a red buoy that divers affixed to pipeline TX219 where it was damaged. Courtesy, Enterprise Products, October 1, 2020.

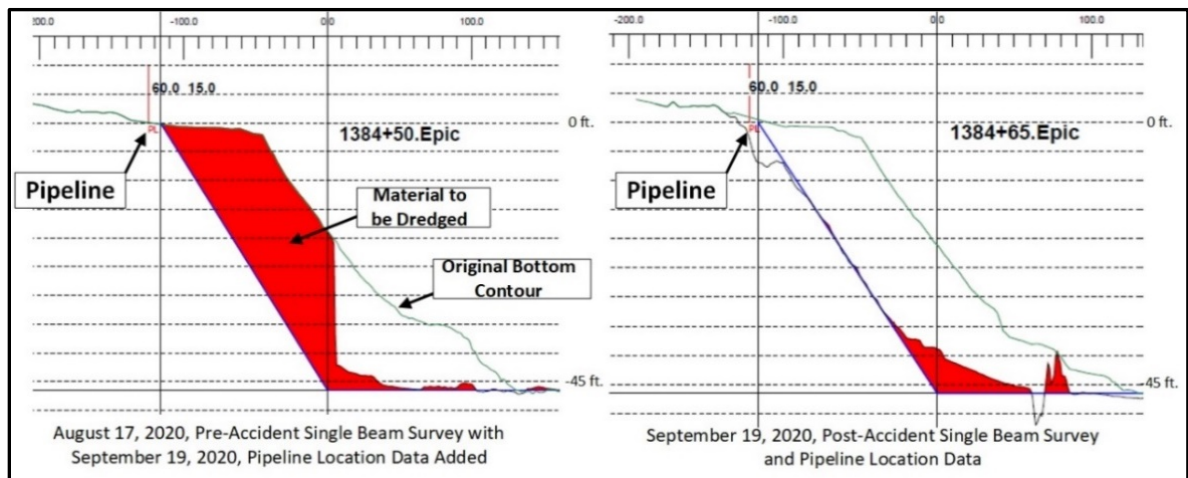
Although he believed the pipelines were outside of the dredge template, on the day of the accident the Orion survey superintendent reviewed the file to reexamine their location in relation to the dredge template. On September 19, 2020, Orion survey crews conducted a post-accident GPS survey to verify the pipeline location and separation distance outside of the template. According to the survey superintendent, this survey found TX219 was 6 ½ to 7 feet from the template at its closest point (see Figure 24).¹¹⁸

Figure 24. Orion Group single beam survey cross sections near the damaged pipeline. The location of the pipeline as determined by Orion's September 19, 2020 GPS survey was added to the pre-accident scan taken on August 17, 2020 (left). The post-accident scan closest to the pipeline is shown on the right.

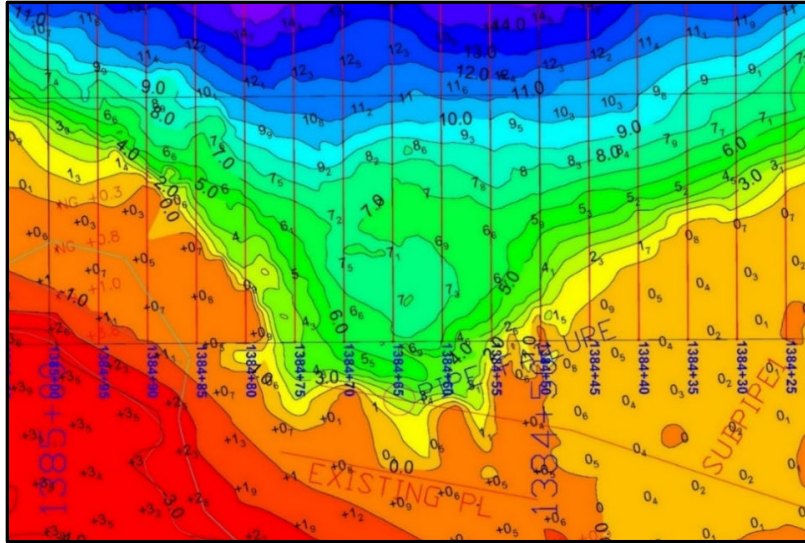
Figure 25. Excerpt of September 19, 2020, Orion Marine Group post-accident plan-view single beam hydrographic survey with dredge template overlay. The surveyed location of the breached pipeline TX219 (orange line) and the location of the “pipe failure” (orange circle) are shown. Coordinate system NAD83, Texas State Plane Grid, South Zone, U.S. Survey Feet.

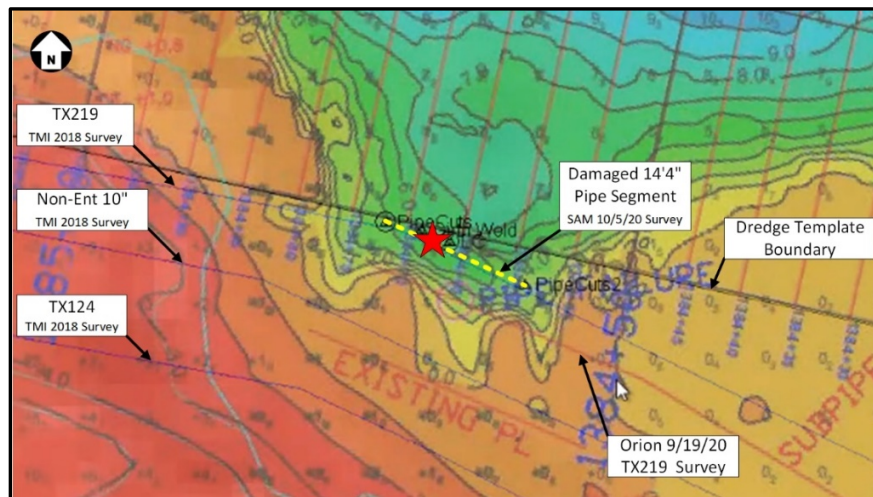
On October 5, 2020, Enterprise contractor SAM collected GPS location data for the east and west pipe cuts that were made to recover a 14 ft. 4 in. segment of the damaged pipeline.¹³⁶ The damaged pipe segment and the location of the accident, measured to be 2 ft. 8 in. east of girth weld 444000, are annotated over a HYPACK 2018 view shown in Figure 26.¹³⁷

Figure 26. Orion Group September 19, 2020, post-accident single beam hydrographic survey, dredge template, and pipeline location base image overlaid onto the TMI Solutions LLC December 28, 2018, pipeline surveys using HYPACK 2018. The SAM survey of the pipe cut locations for the recovered

damaged pipeline segment on October 5, 2020 is depicted with the dashed yellow line and the approximate accident location is indicated by the red star. Dredge template station lines are 5-foot intervals. Image overlay courtesy HYPACK, a Xylem brand with NTSB annotations.

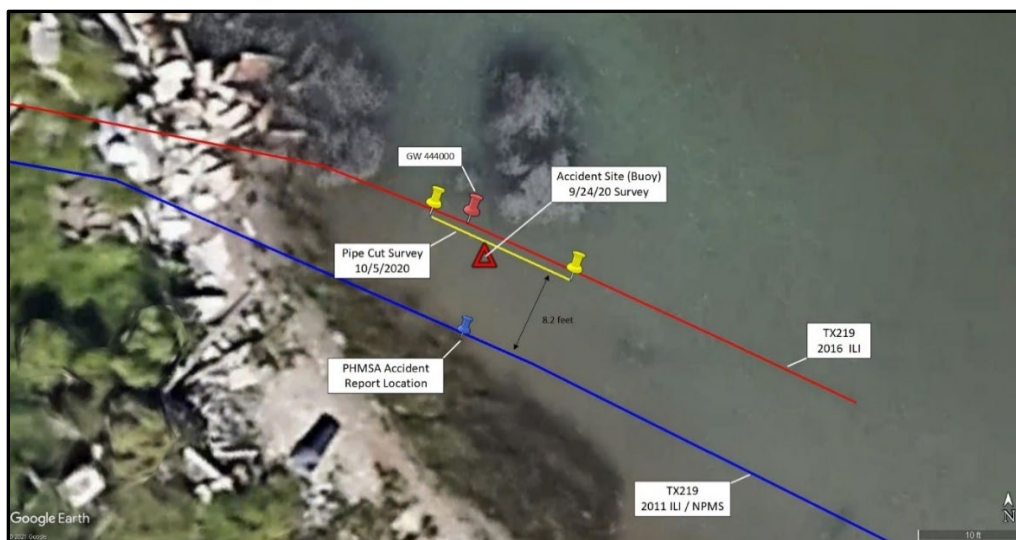
Post-accident surveys and pre-accident inline inspections also also found a difference in the reported location of TX219 and GIS data Enterprise maintained for the line as determined by the 2011 Rosen Group ILI location data. Figure 28 shows a Google Earth view, approximating the location of the offset between the Rosen 2011 ILI location data and the SAM post-accident October 5, 2020 pipeline cut survey, measured to about 8.2 feet near the accident location using Google Earth tools.¹³⁸

Figure 28. Annotated Google Earth base image showing approximate location data for pipeline TX219, including from south to north, the Rosen Group 2011 ILI inline inspection GPS location coordinates file (blue line), the SAM October 5, 2020 evidence recovery pipe cut survey (yellow markers), and the Rosen Group 2016 inline inspection GPS location coordinates (red line). The accident site as determined by a September 24, 2020 SAM survey of a buoy marker is indicated by a red triangle. The base imagery date is January 31, 2020.

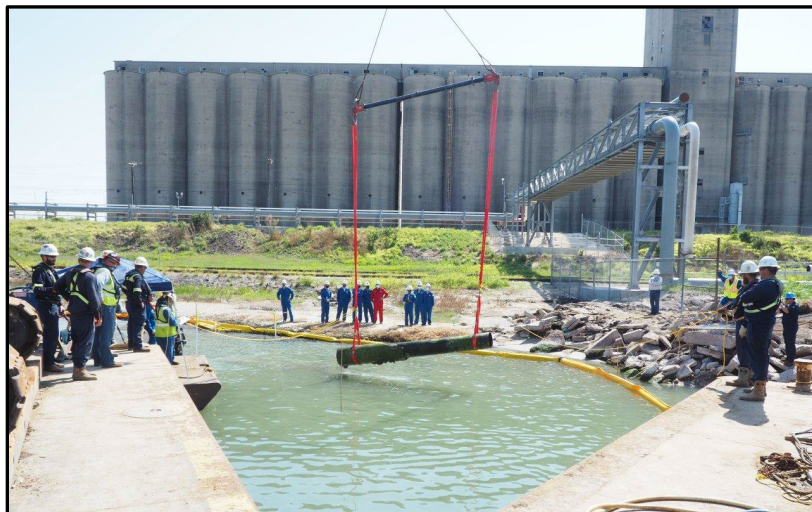
Figure 30. Photograph facing south toward the shoreline as Enterprise Products crews and contractors rigged the extracted damaged pipeline segment from the accident location, October 5, 2020. Courtesy, Enterprise Products.
