National Transportation Safety Board

Group Chairman's Factual Report of the Investigation

Natural Gas Pipeline Rupture and Fire

Hillsboro, Kentucky

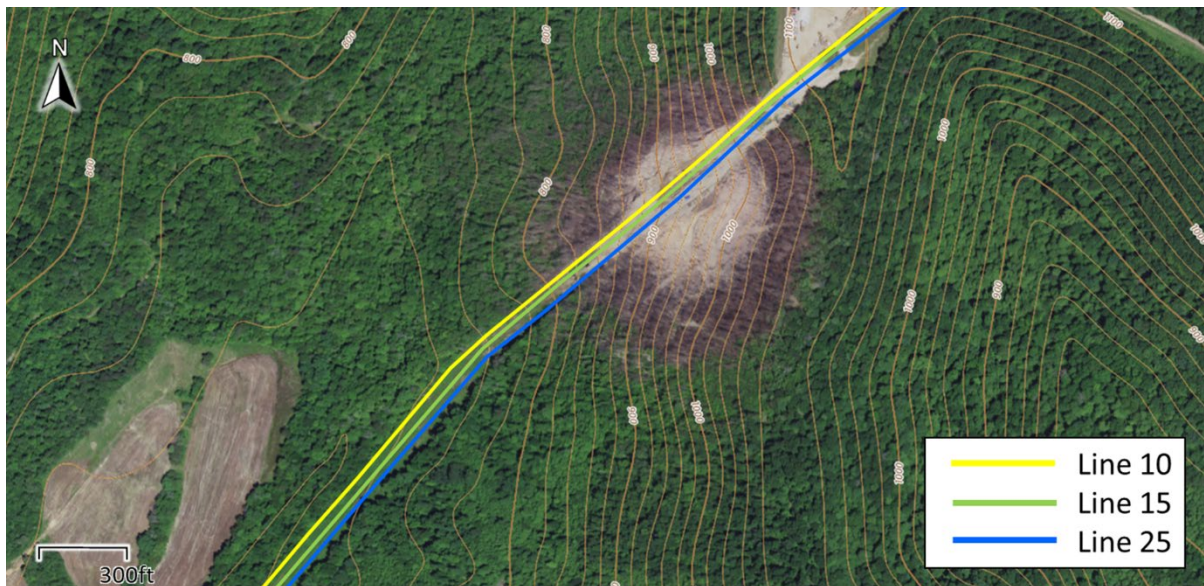
Figure 1. Location of Accident Near Hillsboro, Kentucky⁶

On Monday, May 4, 2020, at about 4:36 p.m., an interstate natural gas transmission pipeline owned and operated by Enbridge Inc. (Enbridge) ruptured, resulting in a subsequent fire in a Class 1 location about 3 miles east-northeast of Hillsboro, Kentucky.² The failure occurred on Texas Eastern Transmission (TET) Line 10 at a location that had been previously identified by Enbridge for geotechnical monitoring and mitigation due to an active landslide.^{3,4} The elevation profile and burned area are shown in Figure 1.

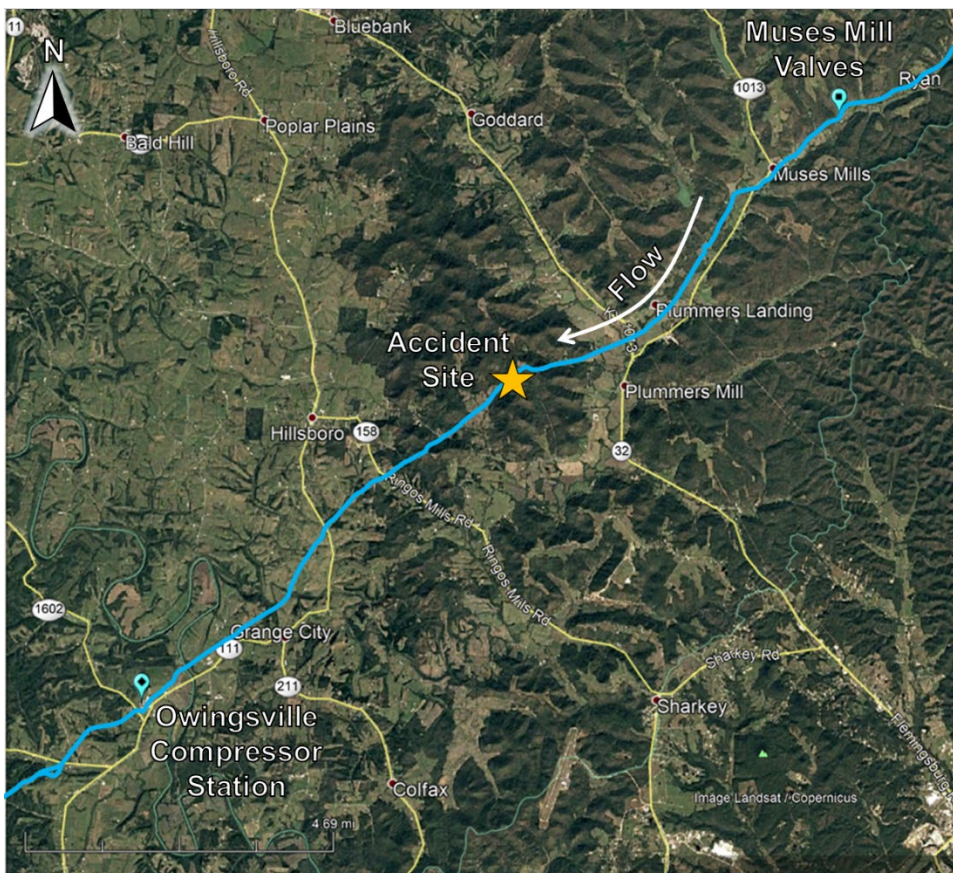
Figure 3. Map of TET Near Accident Site²³

The rupture occurred at a girth weld on Line 10, approximately 7.8 miles northeast of Owingsville Compressor Station (CS) (Figure 3). The failed girth weld had two associated identification numbers, “BHGE HW 12752961” and “EN WN 11330,” and was located at an elevation of approximately 923.35 feet. This failed girth weld location corresponds to station 26921 + 67 (Mile Post 509.876) on Enbridge alignment sheets.²²
