**NATIONAL TRANSPORTATION SAFETY BOARD**

**Attachment 3 –Sitec Aerospace Hydraulic Fire Shut-Off Valves Test Report**

# Engineering Investigation Report

DOC. NO. E03A00-144-02

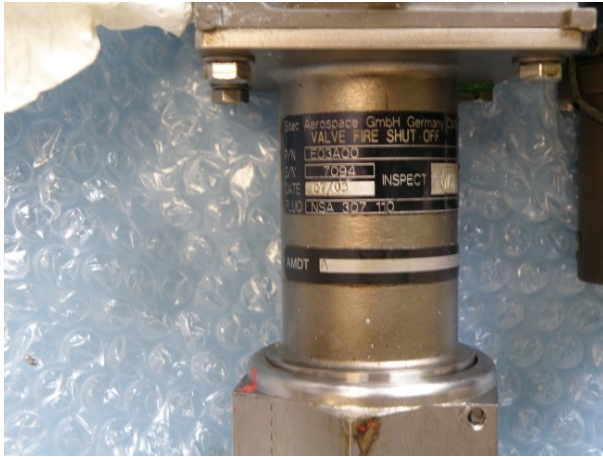
Figure 1: Yellow FSOV S/N 7094

The FSOV with serial number 7094 installed in the yellow hydraulic circuit was inspected first since the reservoir of this circuit was found to be empty after the incident.

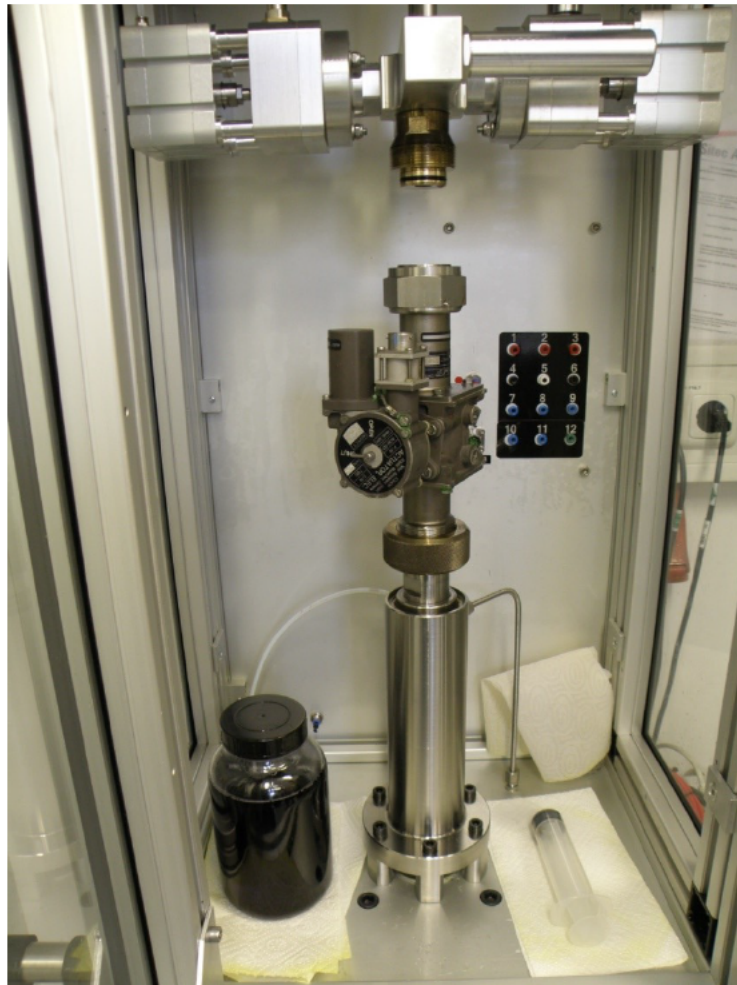
Figure 12: ATP Test Stand with FSOV

The unit was connected to the ATP test stand KA6360-M064 SN1 and the pressure was manually increased to 2 bars, 3.5 bars and 5.2 bars. For each pressure setting the leakage was measured.

On the ATP test stand the pressure is applied with a cylinder which is forced towards the valve and compresses the skydrol inside the system. Once the required pressure level is reached the leakage of the valve results in a further movement of the cylinder. Therefore leakage rate is not measured directly but calculated from movement of the cylinder.

It can be noticed that a higher pressure level results in a lower leakage rate due to the fact that the higher the pressure the higher the force on the ball forcing it into the sealing ring which further reduces the leakage. This is a typical static sealing behavior of valves.

As per ATP E03A00-05 Issue 01 §3.3 of the FSOV (Appendix B) the internal leakage rate (ball in closed position) should be below 0.7 cm<sup>3</sup>/min. Therefore all measurements are within specification and indicate that the valve is fully closed.

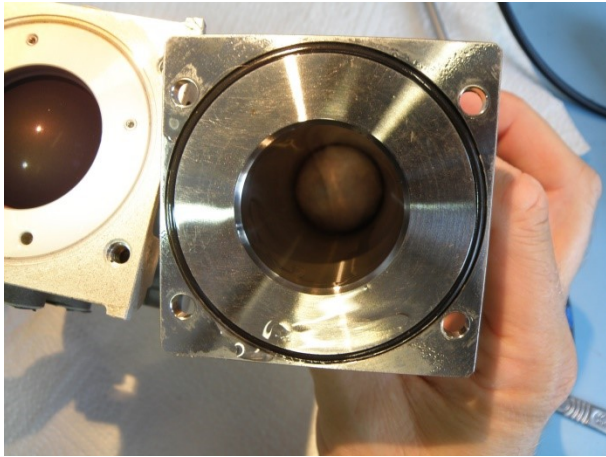
Figure 30: O- ring seal of valve flange

- When the flanges were disassembled from the valve body all screws were still tight.
- The o-rings were found to be in good condition. No scratches or dents could be detected on either body or flanges.
- No imperfections of neither ball nor sealings were found. No dirt or other FOD was detected (Figure 31).

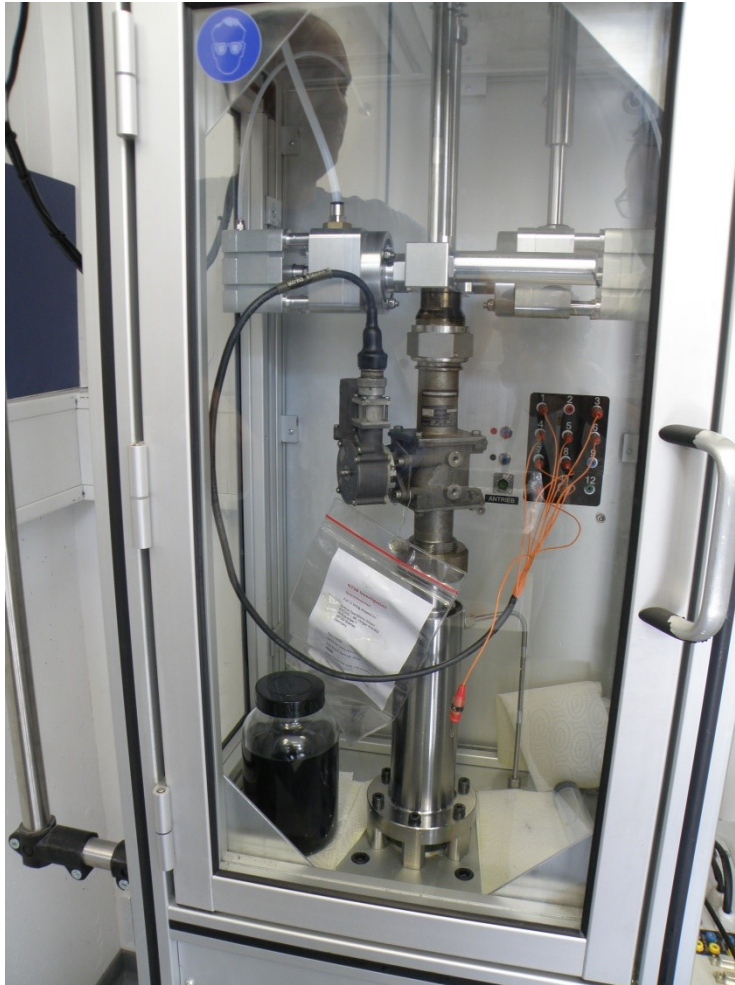
Figure 36: Green FSOV S/N7095 on ATP test stand

The acceptance test procedure was carried out in accordance with E03A00-05 issue 01 on the ATP test stand. All electrical values and leakage rates were in tolerance. The travel time was in tolerance. The bonding measurement failed due to the loose screw holding the bonding leash. The ATR can be found in Appendix C.
