Railroad Investigation Report RIR-23-15

Derailment of Washington Metropolitan Area Transit Authority Train Near Rosslyn Station

Arlington, Virginia
October 12, 2021

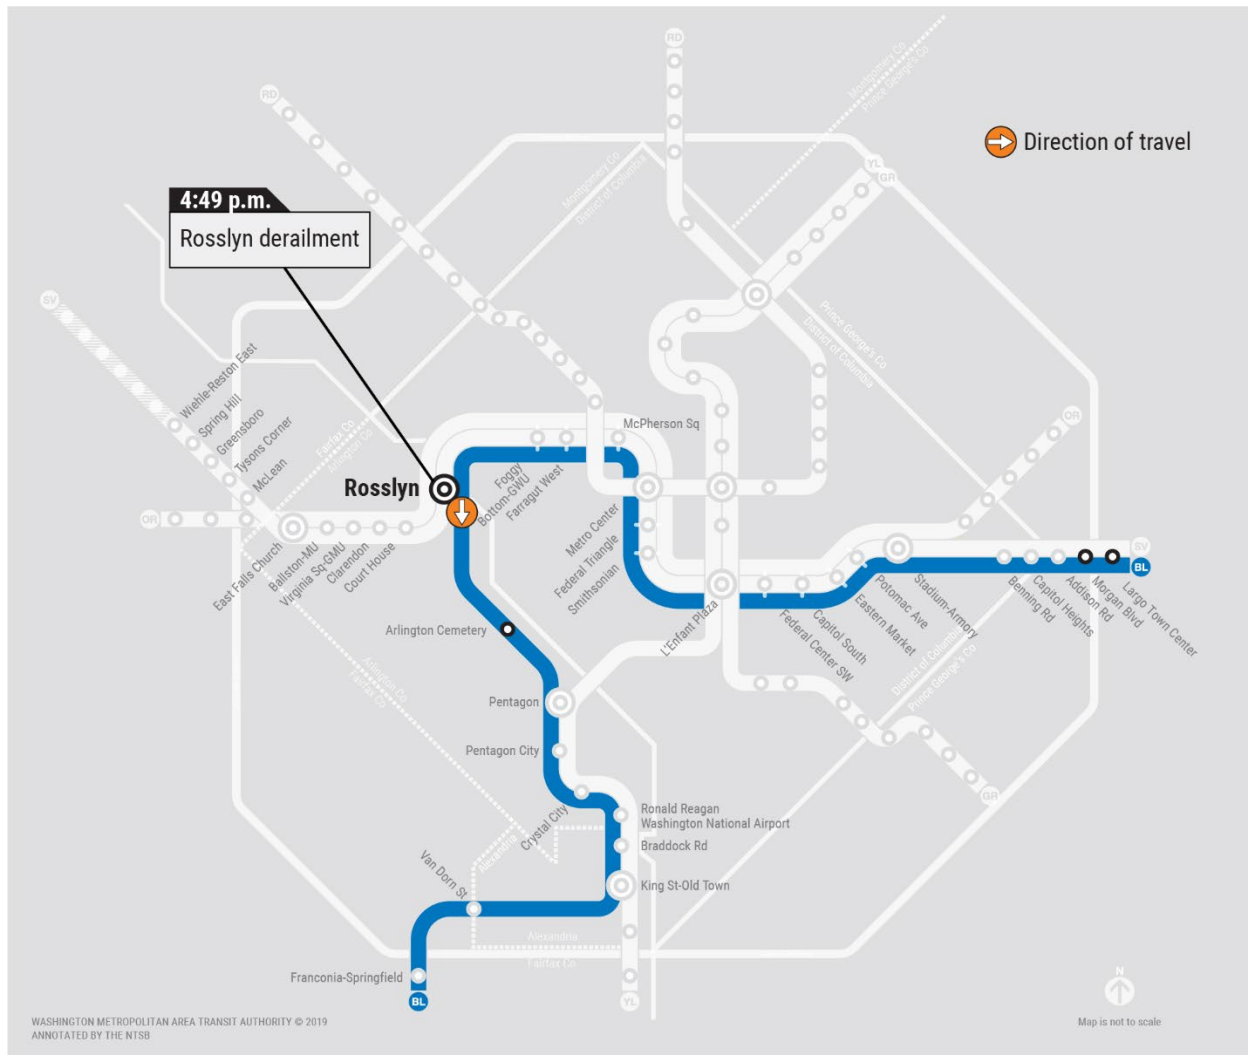
Figure 1. Map showing the Rosslyn derailment.

On October 12, 2021, about 4:49 p.m. local time, Washington Metropolitan Area Transit Authority (WMATA) train 407, consisting of eight 7000-series railcars, was traveling from Rosslyn Station toward Arlington Cemetery Station on track 2 of the Blue Line in Arlington, Virginia, when the last wheelset on the fourth railcar (wheelset #4 on railcar 7200) derailed.¹ The derailment occurred at a turnout within a tunnel south of Rosslyn Station.² (See figure 1.) The train was traveling about 37 mph before the derailment. The train decelerated after the derailment, traveling about 430 feet before the operator stopped it within the tunnel. All railcars remained upright and in-line.

Train 407 was traveling on main track 2 on the Blue Line from Rosslyn Station toward Arlington Cemetery Station when, about 4:49 p.m., the train began to decelerate south of the Rosslyn Station platform. Data from an inward-facing image recorder in railcar 7200 showed the railcar moving laterally relative to other railcars at 4:49:22 p.m. and a shower of sparks visible through a window on the right side.

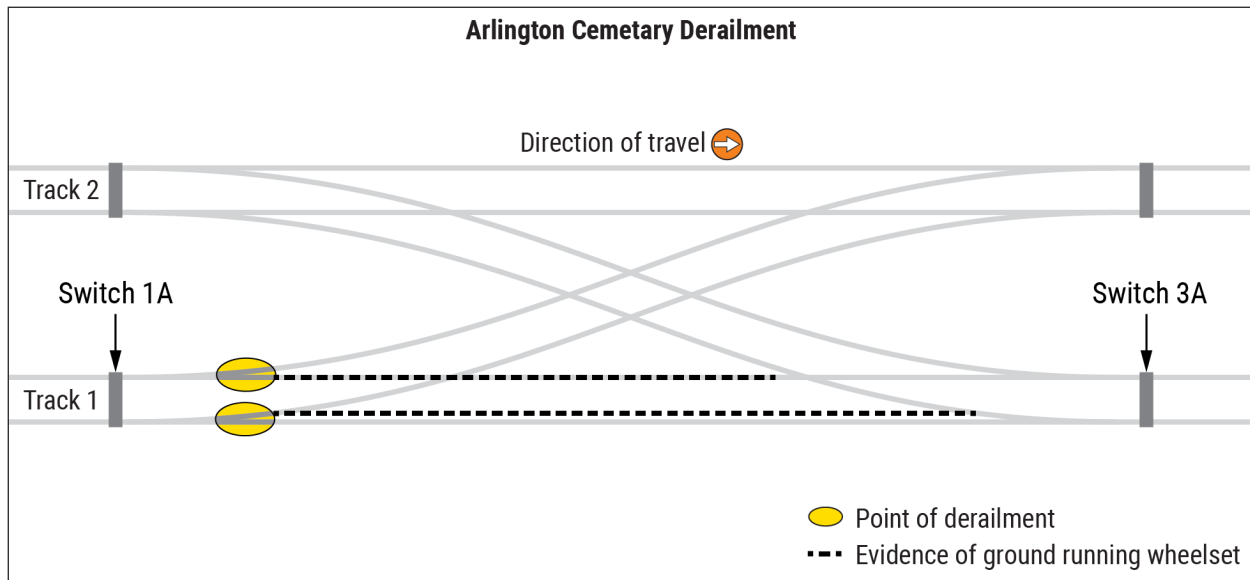
Figure 6. Diagram of Arlington Cemetery derailment site.

As a result of the investigation into the Rosslyn Station derailment, WMATA employees discovered damage to switches 1A and 3A chain marker 187+25 on main track 1 in a crossover north of Arlington Cemetery Station, including wheel flange departure marks near the switch point (across a switch point guard) of switch 1A.¹² (See Figure 5.) While examining the track between switch 1A and switch 3A, the NTSB noted damage to two switch heel blocks, bolts, ties, and automatic train control

equipment consistent with one or more derailed wheels running along the ground and re-railing as they approached switch 3A. (See figure 6.) WMATA employees also found broken sections of brake disc in this area, which the NTSB matched to the right-side brake disc on wheelset #4 of railcar 7200.¹³

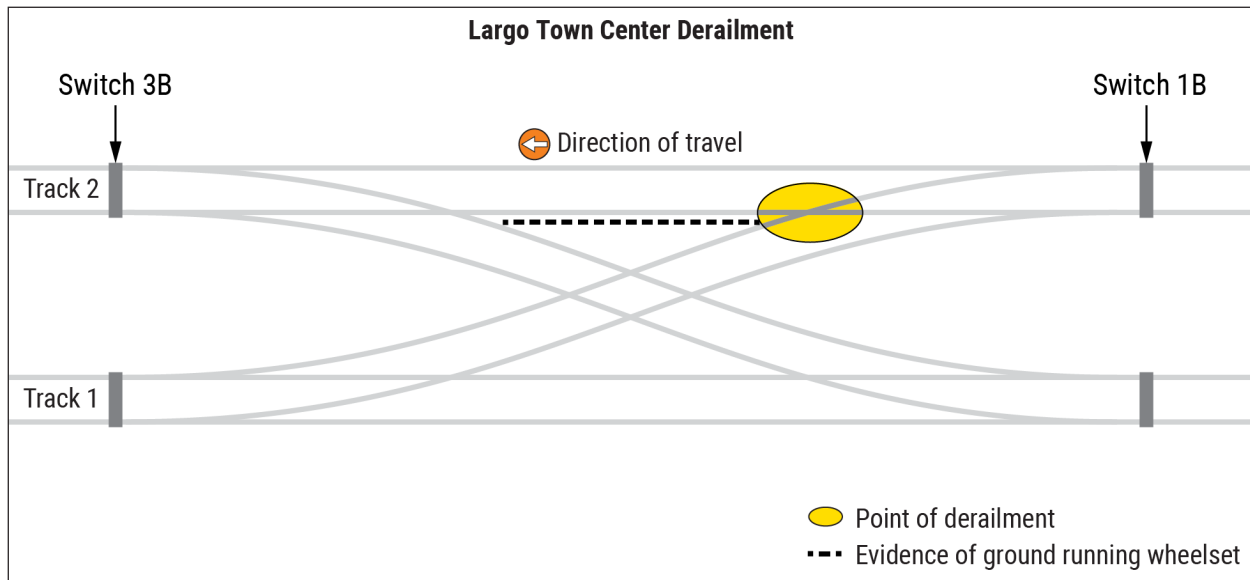
Figure 8. Diagram of Largo Town Center derailment site.

The NTSB also identified wheel flange departure marks on the tread portion of the track (the tread portion carries the wheel tread) on switches 1B and 3B at crossover G05 west of Largo Town Center Station at chain marker 621+98 on main track 2. (See figure 7.) In addition, the NTSB identified wheel marks on the ground, broken ground pads, and damaged automatic train control equipment between switch 1B and switch 3B. The damage was consistent with one or more derailed

wheels running along the ground and re-railing as it neared switch 3B. The NTSB found fragments of brake disc at the crossover.¹⁴

About 4:13 p.m., a camera at the southwest end of the Largo Town Center Station platform recorded railcar 7200 moving side-to-side in a manner consistent with derailment as the train departed the station and railcar 7200 traversed crossover G05. The camera also recorded a dust plume beneath railcar 7200, consistent with a railcar component contacting the concrete beneath the rails. Railcar 7200 resumed normal motion after about 5 seconds. No other railcars exhibited unusual motion.

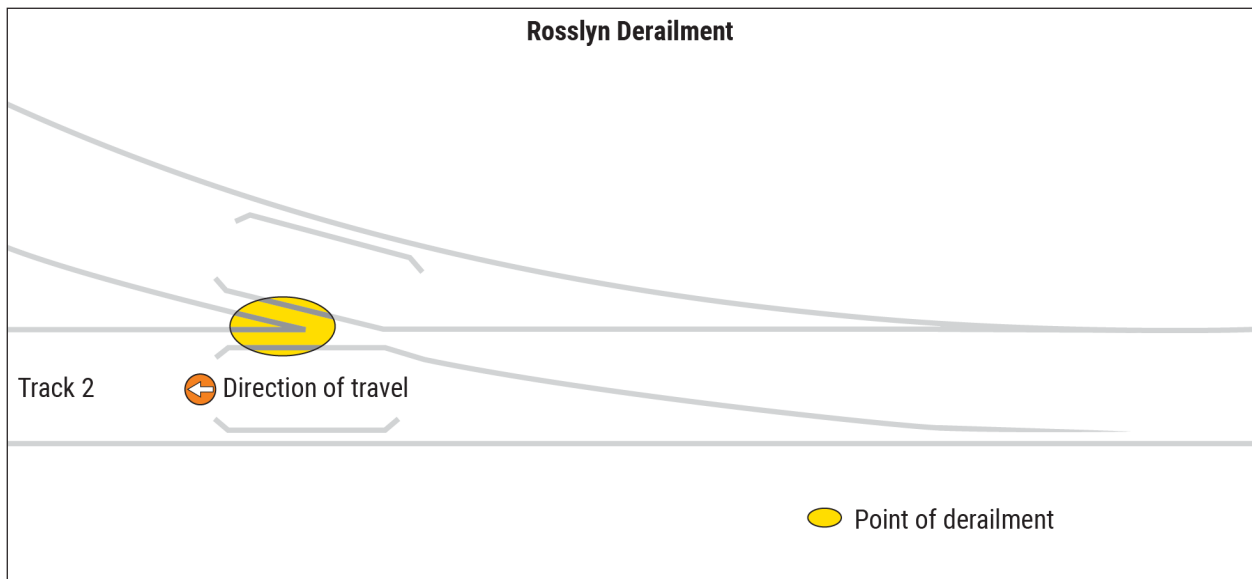
Figure 10. Diagram of Rosslyn derailment site.

The NTSB identified wheel flange departure marks in the turnout at the frog of the switch in the C05 turnout at chain marker 146+70, about 166 feet south of Rosslyn Station. (See figure 9 and figure 10.) Investigators also found wheel departure marks on other track components nearby. This turnout was the final point of derailment.

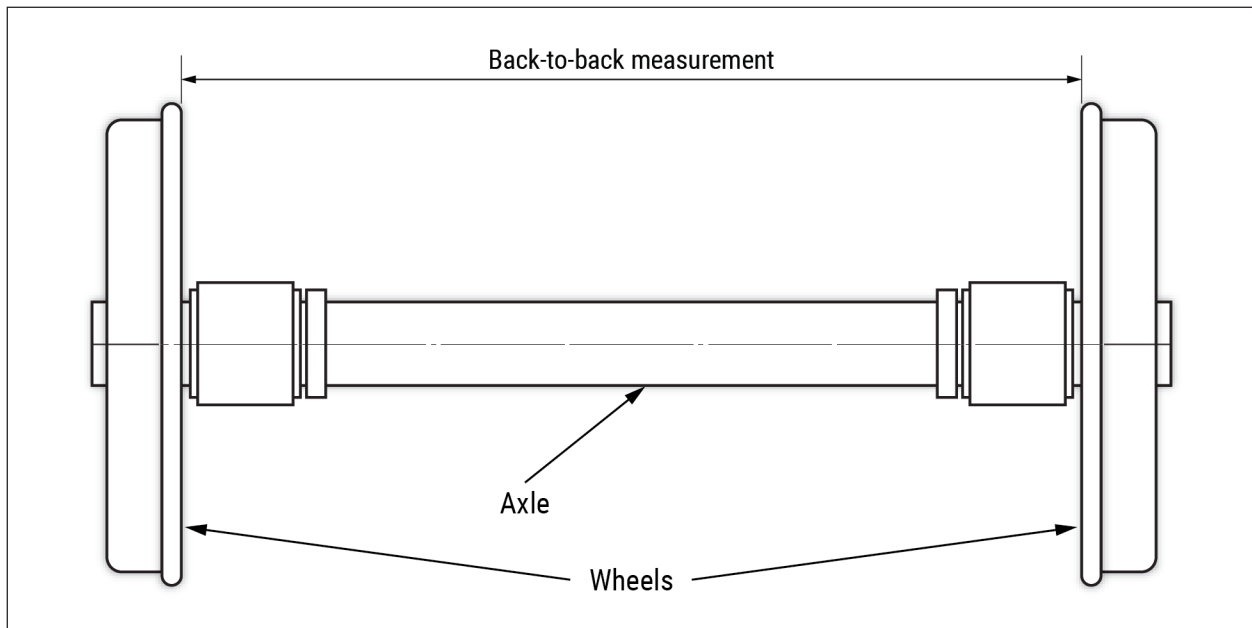
Figure 11. Diagram of a back-to-back measurement.

On October 16, 2021, the NTSB worked with WMATA technicians to inspect the lead truck (containing wheelsets #3 and #4) on railcar 7200. All inspected components were within WMATA's design specifications except for wheelset #4, which had an out-of-specification back-to-back measurement as described below. A back-to-back measurement is the distance between the inner faces of the wheels on a single axle. (See figure 11.)
