RECORD OF CONVERSATION

Date: April 25, 2020
Person Contacted: Gary Hendrickson (Aviation Safety Inspector – Airworthiness)
NTSB Accident Number: WPR20LA130

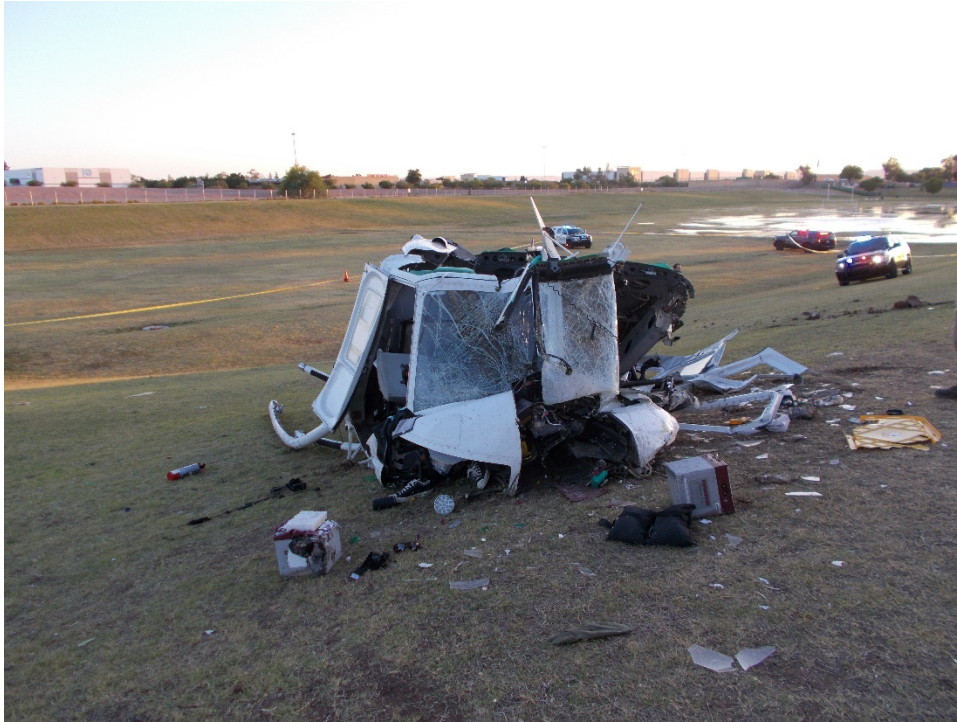
Figure 4: The Front of the Helicopter

- Continuing along the debris path were two long and narrow ground strikes consistent with main rotor blade strikes.
- Next was the main wreckage, which came to rest on a small hill. The helicopter was slightly nose and left side low facing a heading of about 49 degrees. The helicopter exhibited upward crushing throughout the cabin and fuselage, most extensively on the left side of the fuselage. The mast and the main transmission were displaced forward, and the main rotor assembly was fracture separated.

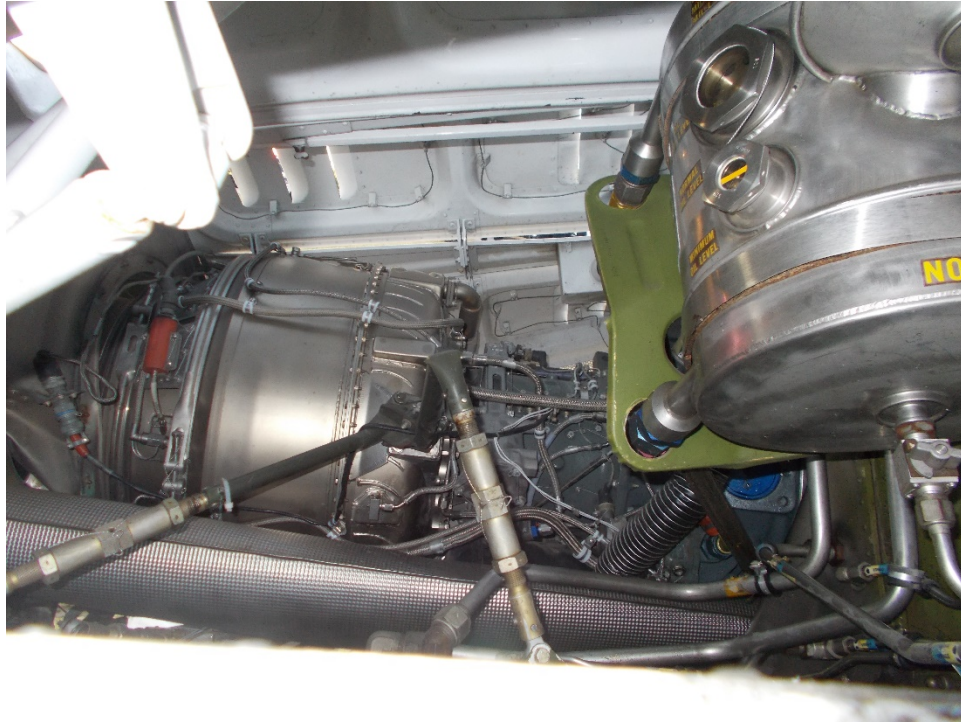
Figure 10: Engine Compartment

- Honeywell representatives were present on scene and they reported metal spray was noted on the turbine blades.
 - There was a strong, pungent, smell of Jet A fuel around the main wreckage.

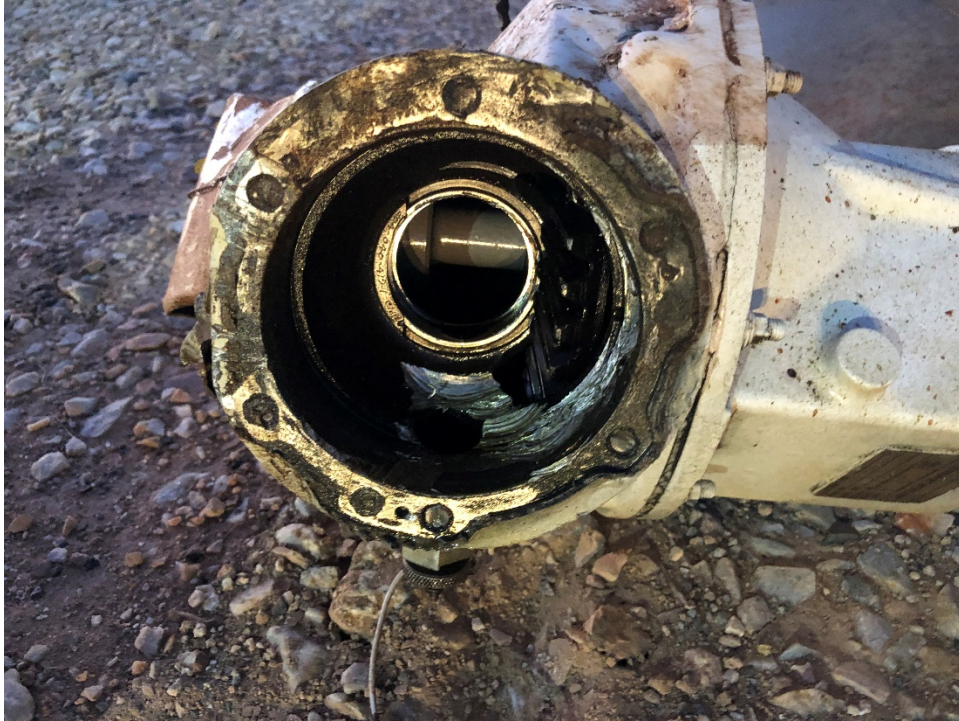
Figure 18: 90-degree Gearbox Attachment Points

- The 90-degree gearbox housing exhibited rotational scoring where the input quill would be present.
 - The input quill came to rest inside of a nearby building and it impacted a concrete floor.
