# National Transportation Safety Board

## **TANK CAR DERAILMENT DAMAGE FACTUAL REPORT**

**March 30, 2023, Derailment of BNSF Railway Freight Train  
L-TWI8801-29 and Subsequent Hazardous Materials Release**

**RRD23LR009**

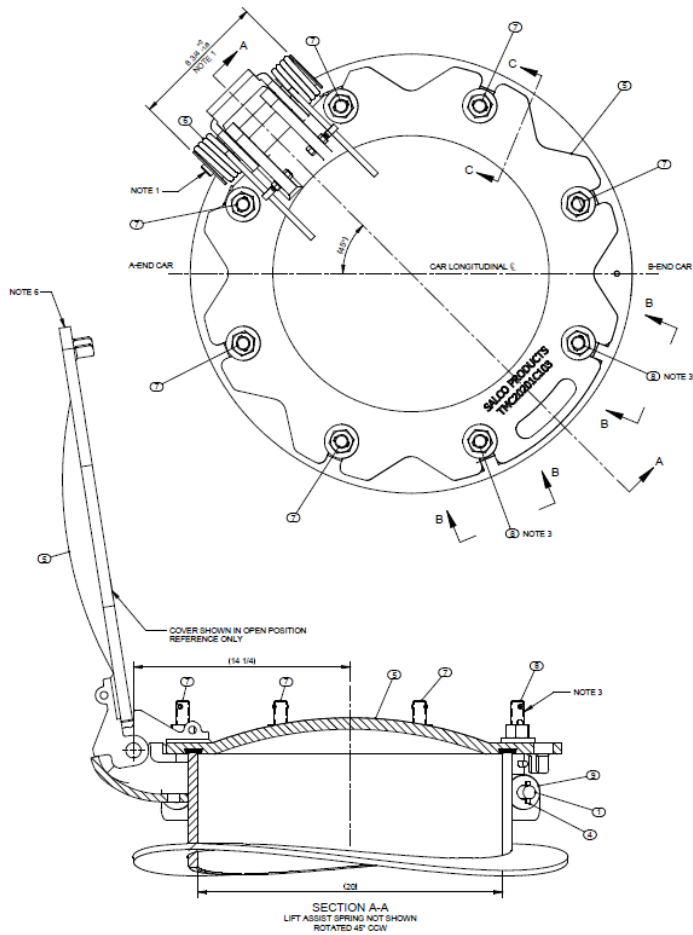
**Figure 5. Excerpt of Greenbrier 20 Inch Manway Assembly**

NTSB investigators found the nitrile manway gaskets on 3 of the derailed cars were thermally damaged (see Tables A-3 - A-5 near the end of this report for further details).
