National Transportation Safety Board

DCA22FA132

AIRCRAFT PERFORMANCE STUDY

July 7, 2023

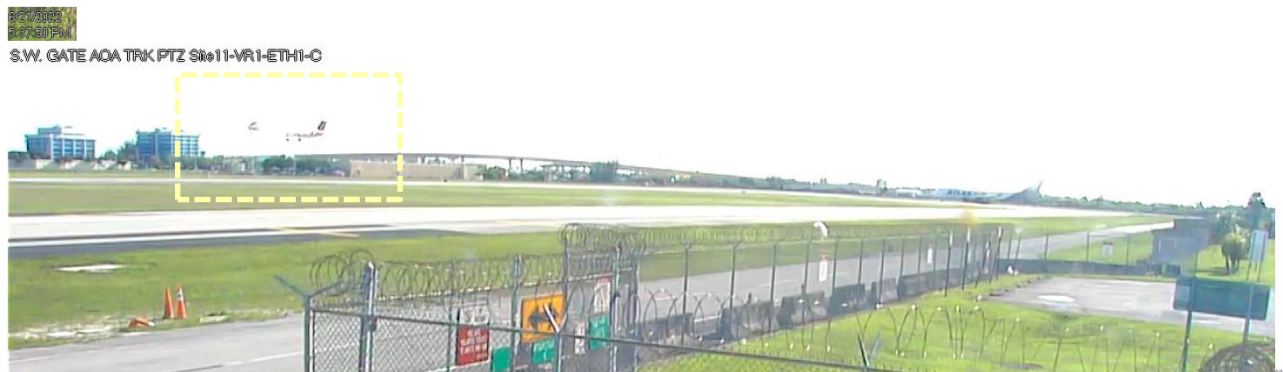
“SW GATE AOA TRK PTZ Site 11” Camera, Attachment 3

Figure 1: Excerpt of cropped and enlarged image sequence extracted from “SW GATE AOA TRK PTZ Site 11” surveillance camera recording. Airplane is moving right to left on short final approach.

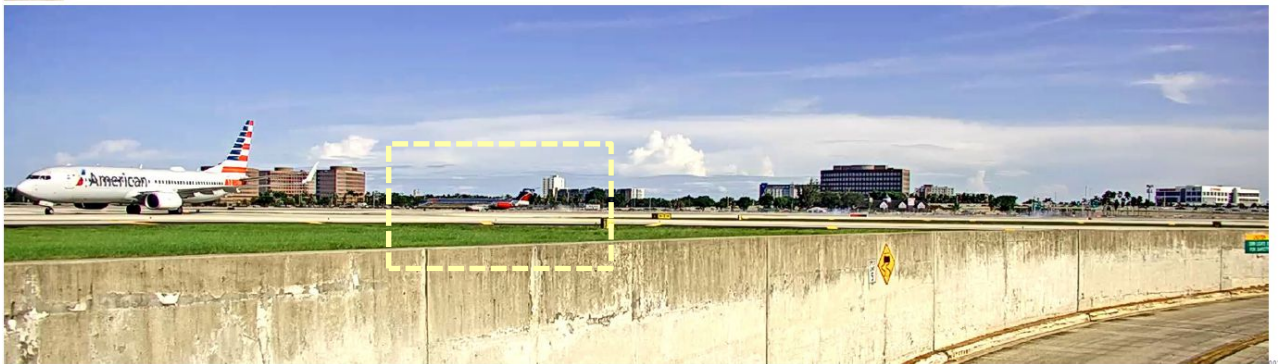
"Tunnel Airside South" Camera, Attachment 5

Figure 3: Excerpt of cropped and enlarged image sequence extracted from "Tunnel Airside South" surveillance camera recording. Airplane is moving right to left.

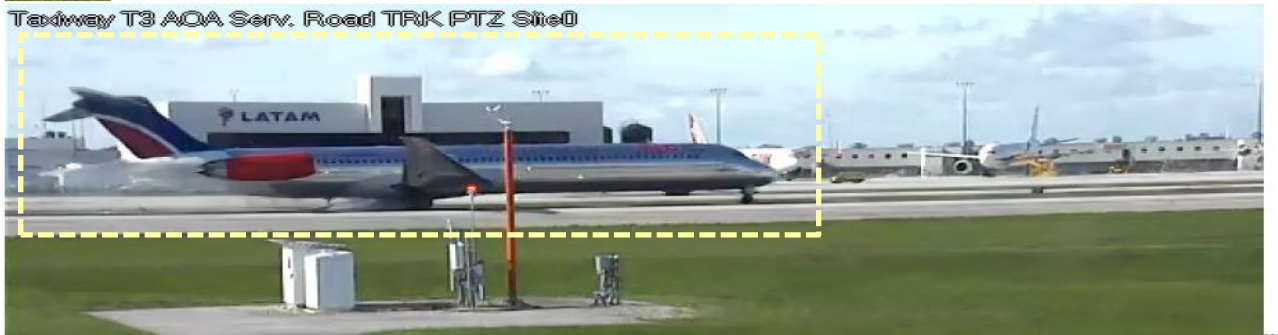
"Taxiway T3" Camera, Attachment 6

Figure 4: Excerpt of cropped and enlarged image sequence extracted from "Taxiway T3" surveillance camera recording. Airplane is moving left to right.

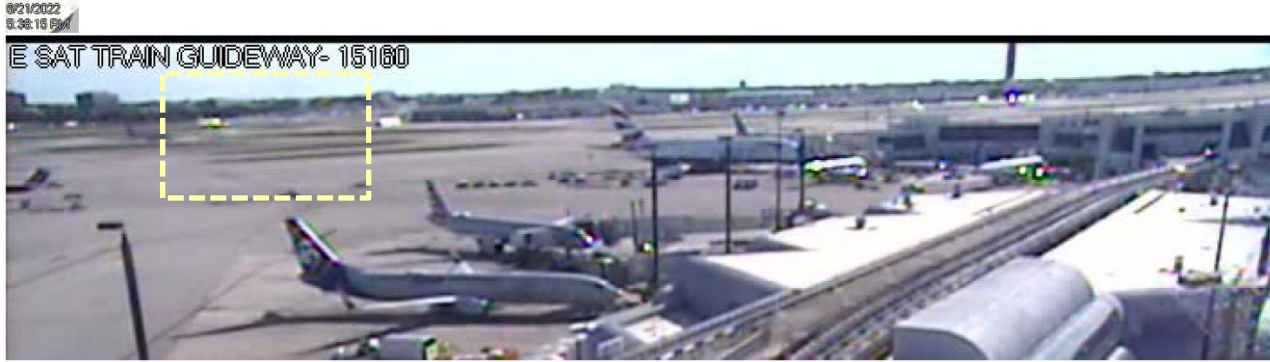
"E Sat Train Guideway" Camera, Attachment 7

Figure 5: Excerpt of cropped and enlarged image sequence extracted from "E Sat Train Guideway" surveillance camera recording. Airplane is moving right to left.

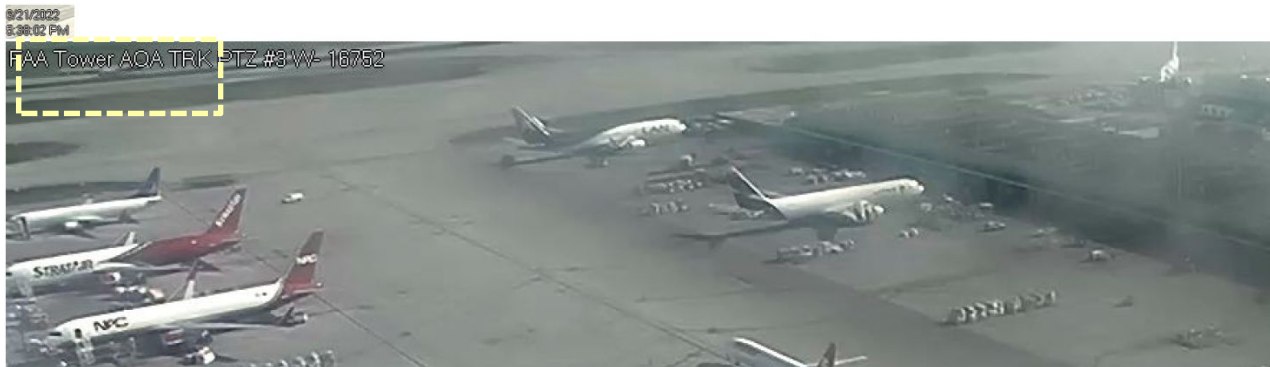
"FAA Tower AOA TRK PTZ 3 W" Camera, Attachment 8

Figure 6: Excerpt of cropped and enlarged image sequence extracted from "FAA Tower AOA TRK PTZ 3 W" surveillance camera recording. Airplane is moving right to left.

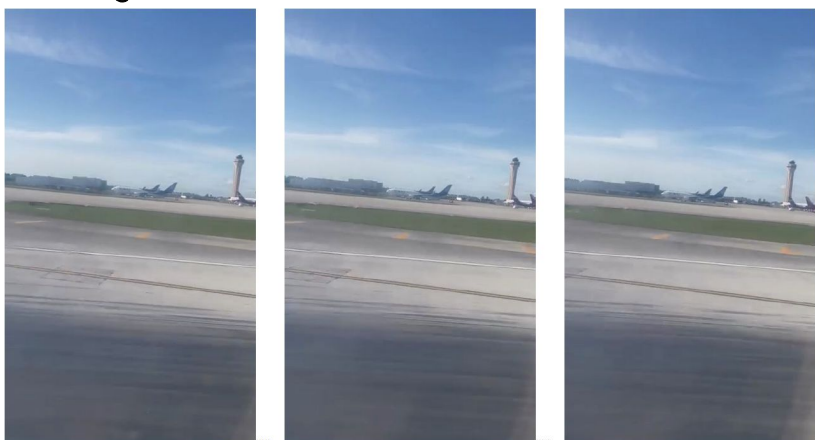
"Passenger" Camera, Attachment 11

Figure 9: Image sequence (3 images) extracted from "Passenger" cellular telephone recording. Airplane is moving left to right. The air traffic control tower is visible in the background, right-hand side of each frame.
