**SURVIVAL FACTORS GROUP CHAIRMAN'S  
FACTUAL REPORT**

**Schoharie, NY**

**HWY19MH001**

**NATIONAL TRANSPORTATION SAFETY BOARD  
OFFICE OF HIGHWAY SAFETY  
WASHINGTON, D.C.**

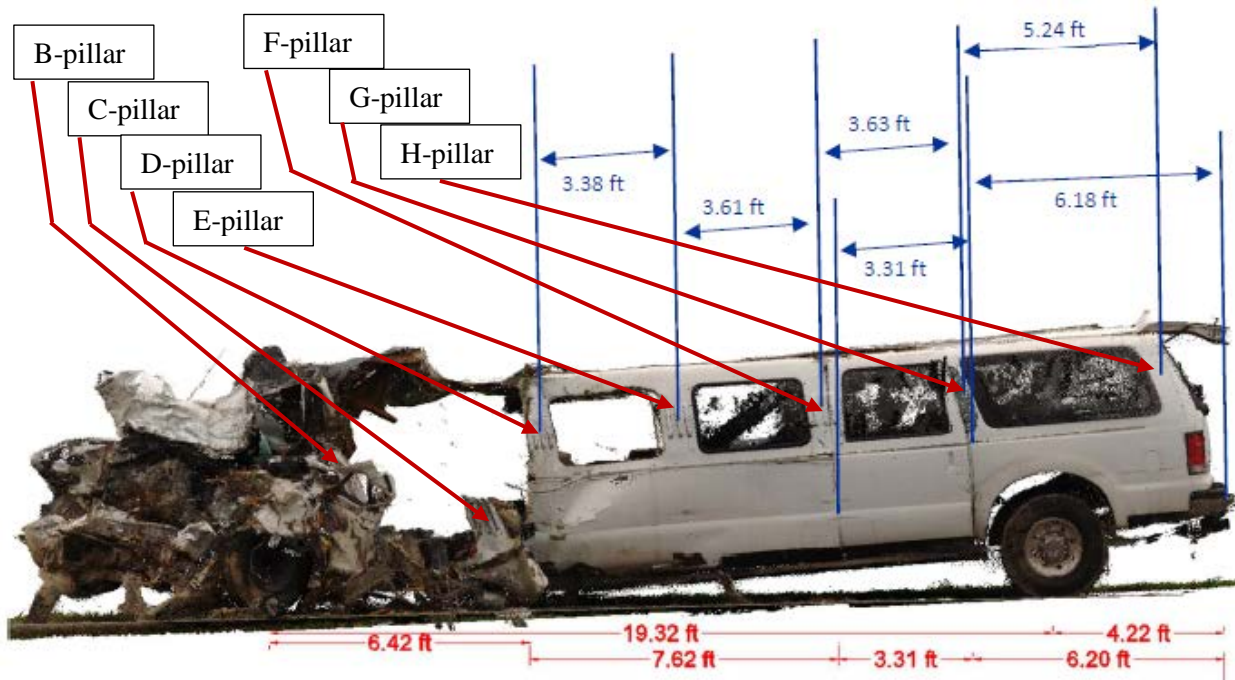
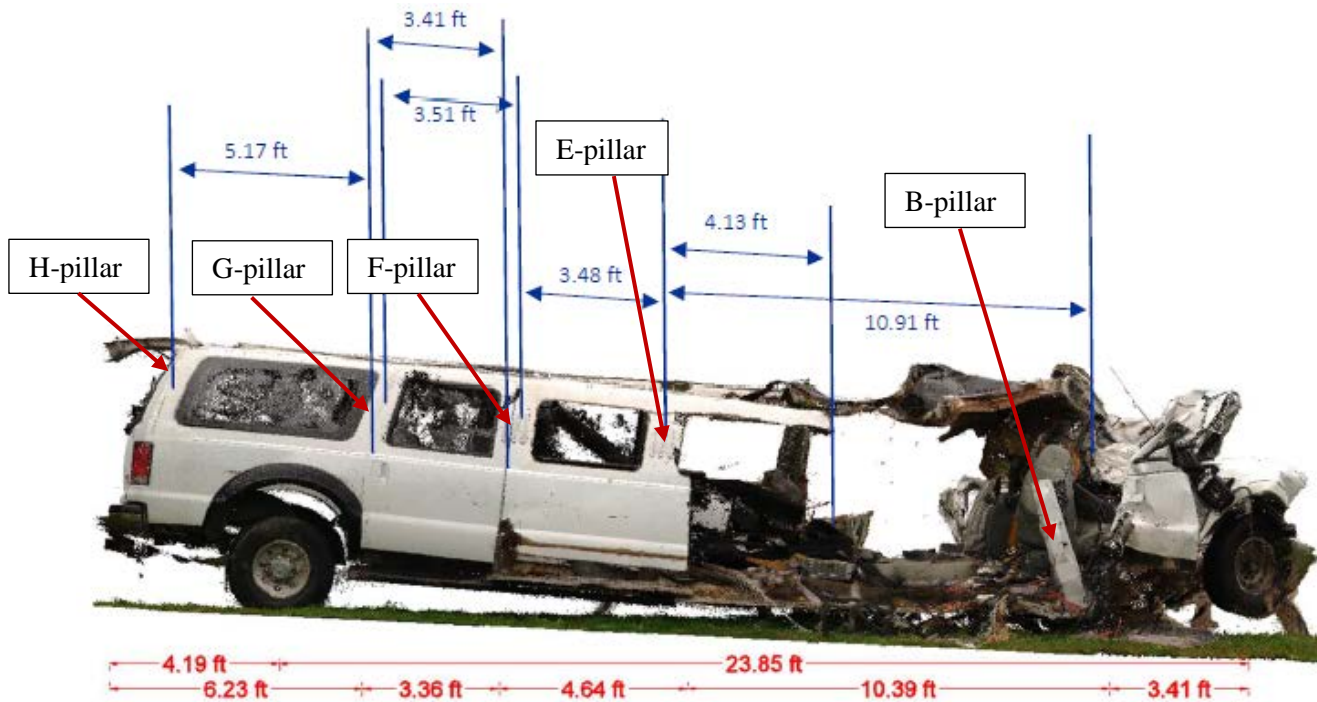
Figure 7: Image from 3D scan of the limousine conducted on October 8, 2018.

The A-pillar on the left side was folded in half. The B-pillar on the left side was missing. The glass from the driver's door and the window to the rear of the driver were missing. The three additional windows on the left side were intact. The rear window was missing.

The right fender was damaged but in place. The front passenger door was still attached at the A-pillar, but the top of the pillar and the top of the door were displaced rearward and to the right. The door was folded almost in half. The B-pillar on the right side had been cut approximately halfway between the floorboard and the roof. The rear two windows on the right side were intact, but the front two windows were missing.

There was considerable corrosion noted throughout the vehicle. The roof was folded upward and had partially detached from the side panels of the vehicle, exposing the sheet metal and headliner. Portions of the body panels had also separated exposing the corrosion within.

A large opening was cut by emergency responders for access post-crash into the driver side, separating the roof from the B and C pillars, and another on the passenger side, separating the roof from the B pillar and removing the C and D pillars. Figure 7 and Figure 8 provide images of the driver and passenger sides respectively, as generated from 3D scanning.<sup>35</sup> The locations of the pillars are indicated and basic exterior dimension are provided. The dimensions were generated by selecting points on the 3-D scan and along the longitudinal axis of the limousine (using the body panel crease and window frames to establish the longitudinal axis).

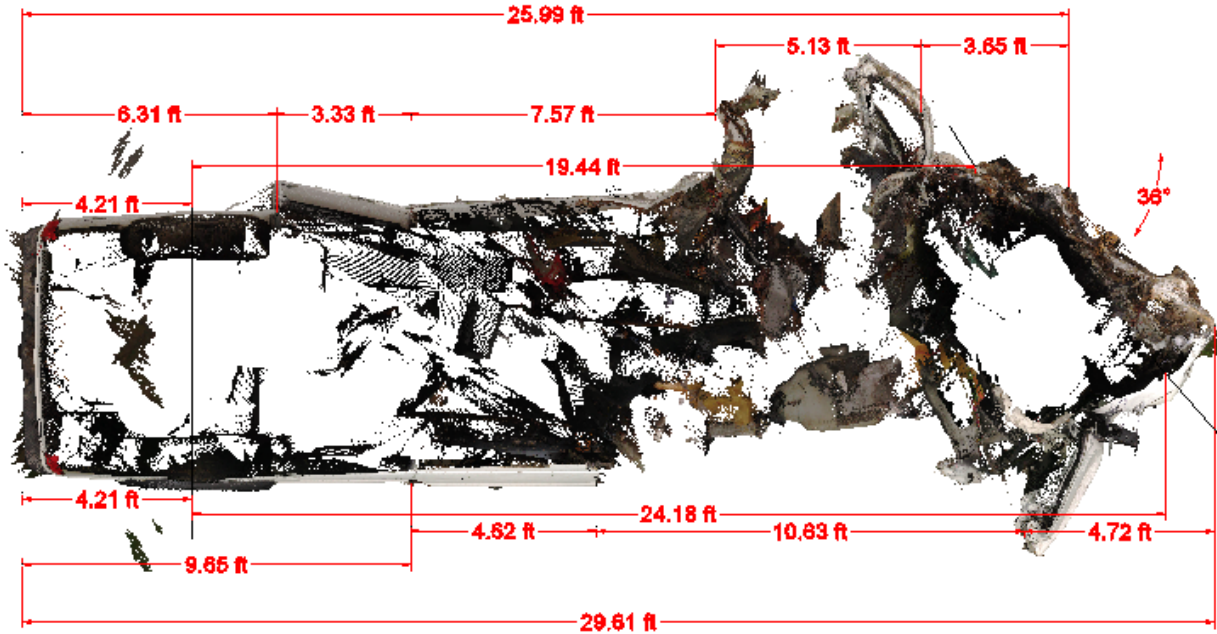
Figure 9: Image of Horizontal Slice at Floor level from 3D Scanning. The front of the vehicle is on the right side of the slice.

An image of a horizontal slice through the vehicle at approximately the passenger floor level was also generated by 3D scanning, as shown with basic dimensions, in Figure 9.

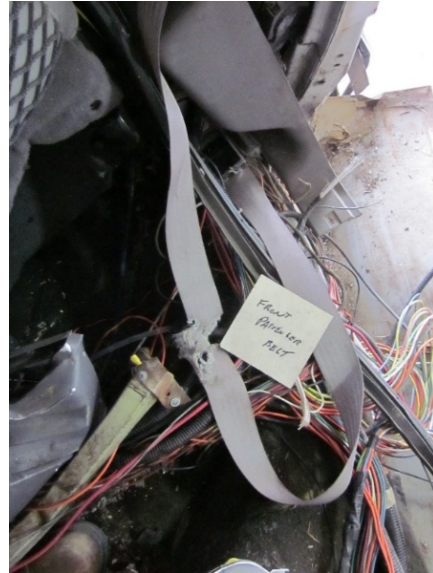
Figure 13: Front Passenger Seat Belt

The deployed passenger airbag was visible on the deformed dashboard, as shown in Figure 12. The front passenger seatbelt was visibly attached to the inertial reel which remained attached to the lower B-pillar, and the trim panel was partially displaced as shown in Figure 13. The upper attachment of the front passenger seat belt was not located, and the upper half of the B-pillar was cut and displaced. The front passenger seat, airbag, and belt did not have evidence of being occupied at the time of the crash. The front passenger seat belt had damage consistent with responder cutting operations which occurred in this vicinity. The passenger side airbag measured 22 by 22 inches.

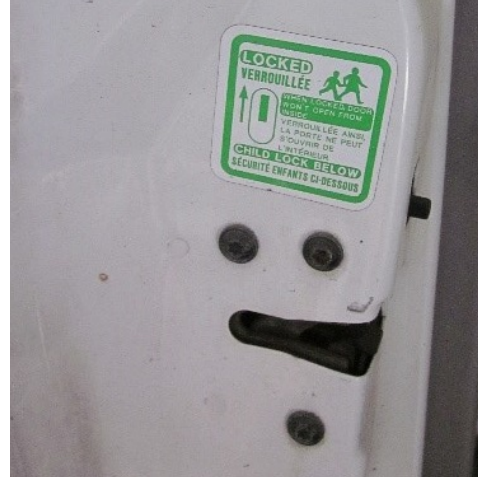
Figure 16: Right Rear Door Latch

The left rear OEM doors were intact. The left rear door would not fully close due to damage at the forward surfaces. The right rear door was functional. Both doors were labeled as emergency exits, as shown in Figure 15. The rear doors had child locks (found unlatched) located near the door latches and included labels describing their use, as in Figure 16.

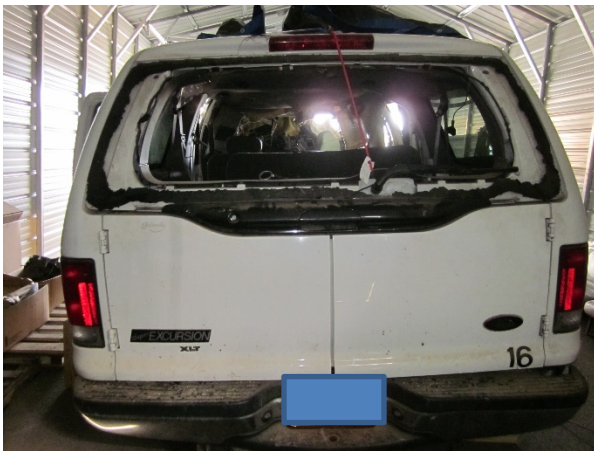
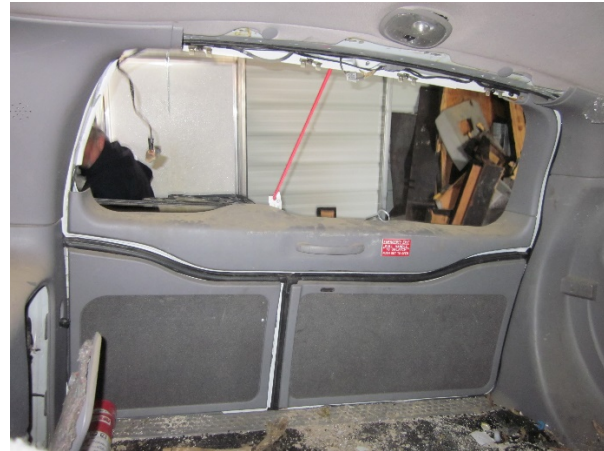
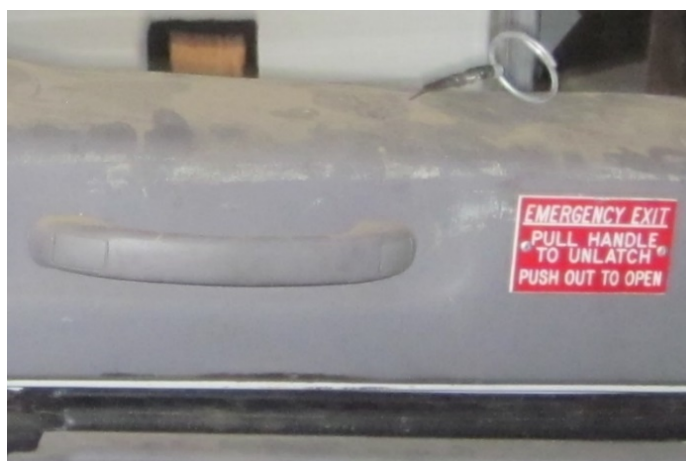
The OEM rear cargo hatch consisted of a widow panel which was hinged at the top, and side by side doors below the rear window, as shown from the exterior in Figure 17 and the interior in Figure 18. The hatch glass was broken out and the rear cargo doors were intact and operational. The rear hatch was labeled as an emergency exit, and had a ring pull tab to release the hatch, as shown in Figure 19.

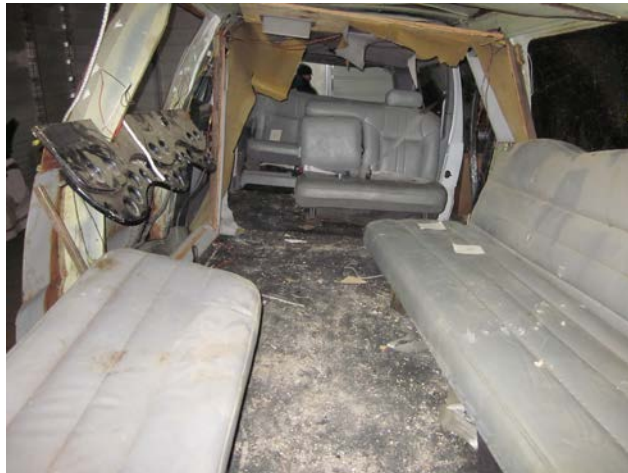
Figure 24: View of limousine interior looking aft, with lateral seat cushions put back in approximate position during post crash inspection

The non-OEM seat cushions were found in the debris pile, except the seat back for the passenger side bench seat, which likely was destroyed when emergency responders cut into that portion of the limousine sidewall. They were constructed of 0.75 inch thick plywood with approximately 4 inches of foam and a vinyl covering. The seat pan cushions were rectangular, and were 18.5 inches deep. The seatback cushions had a wavy upper contour, which were 18 inches at the tallest points and 16.5 inches at the shortest points. The peak to valleys were about 13 inches apart. Figure 24 shows the lateral-facing seats (with the cushions put back in approximate position) and the rear OEM passenger seats.

The passenger side lateral bench seat measured 65 inches long. According to the pre-crash photos, the seatback had 3 peaks and 2 valleys. The aft-facing bench seat, at the front of the passenger compartment, measured 46.5 inches wide and the backrest had 2 peaks and 1 valley. The driver side lateral bench seat measured 97 inches long. The seatback had 4 peaks and 3 valleys.

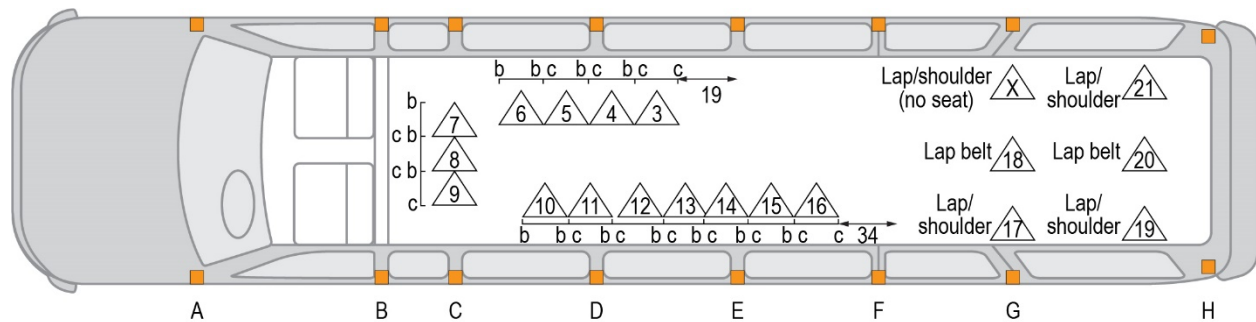
Figure 25: Limousine passenger cabin seat belt anchor points, with a “b” and “c” designating buckle and connector respectively for the stretch seating. (The buckles for the rear OEM seats were on the interior side for seats 17, 19, 21, and on the right side for seats 18 and 20.)

were attached, both were attached to the vehicle structure using the same bolt. The positions of the floor anchor bolts are provided in Figure 25, with the line of bolts for that group of seats located in reference to a pillar, and the dimensions between anchor bolts are provided in Table 6.

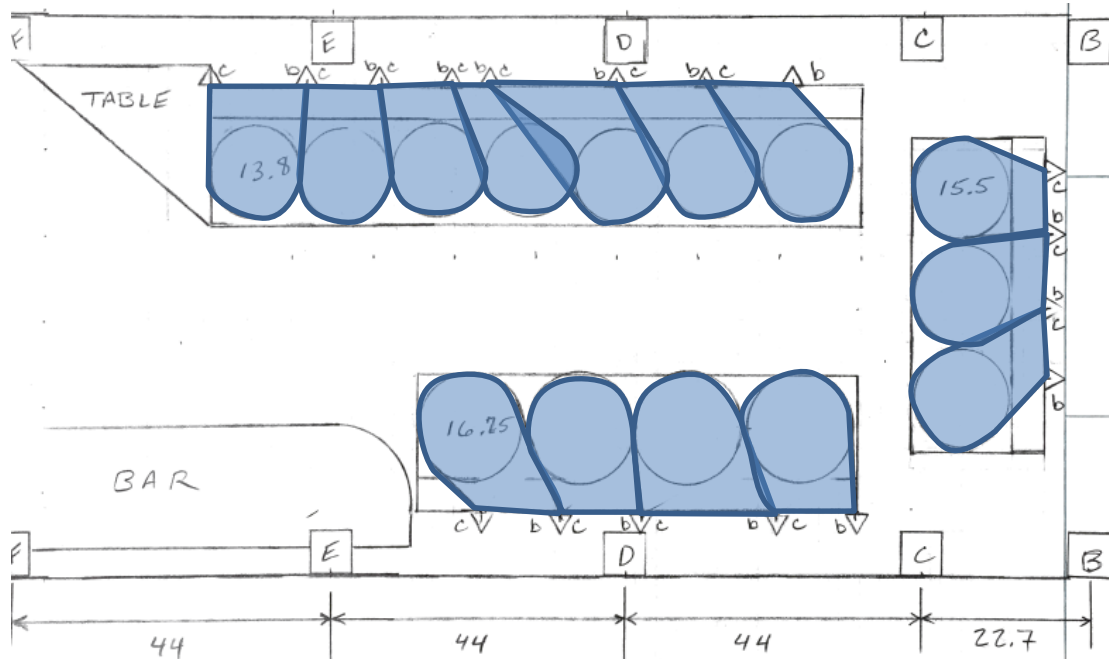
Figure 26: Perimeter seating layout with seat belt anchor locations and approximated body positions for restrained passengers. (Note that the figure is oriented with the front of the limousine to the right.)

The seat belt sets were used to approximate the maximum seat placements on each seat, and then the belt configurations that would line up with the occupants are illustrated in Figure 26. The width of the seat placements using this method was 15.5 inches, 13.8 inches, and 16.25 inches for the aft-facing, driver-side lateral, and passenger-side lateral, respectively.

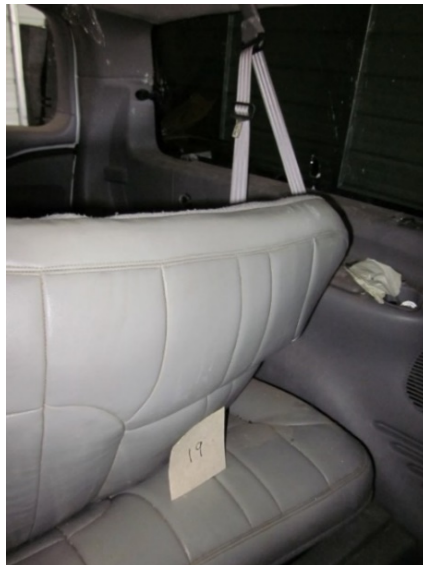
Figure 28: Limousine OEM seat position 19 D-ring location between G and H pillar.

The aft row of OEM seats (seat positions 19, 20, and 21) had the following overall dimensions: seat cushion height was 5 inches, entire seat cushion width was 47 inches, seat cushion depth was approximately 19 inches, and the seatback was 19 inches tall. The seatback was deformed into a bow shape in the forward direction. At the top edge of the seatback, the depth of the bow had a maximum indent of about 5 inches, and was located 24.5 inches from the passenger side outboard edge, as shown in Figure 27. Seat 19 (the outboard driver side seat) was equipped with a lap/shoulder belt with a D-ring that was mounted 29” aft of the left side G pillar and forward of the H pillar and was in the stowed position, as shown in Figure 28. The buckle was located 33 inches from the passenger side outboard edge of the seat (right side wall).
