SUMMARY OF FINDINGS

Eric M. Gutierrez
Air Safety Investigator
Western Pacific Region

Date: June 29, 2022
Person Contacted: Sergeant Brandon Littrell
NTSB Accident Number: WPR22LA238

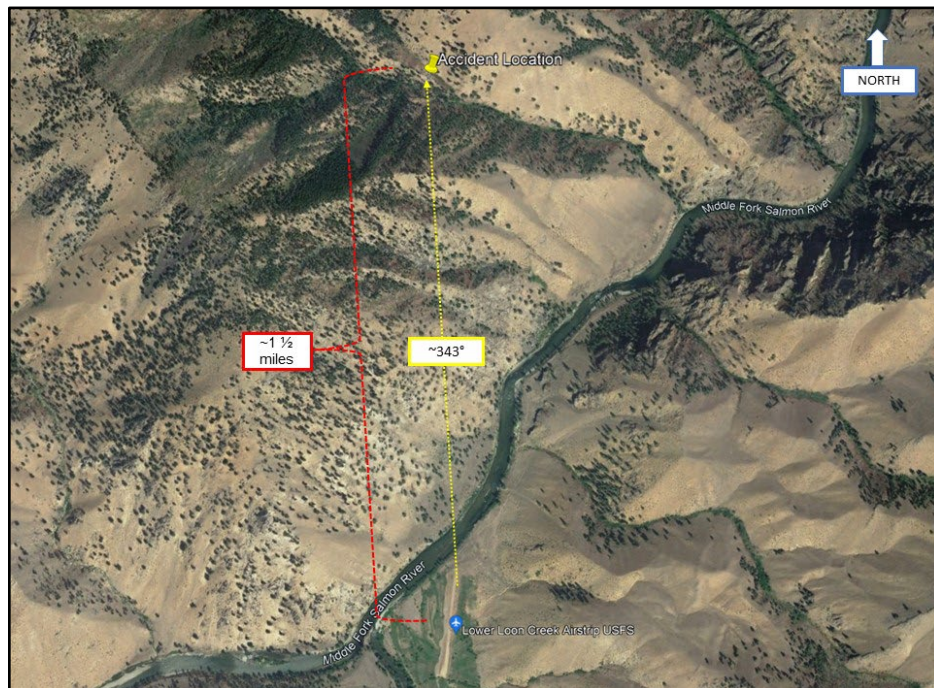
Figure 1: Overview of the accident site location.

Examination of the accident site revealed that the airplane impacted steep rising mountainous terrain at an elevation of about 6,240 ft mean sea level (msl), in an approximate southern heading. The main wreckage came to rest upright about 30 ft below the initial impact point and was mostly consumed by fire. All major structural components of the airplane were observed at the accident site.
