In the frame of the investigation on the accident of the EC130T2 helicopter, registered N11VQ, that occurred on January 17th, 2016 in Hawaii, Safran Helicopter Engines (formerly known as Turbomeca) produced the following documents:

INVESTIGATION REPORT	Preliminary <input type="checkbox"/> Final <input checked="" type="checkbox"/>
-----------------------------	---

N11VQ ACCIDENT INVESTIGATION

N11VQ – Ruptured Pipe : Additional Examinations & Analyses at SafranHE

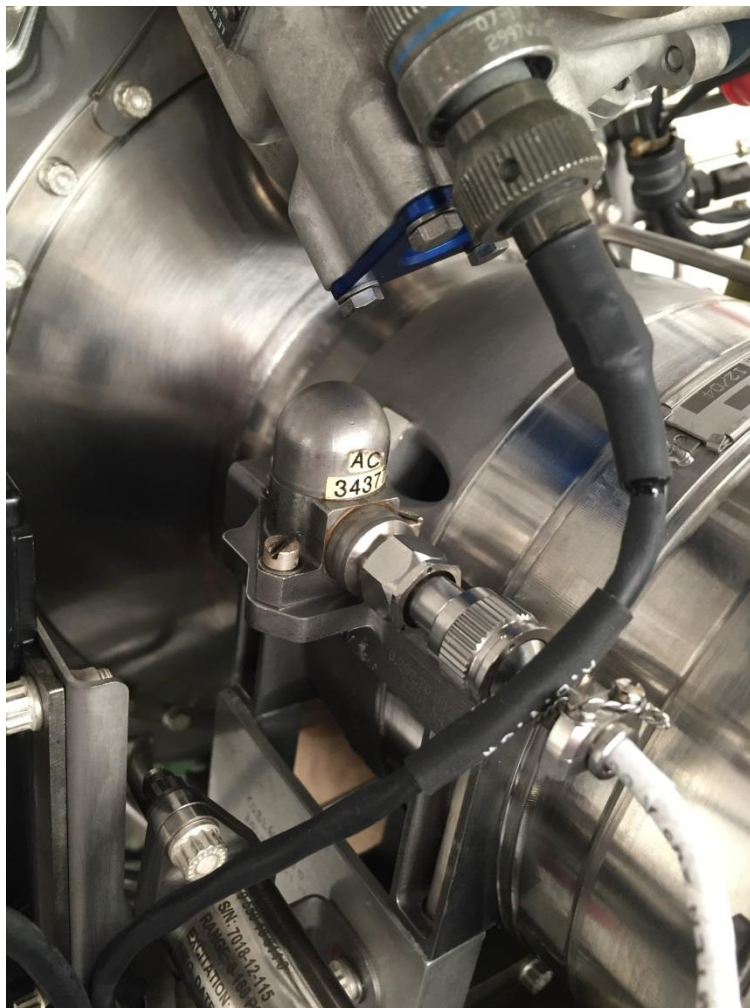
The vibration sensor used in the test bench (CA135) was mounted on the front mounting pad as shown in picture. The engine was first started using the accident starter. An unusual noise and vibration was immediately identified by the test cell operator however the test bench vibration levels were within limits of the TM maintenance manual (15, 6 mm/s measured for a maximum value of 20 mm/s). At both ground idle and flight idle the fuel injection pipe could be observed oscillating for and aft. All preliminary tests were performed (leak check, oil pressure, vib limit etc.). A vibration check was performed from 0 – 99.72% Ng. The engine was shut down and the shuttle starter was installed. A vib check was performed from 0 – 98.36% Ng. The engine was shut down again to complete the prescribed vibration test in accordance with the OEM test manual, by performing the bevel gear vibration check. The shuttle starter remained installed for this test. The test requires 3 checks, each between 4000 and 7000 rpm of the gas generator with a limit of 20g. The results were 1.21g, 1.31g, and 1.17g.

OEM vibration sensor mounting example

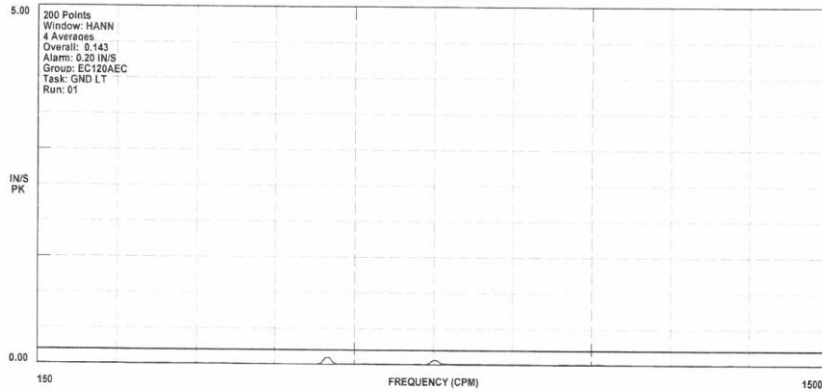
FREQ (CPM)	MAG (IN/S)	ALARM	STATUS	DESCRIPTION	FREQ (CPM)	MAG (IN/S)	ALARM	STATUS	DESCRIPTION
2493.2	0.011	0.200	OK	---	5590.7	0.107	0.200	OK	---
5265.8	0.010	0.200	OK	---	7603.9	0.072	0.200	OK	---
8002.6	0.012	0.200	OK	---	8442.9	0.013	0.200	OK	---
9342.9	0.010	0.200	OK	---	10012.5	0.013	0.200	OK	---
10386.4	0.014	0.200	OK	---	10699.6	0.012	0.200	OK	---

1. Shuttle starter @ starter mount with 0292737310 pipe ground idle

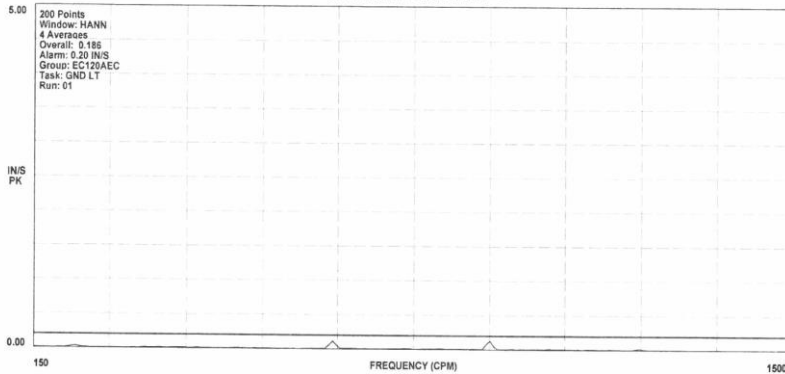
FREQ (CPM)	MAG (IN/S)	ALARM	STATUS	DESCRIPTION	FREQ (CPM)	MAG (IN/S)	ALARM	STATUS	DESCRIPTION
948.7	0.028	0.200	OK	---	2346.8	0.014	0.200	OK	---
2585.7	0.013	0.200	OK	---	2863.0	0.015	0.200	OK	---
3000.0	0.013	0.200	OK	---	3324.1	0.012	0.200	OK	---
5997.4	0.116	0.200	OK	---	6974.8	0.013	0.200	OK	---
9063.0	0.126	0.200	OK	---	11997.4	0.020	0.200	OK	---

2. Shuttle starter @ starter mount with 0292737310 pipe flight idle

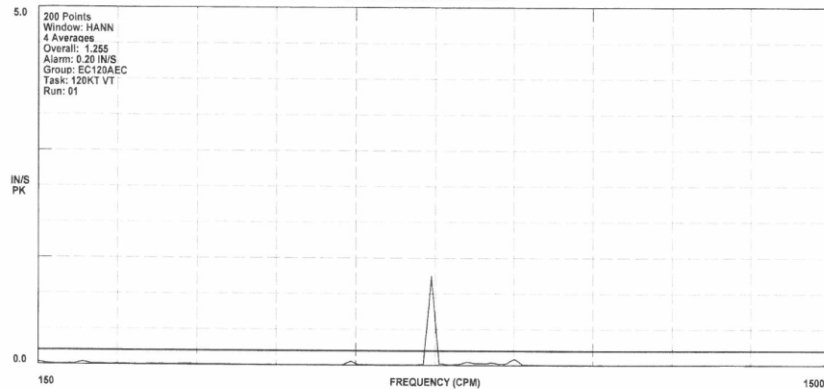
FREQ (CPM)	MAG (IN/S)	ALARM	STATUS	DESCRIPTION	FREQ (CPM)	MAG (IN/S)	ALARM	STATUS	DESCRIPTION
150.0	0.033	0.200	OK	---	750.0	0.013	0.200	OK	---
997.7	0.040	0.200	OK	---	2972.4	0.015	0.200	OK	---
5996.3	0.053	0.200	OK	---	7500.0	1.250	0.200	-WARN-	---
8200.9	0.051	0.200	OK	---	8400.0	0.027	0.200	OK	---
8649.3	0.039	0.200	OK	---	9056.8	0.091	0.200	OK	---

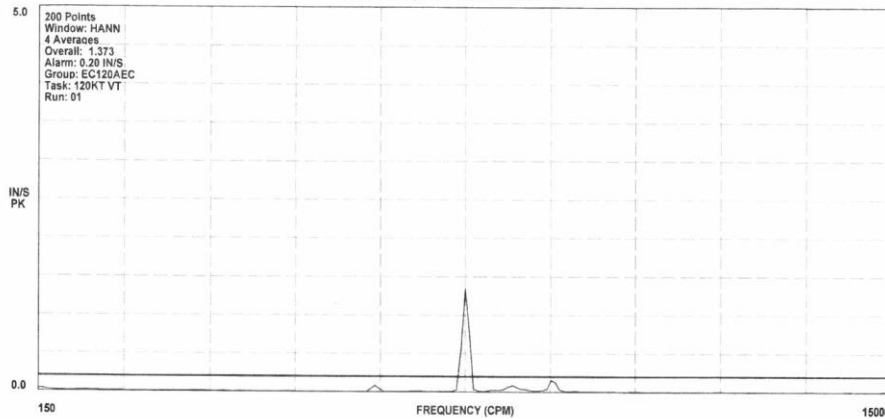
FREQ (CPM)	MAG (IN/S)	ALARM	STATUS	DESCRIPTION	FREQ (CPM)	MAG (IN/S)	ALARM	STATUS	DESCRIPTION
1014.1	0.019	0.200	OK	---	1555.5	0.011	0.200	OK	---
2815.8	0.011	0.200	OK	---	5997.5	0.082	0.200	OK	---
6772.7	0.013	0.200	OK	---	7583.4	1.355	0.200	-WARN-	---
8100.0	0.023	0.200	OK	---	8378.9	0.092	0.200	OK	---
9102.6	0.168	0.200	OK	---	9484.2	0.014	0.200	OK	---

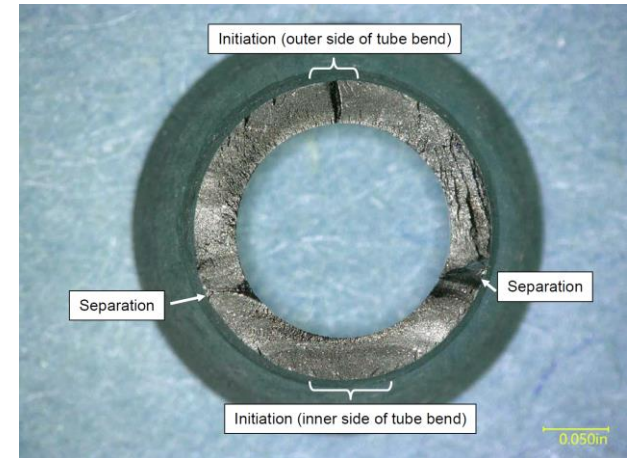
- During the examination of the wreckage of N11VQ aircraft, the fuel supply pipe that was fitted to engine Arriel 2D s/n 50708 was found ruptured
- This pipe was collected by NTSB for examination (final report pending)
- Main NTSB findings :
 - “ marks [on the fracture surface] are consistent with reverse bending fatigue fracture initiation on the outside surface of the tube ”
 - “ two diffuse-origin fatigue cracks that initiated on the outside surface of the tube about 180 degrees from each other. These cracks propagated through the thickness of the tube wall and circumferentially around the tube.”
- The pipe was then sent to SafranHE for examination

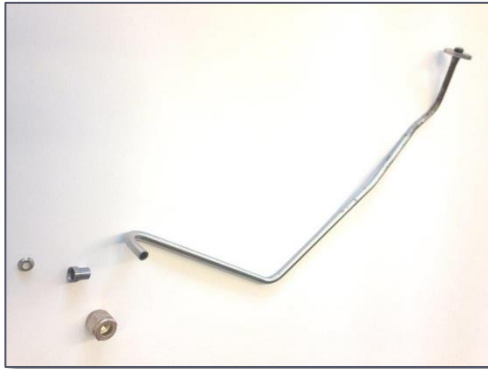
Items received

- Pipe details : Pipe P/N 0 292 73 731 0, s/n 2913AER
- The pipe was received with its sleeve and nut. The flared end of the pipe was received. Part of the tube had been sawn off and was missing.

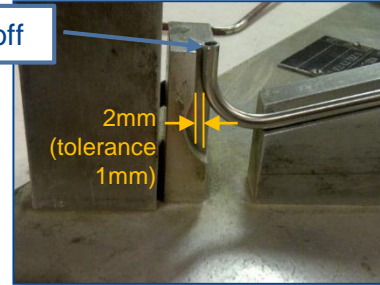
Pipe on control jig

- It is worth noting that the extremity of the pipe had been cut off during controls by NTSB and its end bit was missing.
- Photos of the pipe on the accident engine showed it aligned with the fuel manifold's nipple on engine of N11VQ.
- A video and other photos show that the pipe was manipulated whilst still on the wreckage.

→The presence of a misalignment before the event appears unlikely
