# National Transportation Safety Board

WPR24FA002

## **ACCIDENT SITE SURVEY**

Location: Moab, Utah  
Date: October 1, 2023  
Time: 2022 MDT  
Airplane: Piper PA28-140 / N7153R

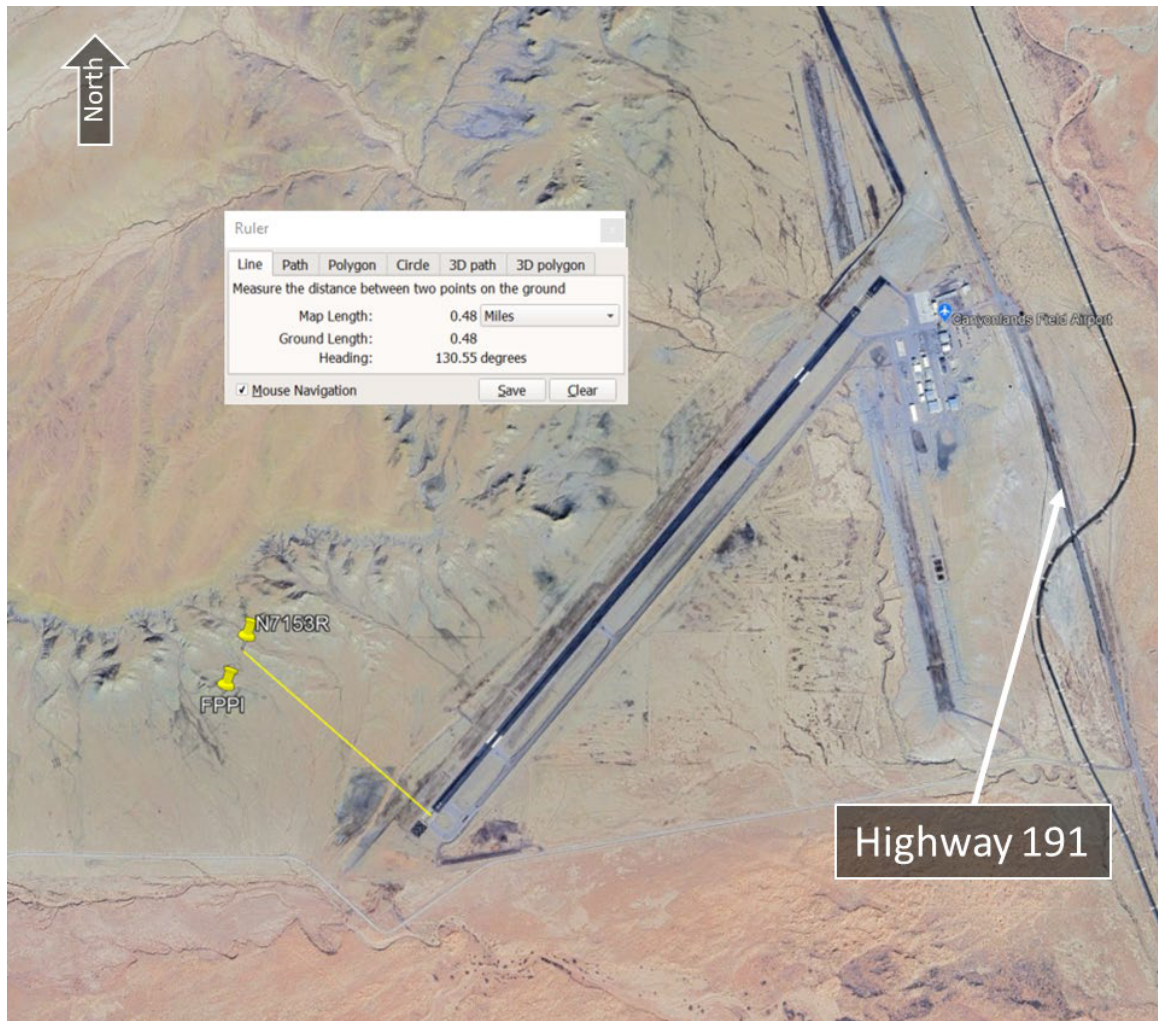
The airplane came to rest on a heading of about 200° magnetic, at an elevation of about 4649 ft mean sea level (msl), about 0.5 statute mile northwest the departure end of runway 21. The accident site was in an area of open rolling hills consisting of soft soil and no vegetation.

Figure 1. Google Earth view of the accident site and the departure end of runway 21 CNY.

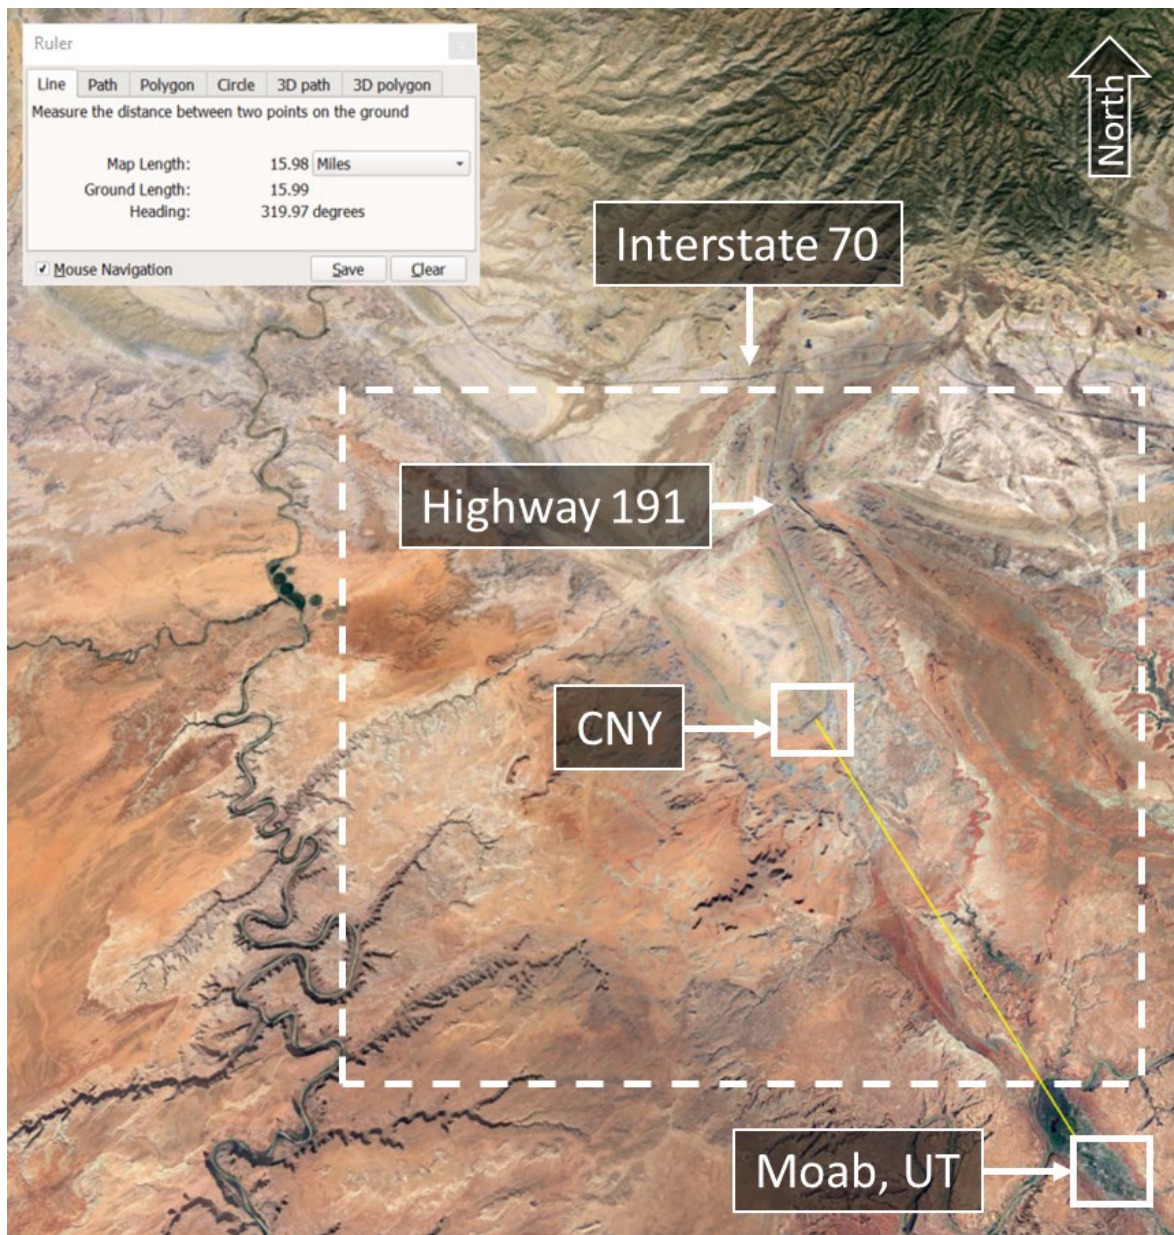
CNY was located about 16 miles northwest of the nearest city of Moab, Utah. Interstate 70 (I-70) was located about 13 statute miles north of CNY. Highway 191 ran from Interstate 70 through Moab. Highway 191 ran past CNY's east boundary. The area surrounding CNY was unpopulated terrain that extended from the Moab city boundary, past CNY and to I-70. There were very few houses or buildings from I-70 to the Moab city limit. (figure 2 and 3).

Figure 2. Google Earth view showing the unpopulated area surrounding CNY, shown in a white dashed square. The distance from CNY to Moab is indicated by the yellow line.

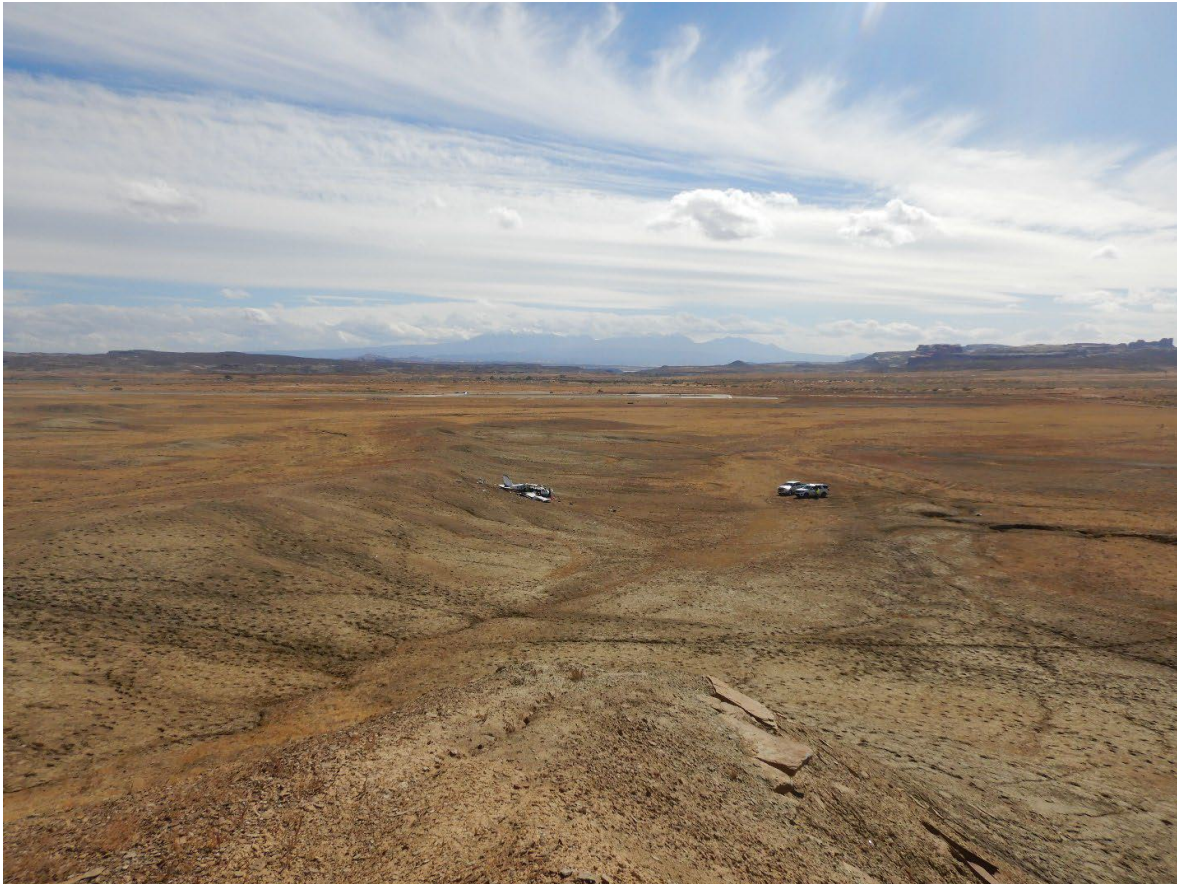
Figure 3. Image showing the unpopulated area surrounding CNY.
