Parker Hannifin Corporation
Hose Products Division
30240 Lakeland Boulevard
Wickliffe, OH 44092
Phone: [REDACTED]
Fax: [REDACTED]

TECHNICAL SERVICE PRODUCT ANALYSIS REPORT

Distributor/OEM: Strato Inc.
Attn:
Address: 100 New England Ave
Piscataway, NJ 08854

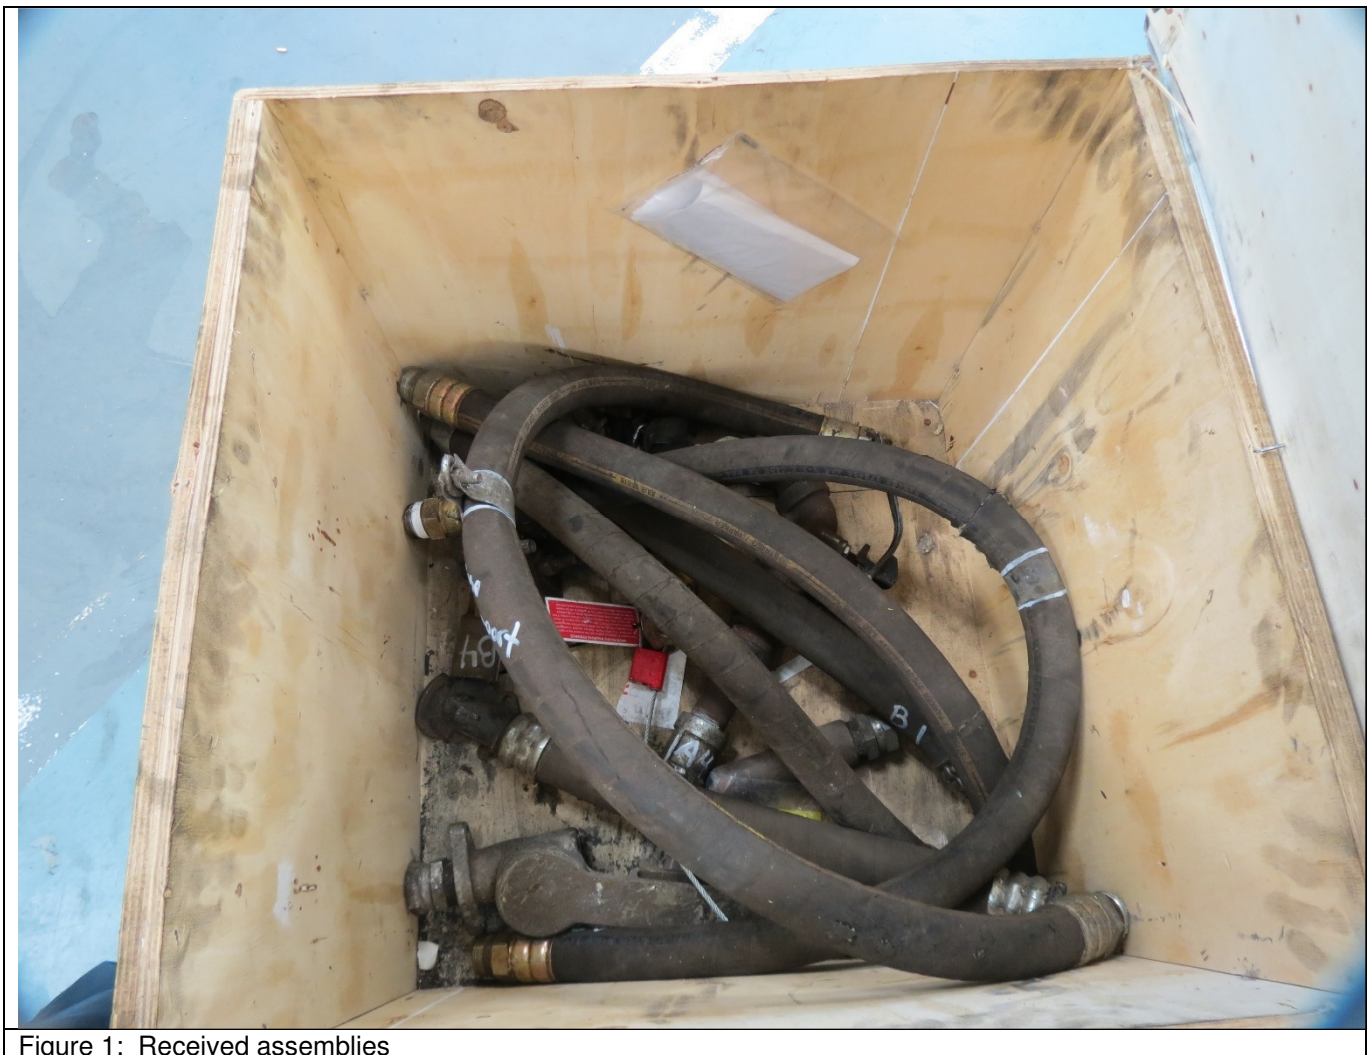
Figure 1: Received assemblies

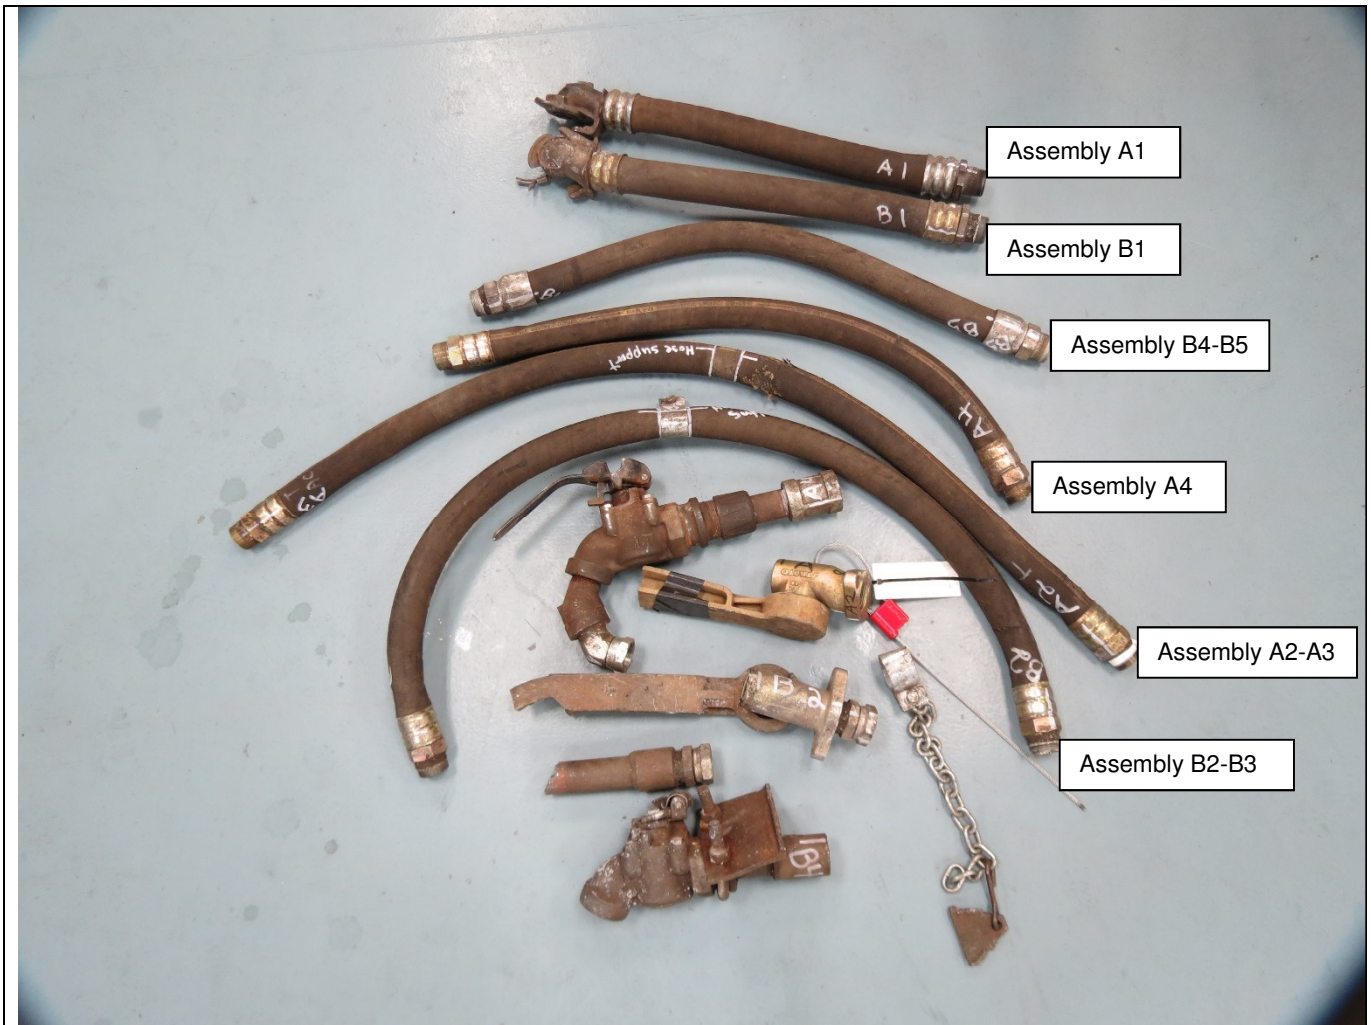
Figure 2: Received assemblies and components. The assemblies will be referred to throughout the report as labeled in the Figure above.
