# NATIONAL TRANSPORTATION SAFETY BOARD

## STRUCTURES GROUP CHAIRMAN'S FACTUAL REPORT

### A. ACCIDENT      **DCA05MA004**

**Location:** Kirksville Regional Airport (IRK), Kirksville, Missouri  
**Date:** October 19, 2004  
**Time:** 1945 Central Daylight Time (CDT)  
**Aircraft:** American Connection 5966, BAe Systems Jetstream 3201, N875JX

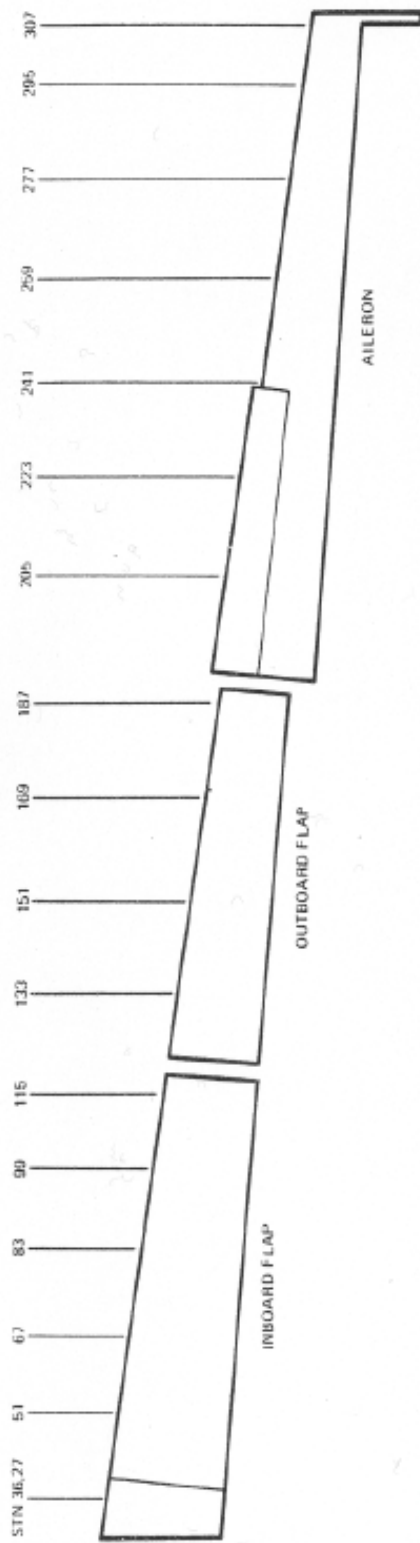
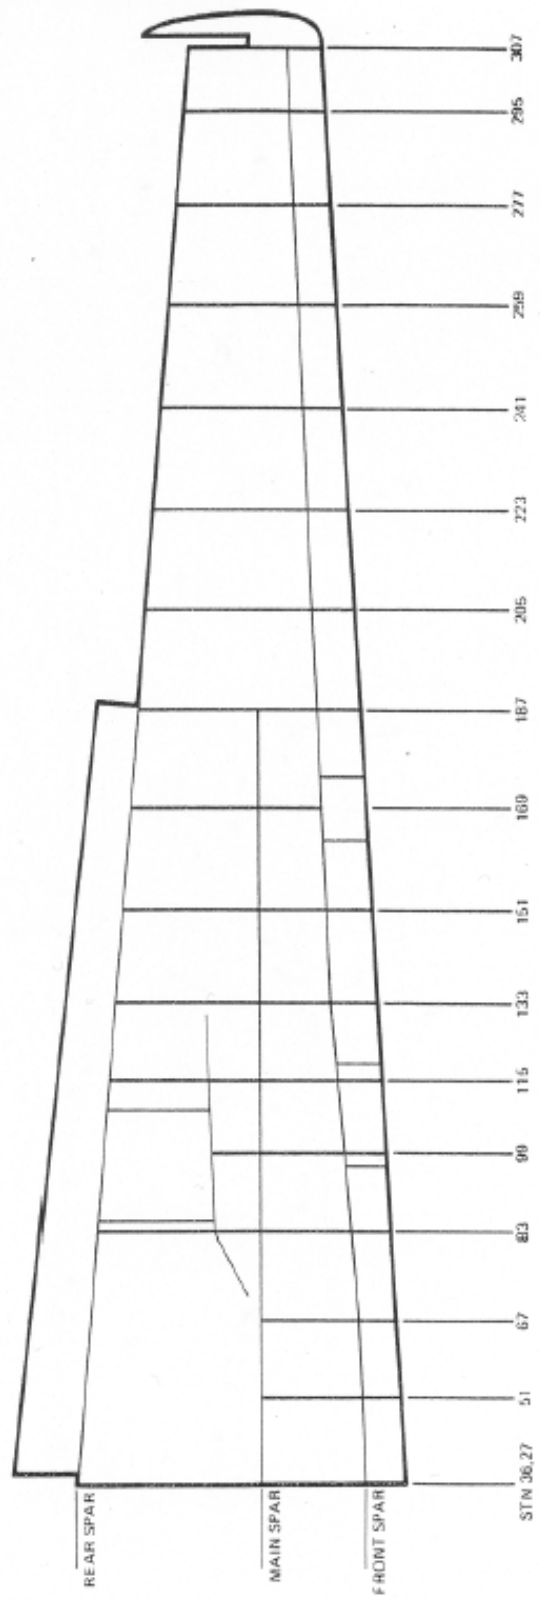
APPENDIX 4  
Jetstream 3201 Wing Station Diagram

The left wing was broken into three major pieces; a section from the side of body at wing station (STN) 36 to the inboard edge of the landing light at about STN 155, a section from STN 155 to the outboard end of the outboard flap at STN 187, and a section from STN 187 to the tip. See Appendix 4 for a wing station diagram.
