NATIONAL TRANSPORTATION SAFETY BOARD
Office of Aviation Safety
Washington, D.C. 20594
July 8, 2018

Group Chairman's Factual Report

STRUCTURES

WPR17LA104

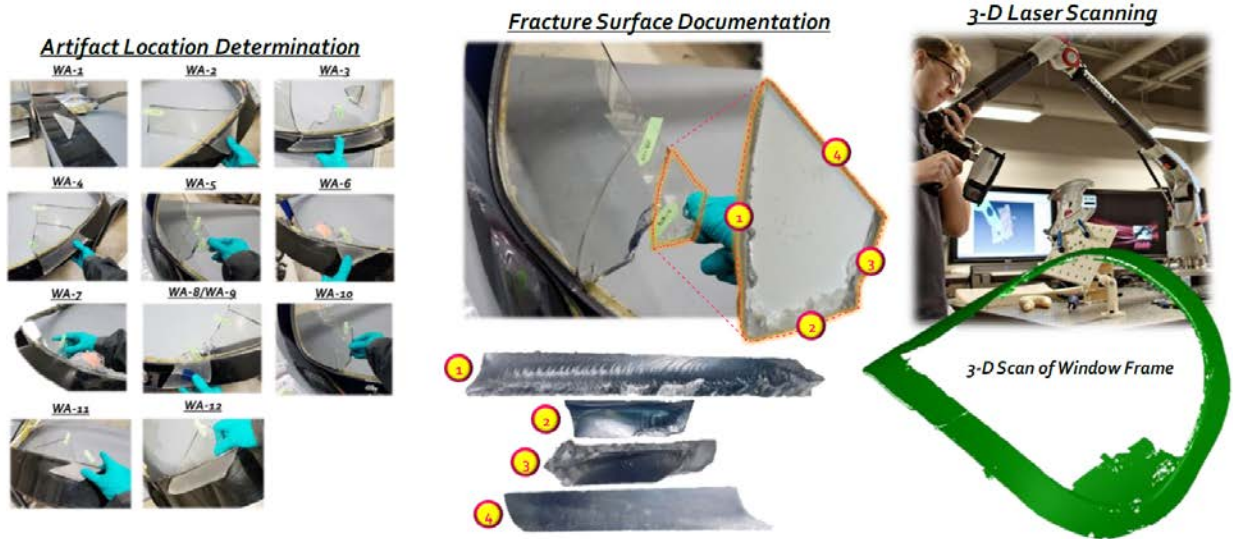
Figure 5 - Documentation of Windshield Frame & Artifacts

The two large sections of windshield shown in Figure 4 were firmly intact with the windshield frame and could not be removed. Although this was the case, gaps witnessed from a visual inspection between the windshield and the frame indicated the remaining portions are not fully bonded in place. The remaining large intact sections of the windshield were documented using a 3-D scanner so that their specific size and location were understood (Figure 5). Furthermore, the location for each windshield artifact was determined, and the fracture surfaces were documented. This created the opportunity to compare the fracture pattern with stress analysis to supplement proposed failure scenarios.
