**Component testing at Mooney International, Kerrville, Texas on behalf of the NTSB
Reference WPR18FA210
Mooney M20J N56039 SN 24-1358**

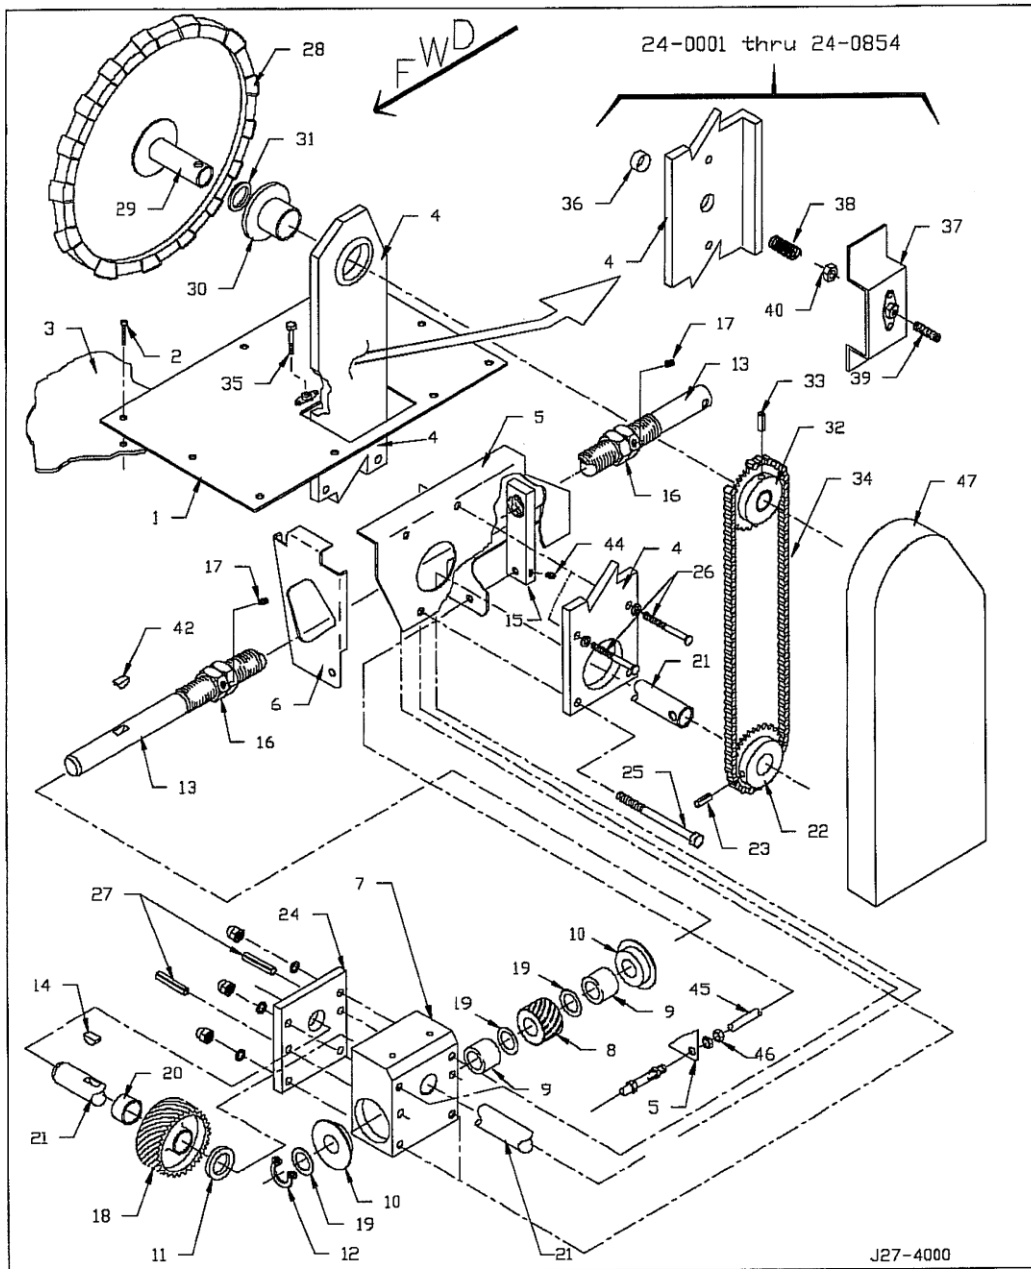
FIGURE - 1 STABILIZER TRIM CONTROL SYSTEM, FWD

The component of the longitudinal pitch trim assembly that was received is from the lower portion of the Stabilizer Assembly, Trim Control 740085-011 (reference Figure 1 of the M20J Illustrated Parts Catalog section 27-40-00). The assembly was tested on August 22, 2019, again witnessed by Randall Kaser.

During the visual examination, it was noted that the two lower bolts on the gear box housing were missing as received. It was also noted that the rectangle traveling block was all the way up against the forward stop nut.
