## **NATIONAL TRANSPORTATION SAFETY BOARD**

### **SUMMARY OF AIRCRAFT EXAMINATION**

**(WPR19LA064)**

Location:	Port Hadlock, Washington
Date:	January 13, 2019
Aircraft:	Beech B35
NTSB Investigator-in-Charge	Thomas M. Little

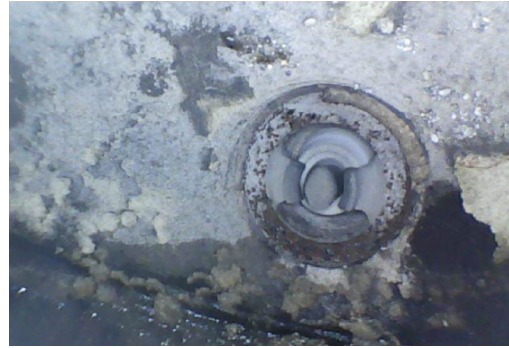
Figure 12 - #1 bottom spark plug

Condition: The top spark plugs were removed, and the spark plug electrodes were visually inspected. It was noted that the #1 top spark plug insulator was cracked in two places. The #1, #3, and the #5 spark plugs were grey in color with no combustion deposits noted. The #2, #4, and the #6 top spark plug electrodes were oil coated consistent with post-accident accumulation. The bottom spark plugs were inspected using a lighted borescope. The #2 bottom spark plug was submerged in oil and was unobserved; the rest of the bottom spark plugs displayed normal operating and wear signatures.

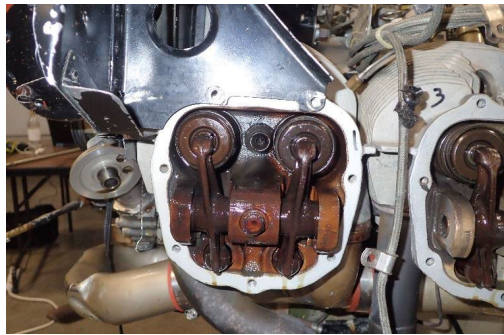
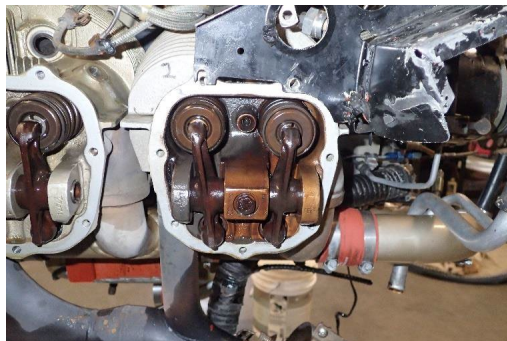
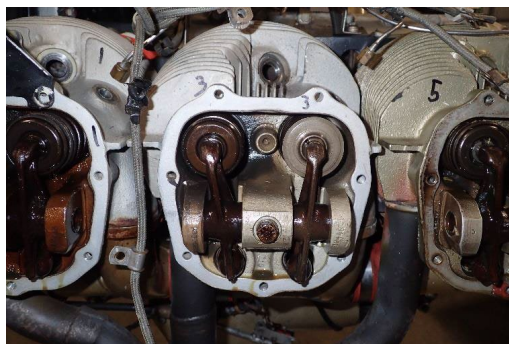
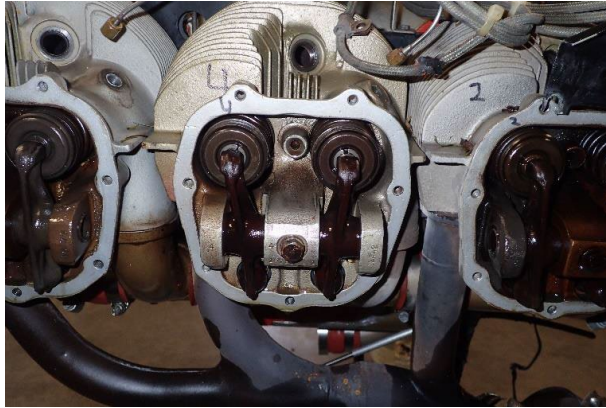
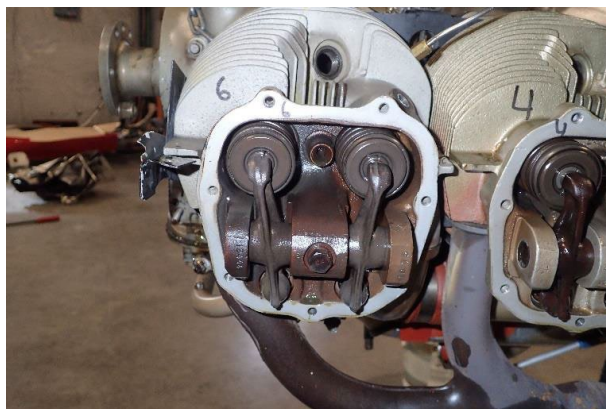
All of the cylinders remained attached to their cylinder bays and the #5 cylinder displayed impact damage signatures, the rest of the cylinders were undamaged. The cylinders were inspected using a lighted borescope; the piston faces, cylinder bores, and valve heads displayed normal operating and combustion signatures. During crankshaft rotation all of the cylinders displayed good thumb compression and suction. All of the overhead components (valves, springs, and rocker arms) displayed normal operating and lubrication signatures. There were no anomalies noted.

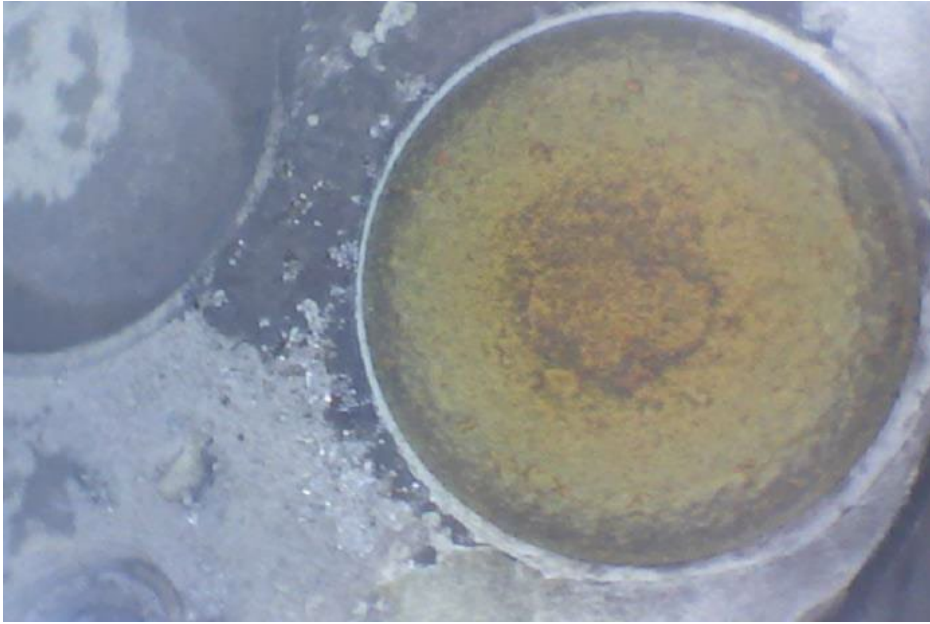
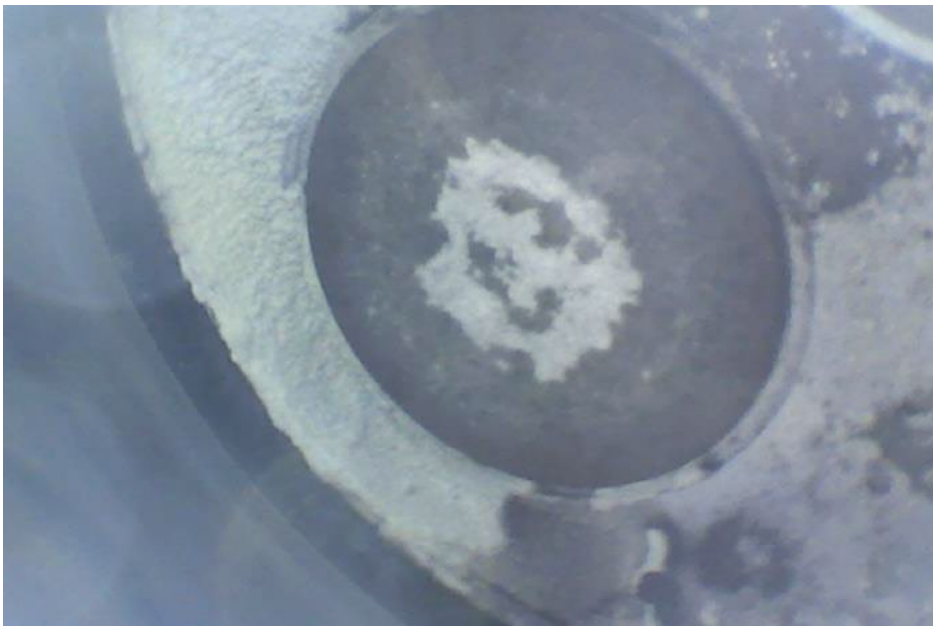
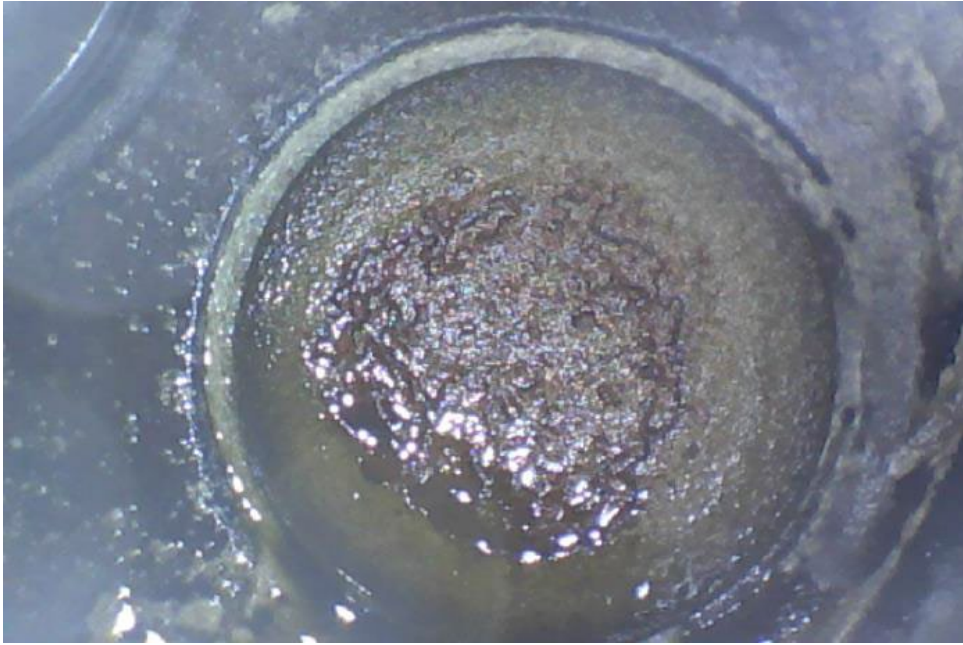
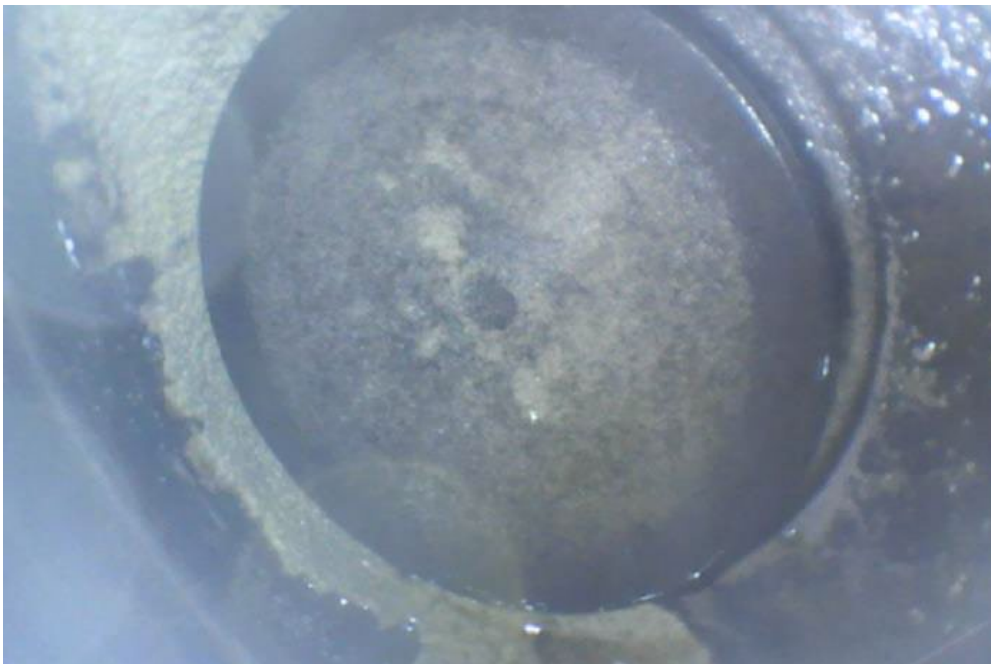
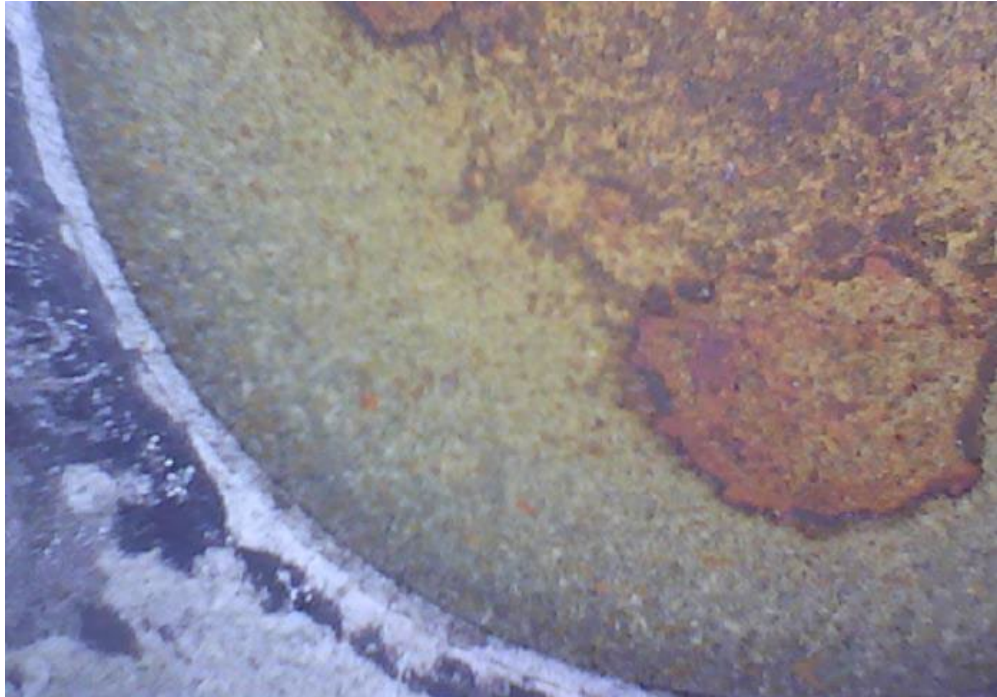
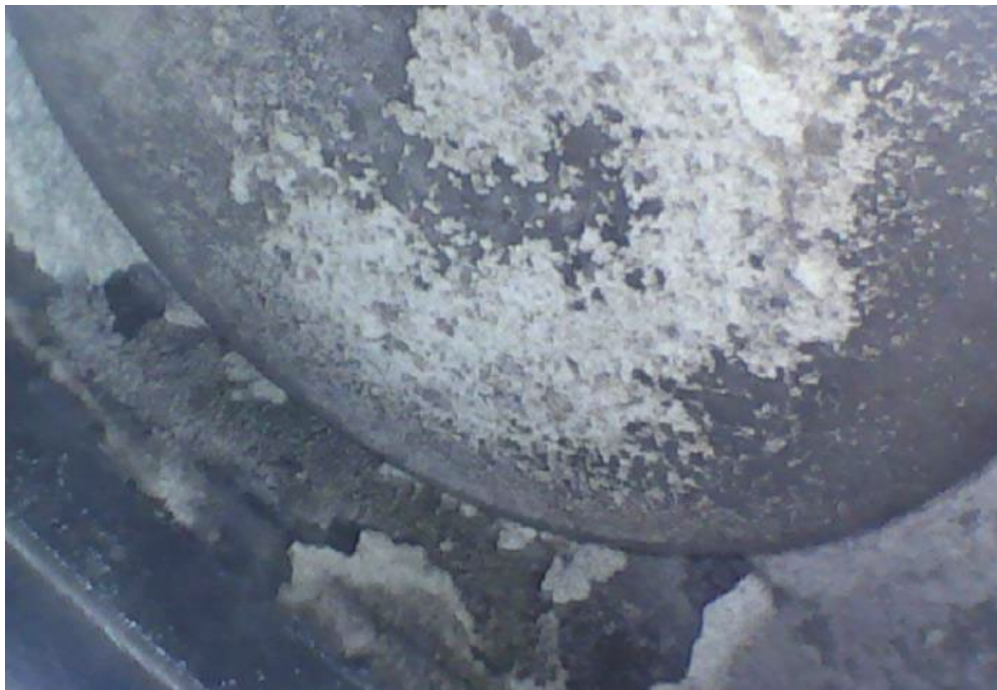
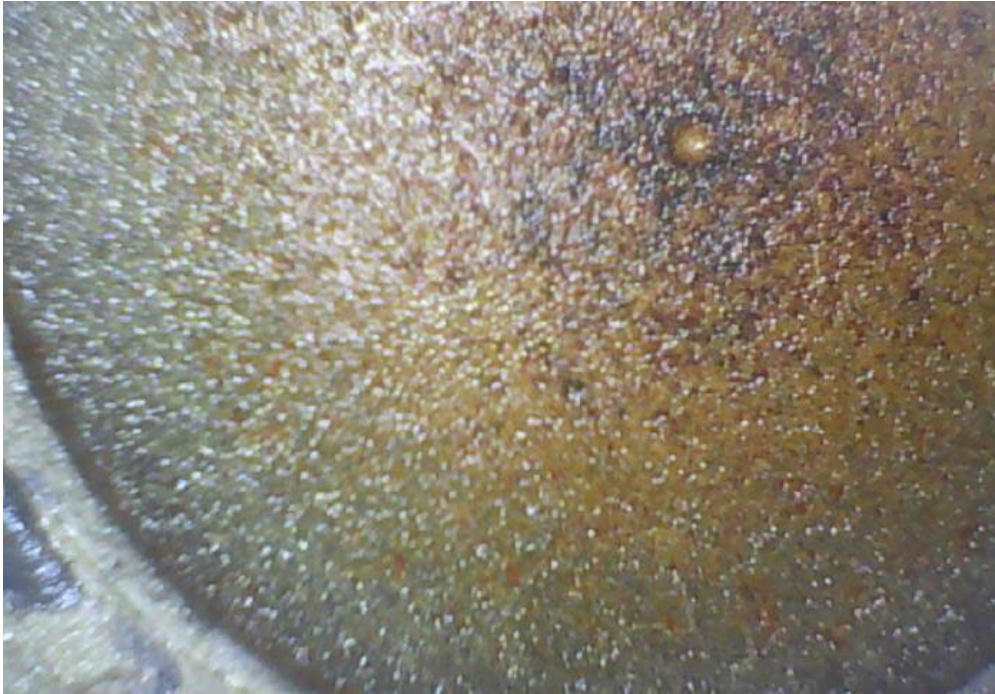
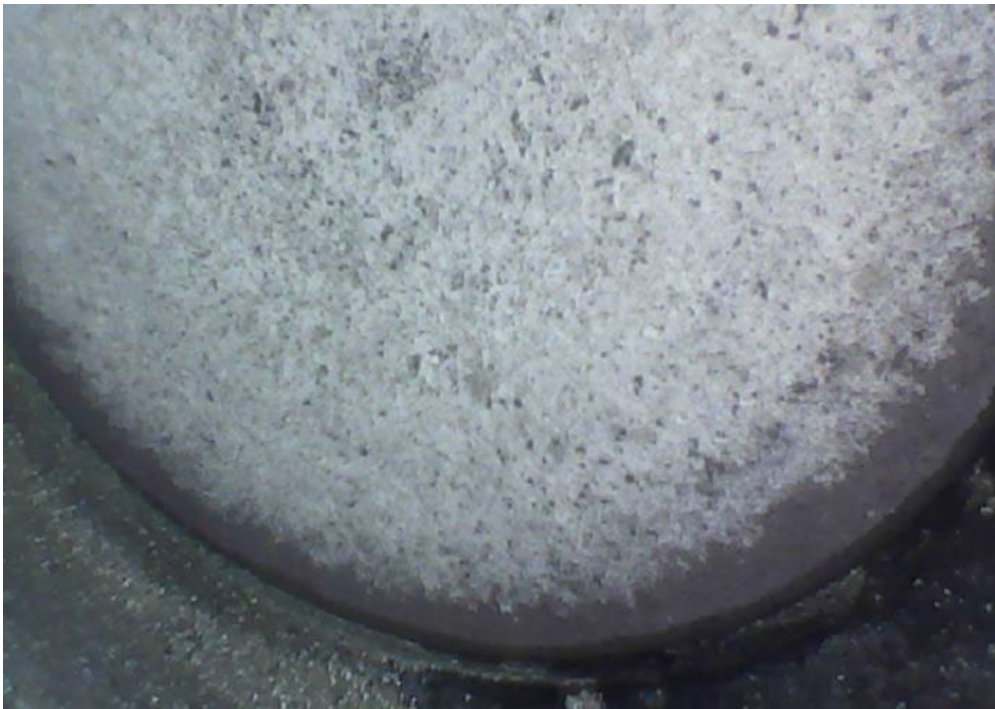
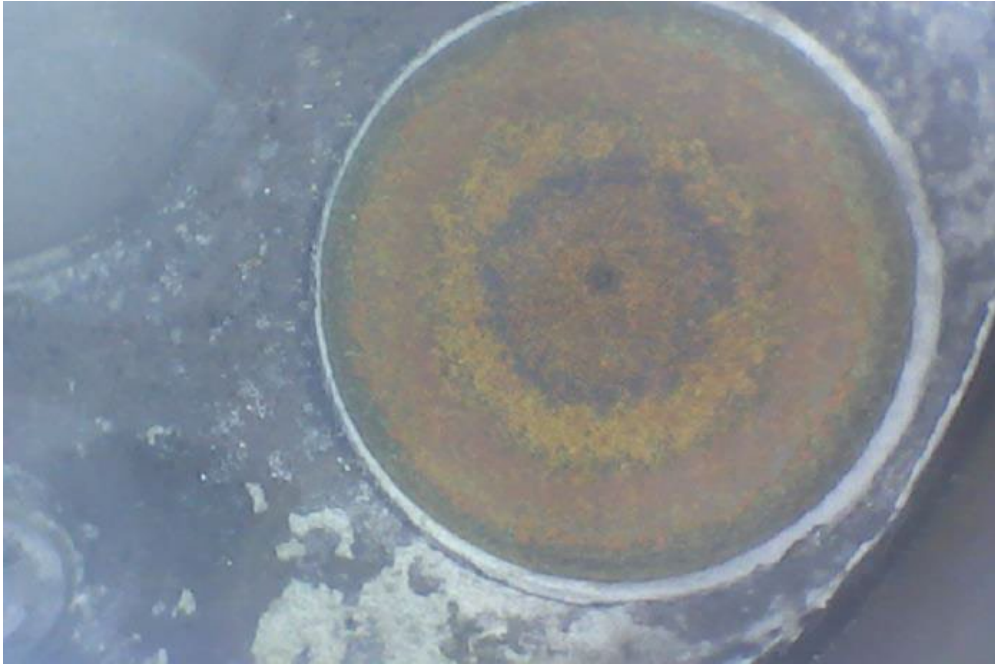
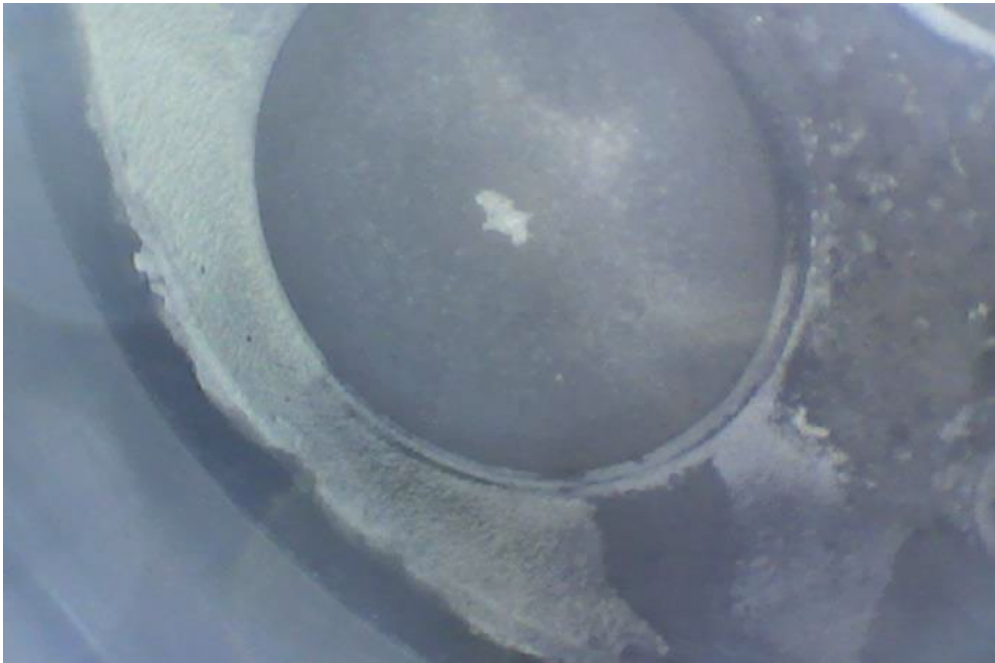
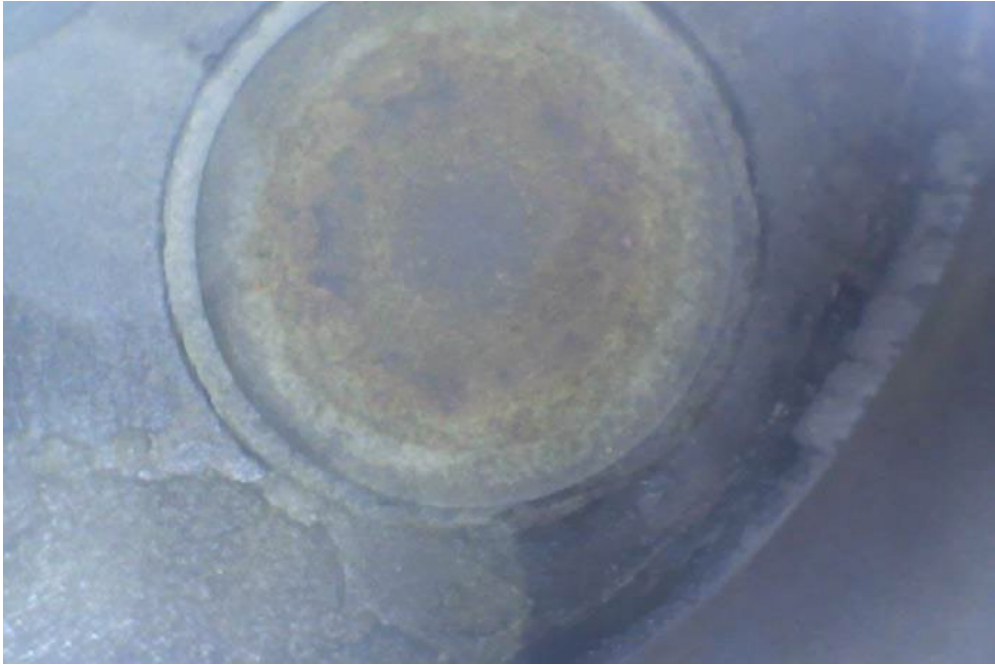
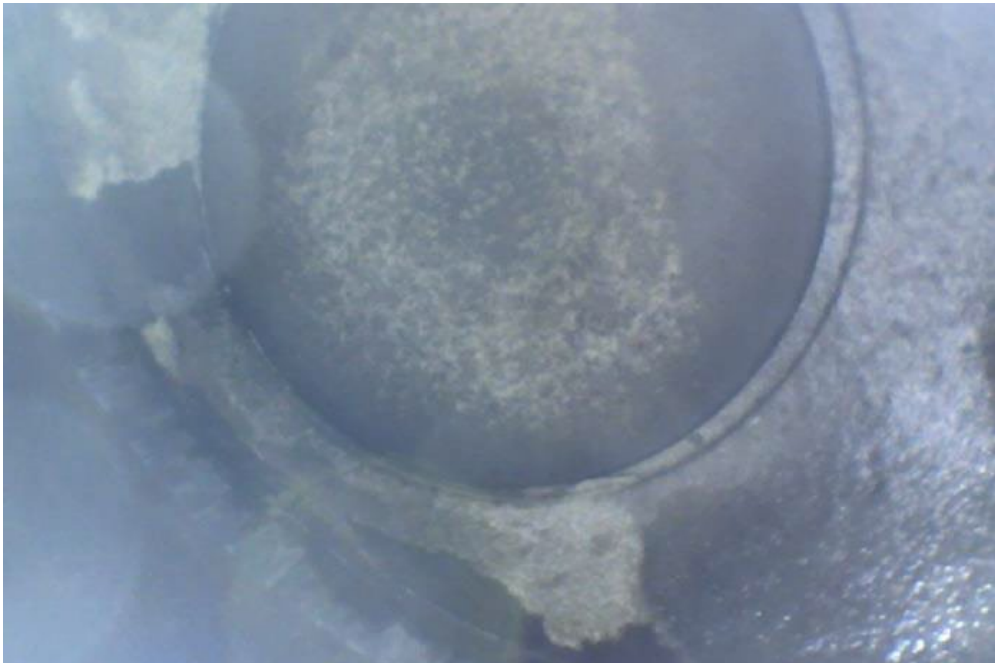
The valve heads were inspected using a lighted borescope. The valve heads displayed normal operating and combustion signatures. During crankshaft rotation all valves operated normally.

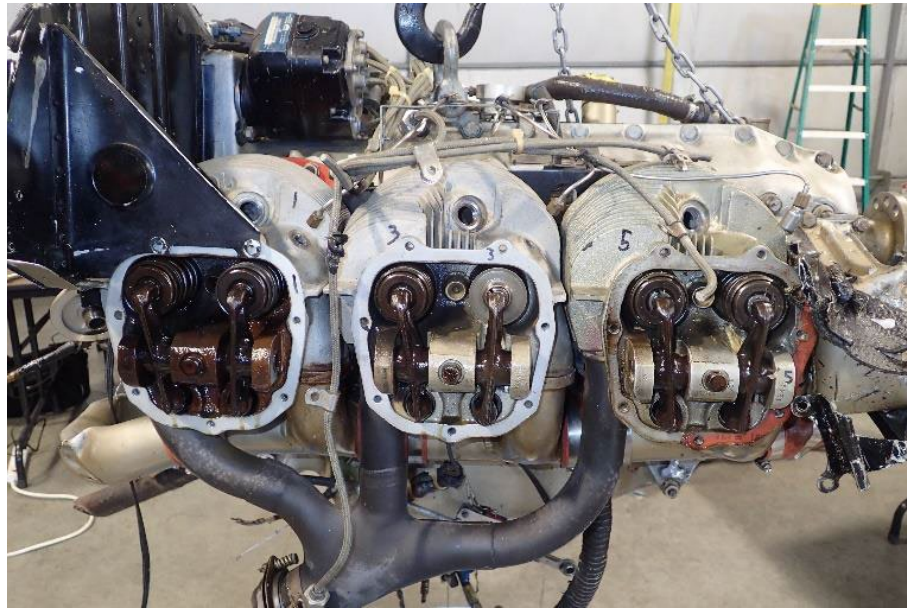
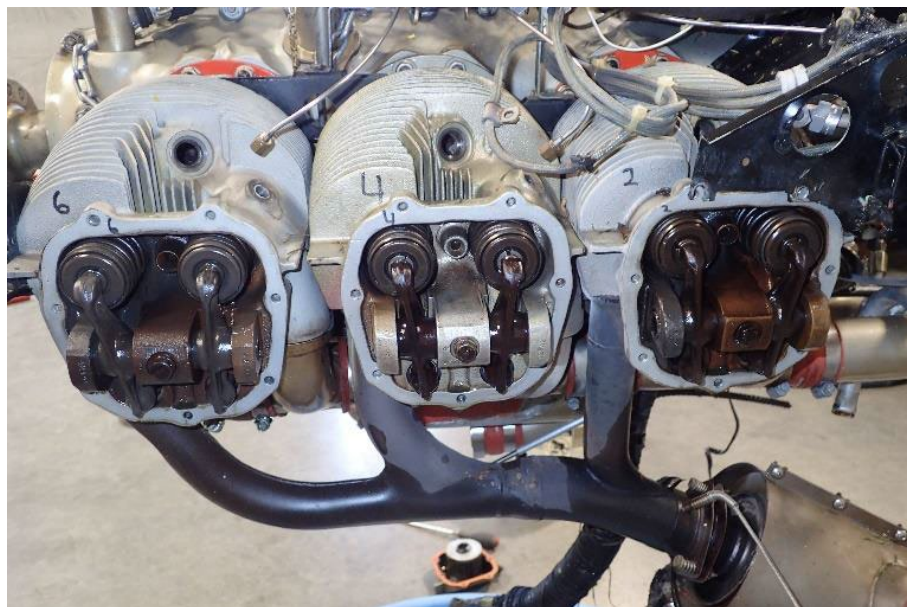
All of the rocker arms remained attached to their installation points and were undamaged. Rocker arms displayed normal operating and lubrication signatures, during crankshaft rotation all of the rocker arms operated normally.
