# NATIONAL TRANSPORTATION SAFETY BOARD

## SURVIVAL FACTORS

### Survival Factors Group Chairman's Factual Report

DCA19MA143

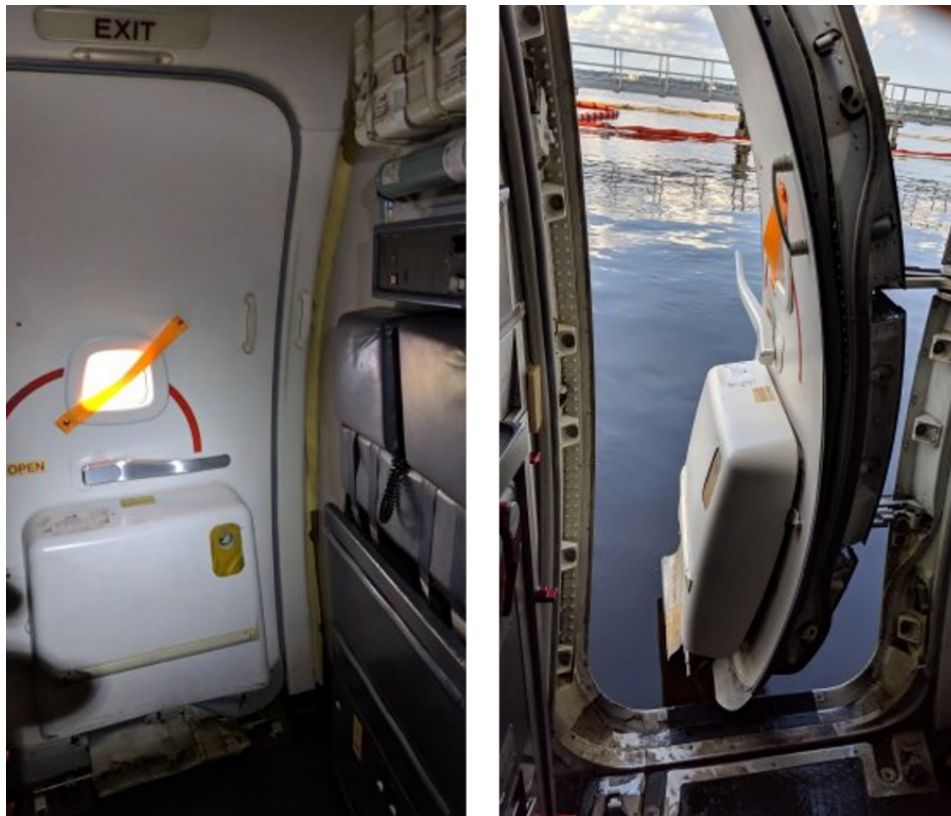
The 2L door was closed and the slide was armed with the slide girt bar attached to the airplane floor fittings. The slide gas bottle pressure gauge needle was inside the green band area<sup>2</sup>. The safety strap was across the window. The Survival Factors group disarmed the door. The door was operable, and the door and door frame had no structural damage. The 2L evacuation slide was manufactured by Collins Aerospace and the following was obtained from the data tag:

The 2L evacuation slide was removed from the door and placed on the ground to be inflated and depressurize the charged cylinder. The slide was removed from its compartment and the safety pin was removed from the slide valise (cover) pocket and installed into the inflation bottle's regulator valve. The slide was unfolded, and restraints were released. The safety pin was removed from the valve and the system was fired by pulling the manual inflation handle. The slide was successfully inflated, and the inflation was recorded by video (attachment 9).

*Photograph 10- Picture of the 2L door.*

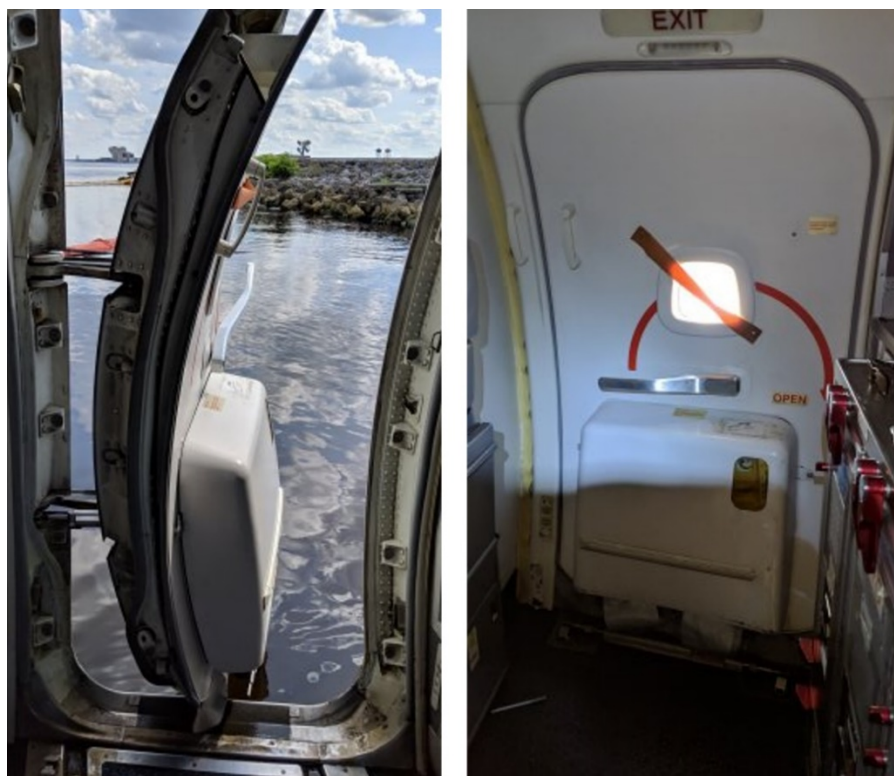
The 2R door was closed and the slide was armed with the slide girt bar attached to the airplane floor fittings. The slide gas bottle pressure gauge needle was inside the gauge green band area. The safety strap was across the window. The SF group disarmed the door. The door was operable. The door frame and door had no structural damage or deformation. The 2R evacuation slide was labeled:

The 2R evacuation slide was removed from door and inflated to depressurize the charged cylinder. Once on the ground the slide was removed from the (clam shell) compartment by pulling on the latch release. The safety pin was removed from the slide valise (cover) pocket and installed into the regulator valve. The slide was removed from the compartment and the valise cover release pin was pulled to allow access to the slide. The slide was unfolded, and restraints released. The safety pin was removed from the valve and the system was fired by pulling the manual inflation handle. The slide successfully deployed, and a video was taken (attachment 10). Approximately 5 minutes after inflation, the slide burst due to seam separation on the left end section of the head end tube. The inflatable portion of the slide was sent to the manufacturer for further examination<sup>3</sup>.

*Photograph 11- Picture of the 2R door.*

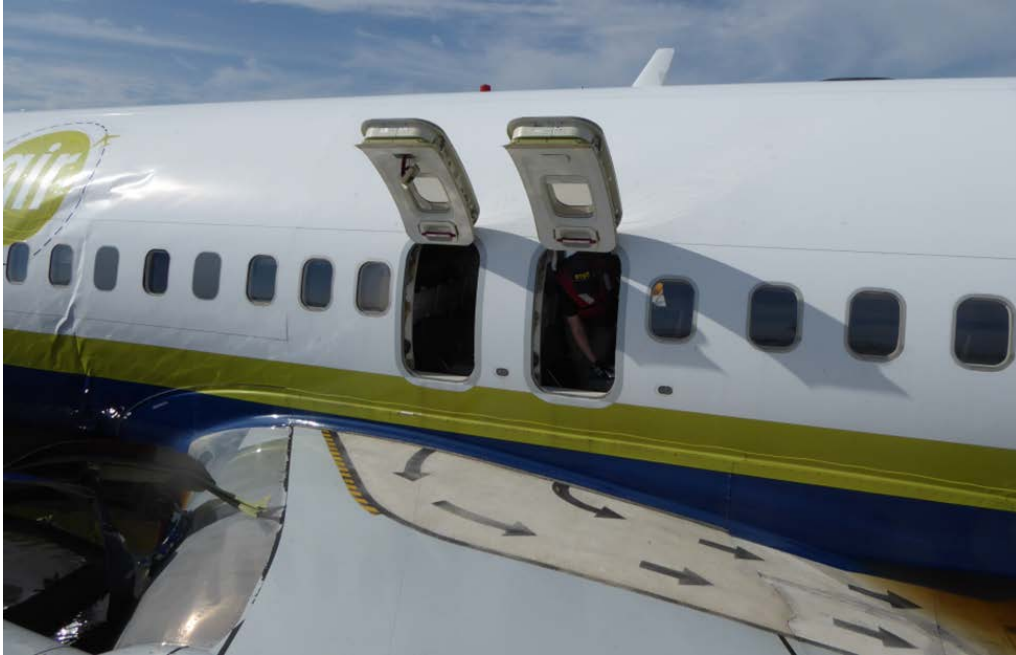
Both left hand OWWE were open and there was no damage to either frame. The door closing strap located at the bottom of the OWWE was out of the compartment. Both doors functioned and the placards were present. The lifeline was stowed in the upper corner of the OWWE at row 15 and not deployed. The lifeline was removed from stowage and was long enough in length to reach the eyelet on the wing.

*Photograph 13- External view of the overwing window exits – left side.*

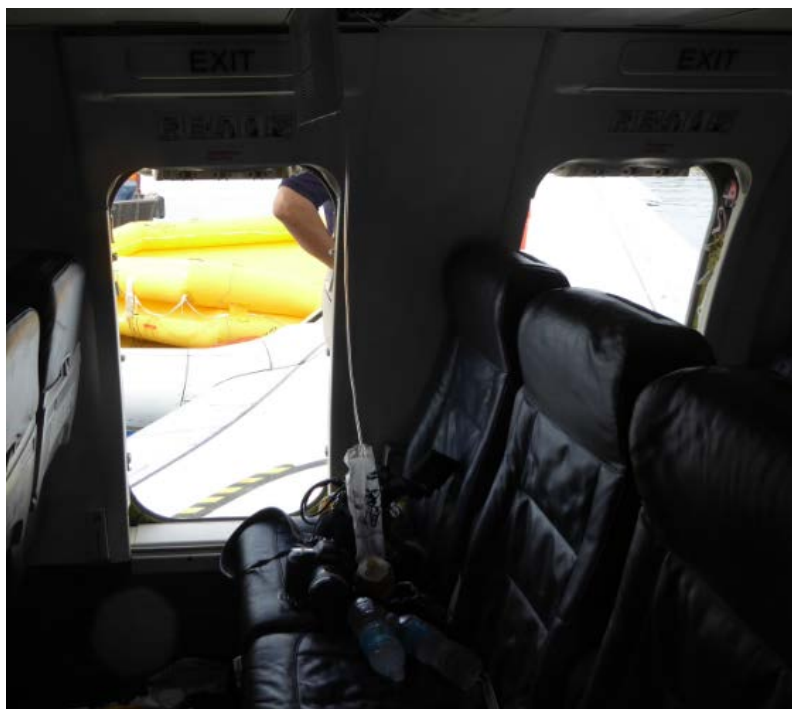
Both right side OWWE were open and there was no damage to either doors or door frames and the door operated when opened. The lifeline was present and stowed in the upper corner at row 15. The lifeline was removed from stowage and there was some difficulty pulling it from the location. They were long enough in length to reach eyelet on the wing.

*Photograph 14- Internal view of the overwing window exits.*

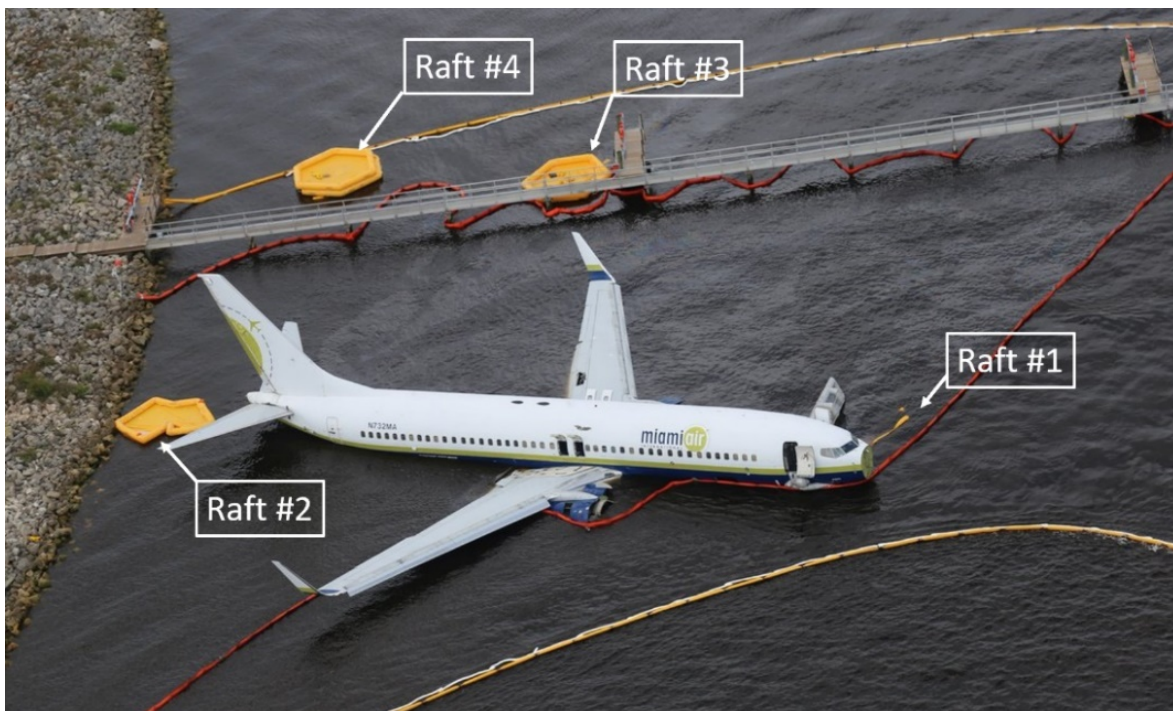
All four inflatable life rafts were found outside the airplane. The life rafts were manufactured by Safran AeroSystems in Belmar, NJ.

*Photograph 22- Picture showing life raft number and location at accident site.*

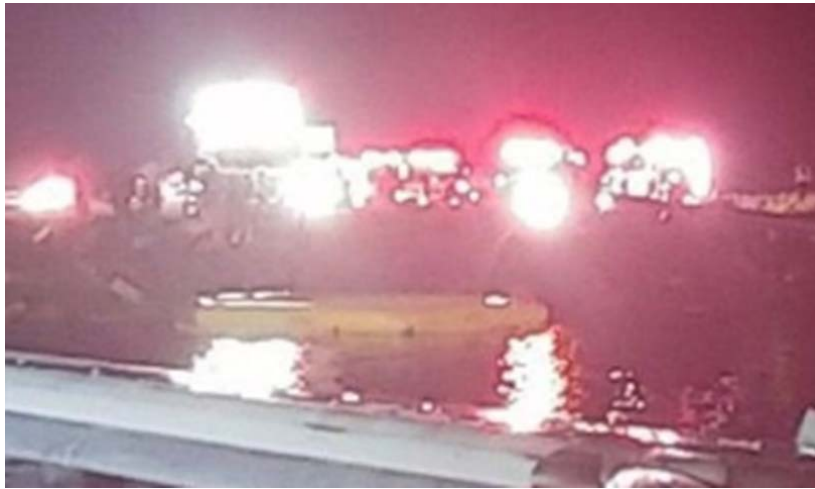
Life raft #3 was a 46-person raft and initial photographs show it fully inflated at the time of the accident.

*Photograph 23- Life raft #3 inflated at the time of accident.*

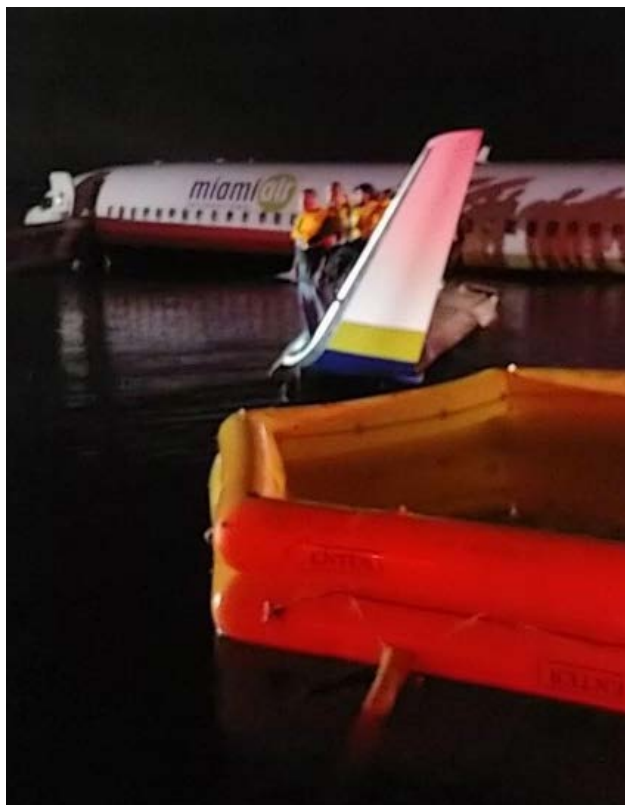
Life raft #4 was a 46-person raft and initial photographs show it fully inflated at the time of the accident.

*Photograph 24- Life raft #4 inflated at the time of accident.*
