## **NATIONAL TRANSPORTATION SAFETY BOARD**

### **Group Chairman's Factual Report**

# **SURVIVAL FACTORS**

DCA22FA132

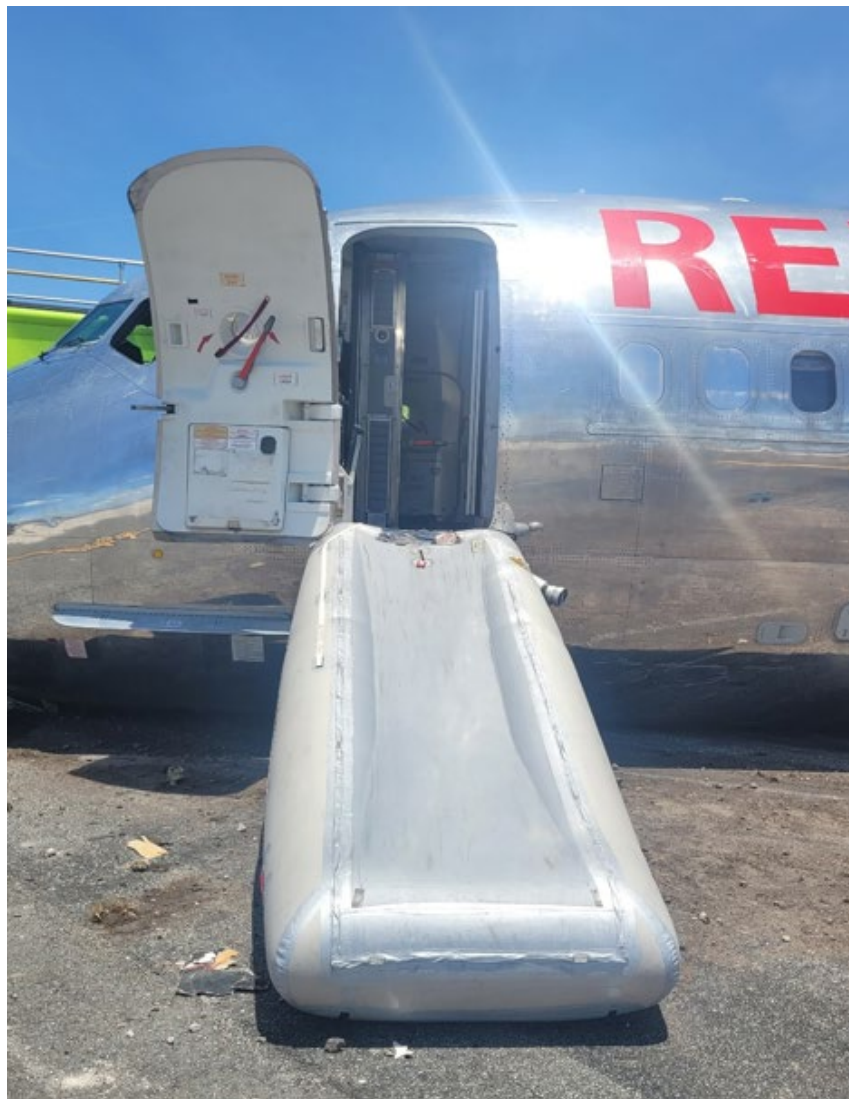
**Figure 17- L1 evacuation slide.**

There were no anomalies found with the slide system or observed during the evacuation. The slide was labeled:

Marking on lacing cover: MOD PER S.B 304-25-20

Inspection Performed: 8/19/2021

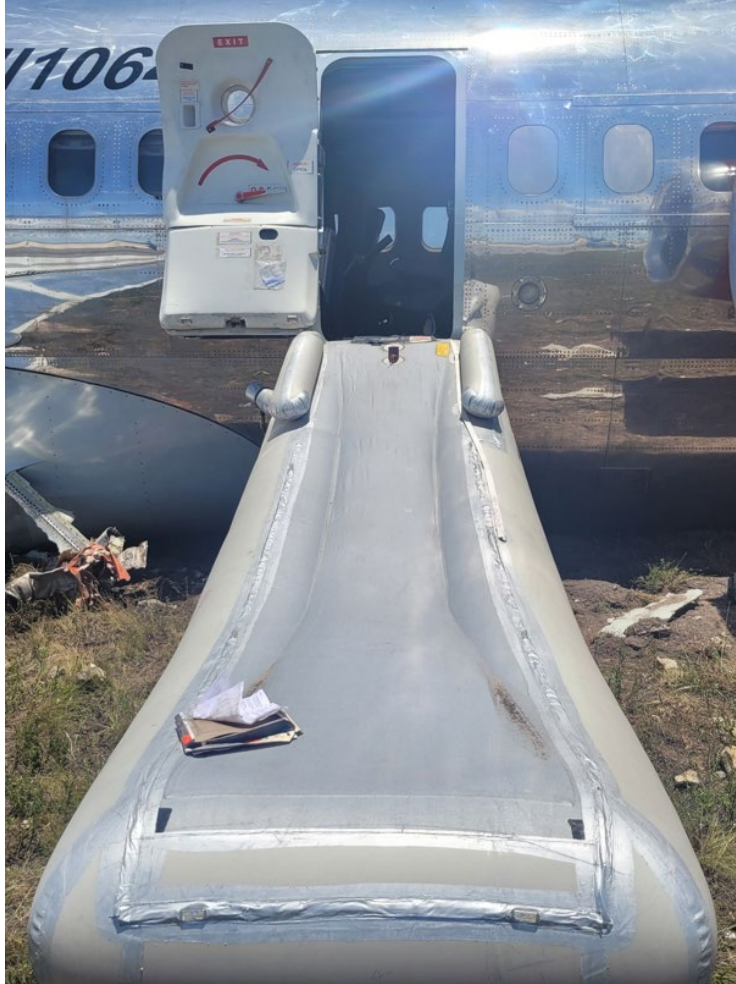
**Figure 20- L2 evacuation slide.**

The L2 slide was fully deployed and was used during the evacuation. The inspection record was on the door bustle and labeled 8130-3. The company that performed the last overhaul was Carmas Aviation Equipment (CAE) Inc. in Medley, Florida. There were no anomalies found with the slide system or observed during the evacuation. It was labeled:

Marking on lacing cover: MOD Per SB 304-25-20

Inspection Performed: Nov 2020

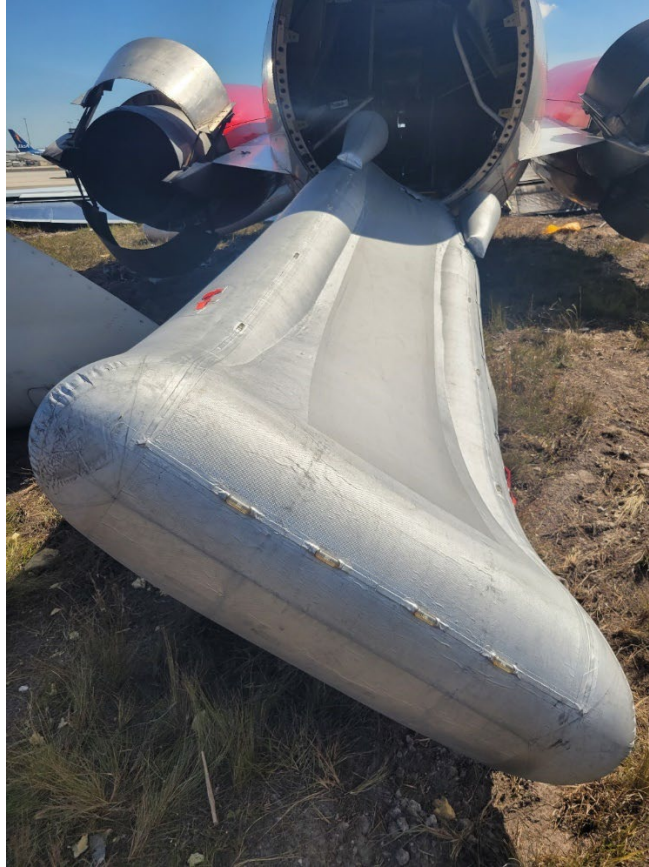
**Figure 21- Tailcone evacuation slide.**

Marking on lacing cover: Nothing notable found on the slide container.

Inspection Performed: Dec 2021

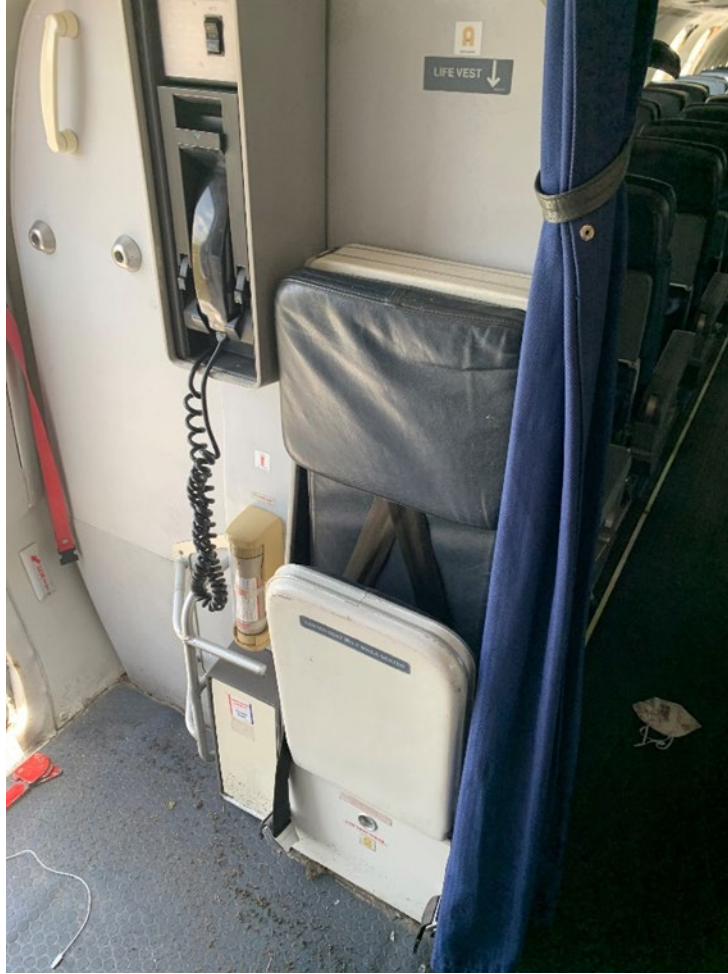
**Figure 24- Aft L2 flight attendant jumpseat station.**

The aft L2 flight attendant station held a flashlight and an interphone. There was a lifevest and fire extinguisher under the jumpseat. The seat bottom retracted and there was no deformation. The restraints retracted. The restraint was unbuckled.

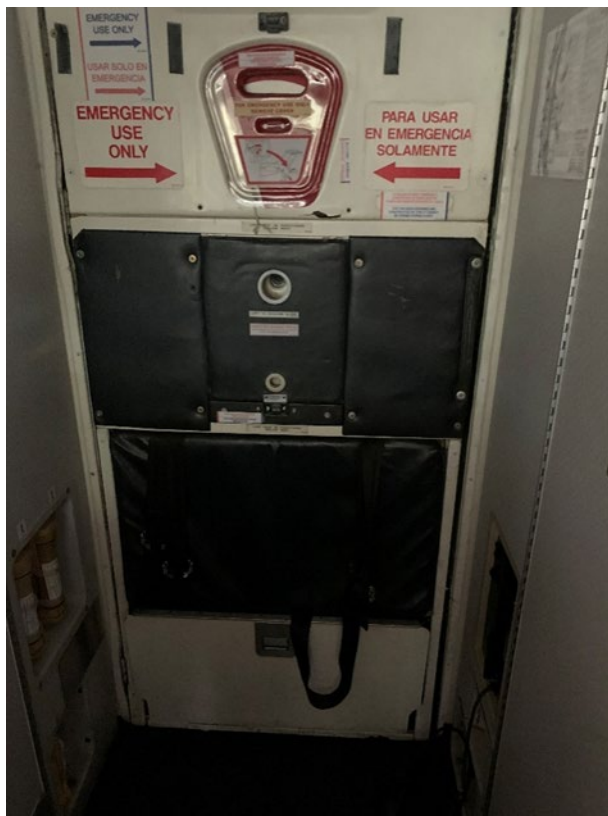
**Figure 25 - AFT flight attendant jumpseat station at the tailcone.**

To the left of the flight attendant jumpseat station there was a flight attendant panel with light controls and an interphone. To right of the station there were two flashlights. There were lifevests and a fire extinguisher under the jumpseat. The seat bottom retracted and there was no deformation. The restraints retracted. The right-side restraint was buckled, and the left side restraint was unbuckled.

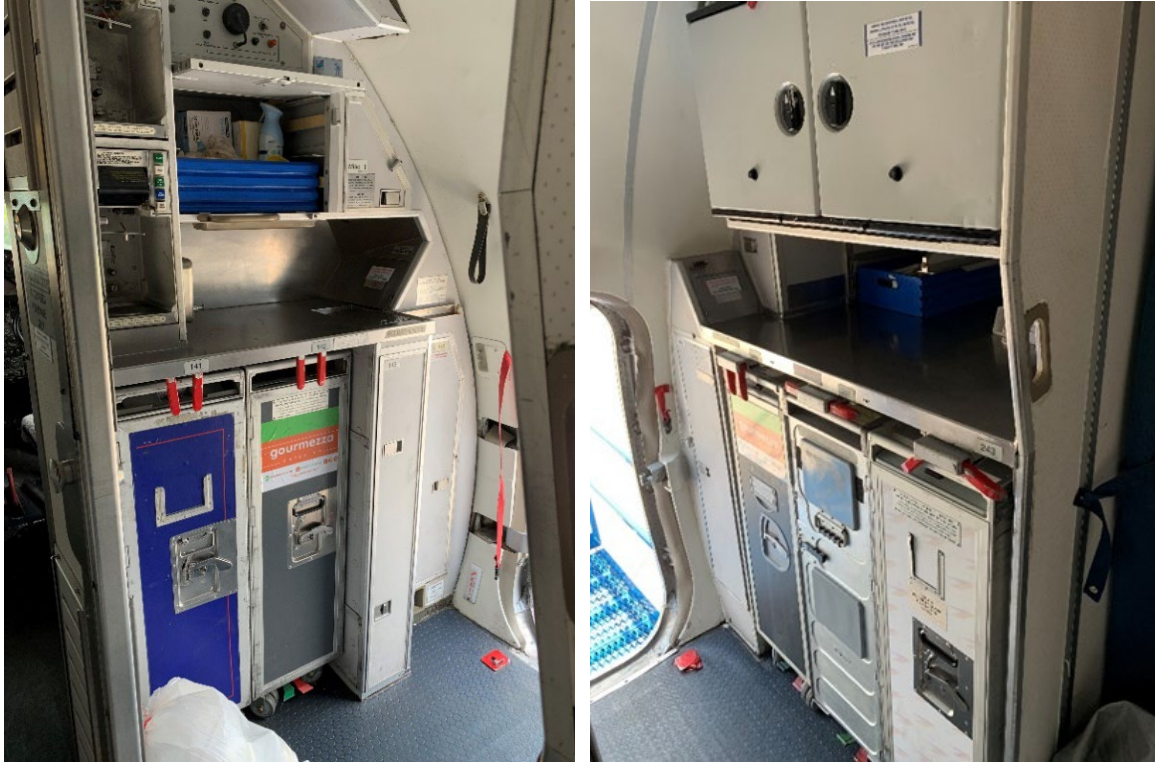
**Figure 26- Forward galley (G1 and G2).**

All galley bins were stowed, locked, and latched at the time of documentation. Galley carts were locked and secured with latches. There was a bag of trash strapped to one of the latches on the galley cart adjacent to R1 door.

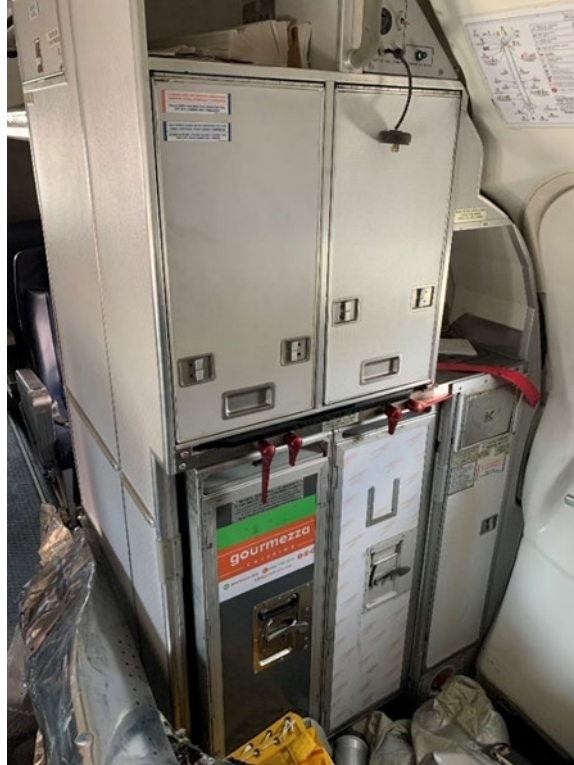
**Figure 27- Aft galley.<sup>3</sup>**

All galley bins were stowed, locked, and latched. Galley carts were locked and secured with latches.
