# National Transportation Safety Board

HWY23FH005

## **SURVIVAL FACTORS**

Group Chair's Factual Report

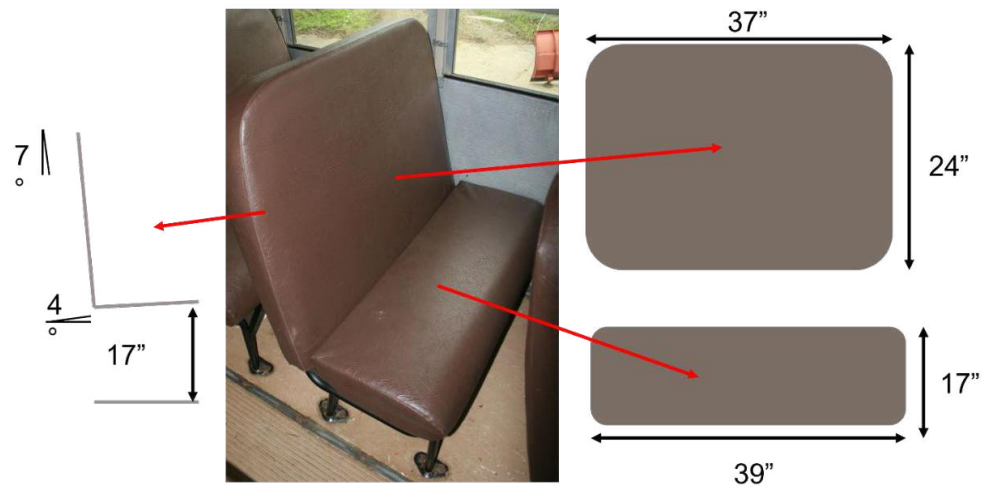
The bus was equipped with an adjustable high-back bucket seat with integral headrest for the driver seat position, as shown in **Figure 10**. Behind the driver seating position were 5 rows of 29.5 inch high-back bench seats on each side. Behind the 5<sup>th</sup> row on the left side the bus was still equipped with the Q'Straint wheelchair tie-downs and lap and shoulder belts which were stored in a bag. The last two rows of seats on the right side were installed by the LBFNY mechanic after the bus was purchased in November 2021. The two seat rows were installed in the area normally left open for the wheelchair lift door operation. The seat manufacturer is unknown. The wheelchair lift mechanism had been removed by the LBFNY mechanic and the wheelchair lift door was secured to the floor with a locking slide bolt and attached to a piece of angle iron that went longitudinally across the door face, forward and aft of the door and made the lift door inoperable. The two seat rows were attached to the piece of angle iron that was spot welded to the exterior side wall and wheelchair lift door. The seat legs were attached to the floor using four tap screws. Post-crash examination showed that both sets of seats remained firmly attached to the floor and sidewall. The three rows of seats forward on the right-side and the five rows of seats on the left-side were original equipment on the bus. Dimensions of the bench seats for the last two right rear seats that were "Add on" seats are shown in **Figure 11** and the original bench seats in **Figure 12**.

**Figure 11.** Dimensions of the "Add-on" passenger seats in the last two rows on the right

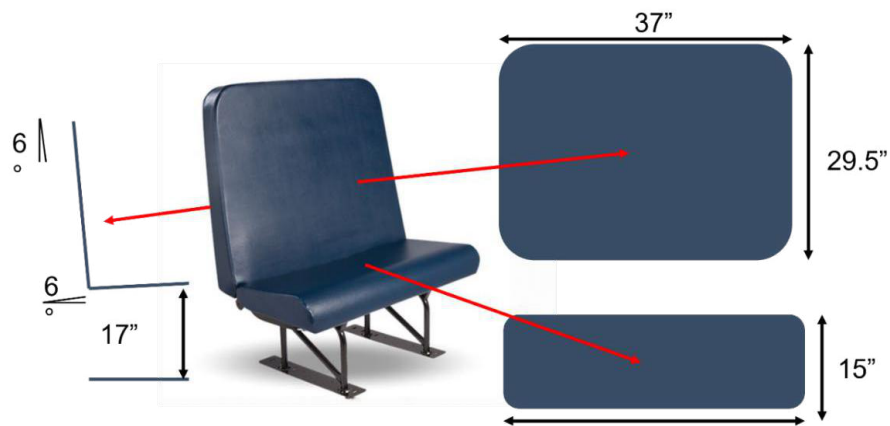
**Figure 12.** Dimensions of the originally equipped passenger seats.  
side.

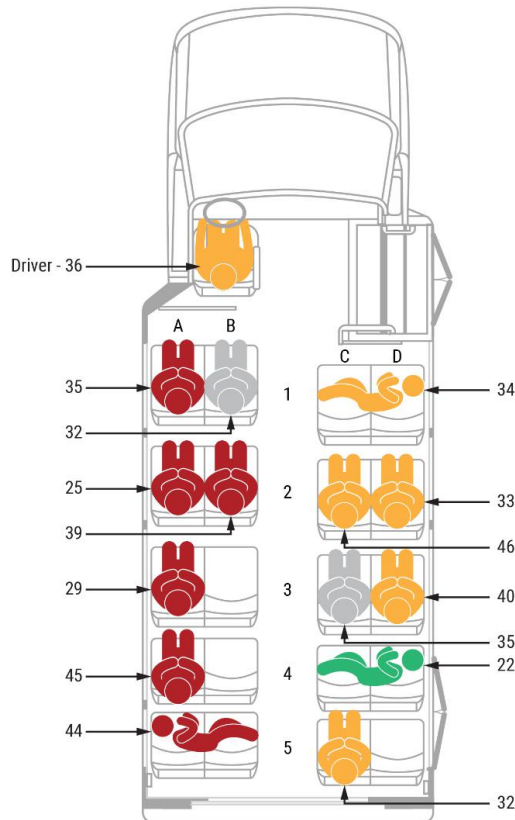
A seating chart was established based on NTSB investigator interviews of the bus driver and seven passengers. The seating chart is shown below in **Figure 15** gives a schematic of the bus with the seating designations.

**Figure 15:** Schematic of bus seating configuration where Row 1 is the front passenger row (closest to the driver), and Row 5 is the rearmost passenger row by the rear exit door. Seats A and B are on the left-side (driver's side) and C and D are on the right-side. An occupant seated in the center of the seat is designated as either A/B (center left side) or C/D (center right side).
