Alaska Airlines Flight 1282

Boeing 737-9, N704AL

Left Mid Exit Door Plug Separation in Portland, OR

Systems Group Chair's Factual Report

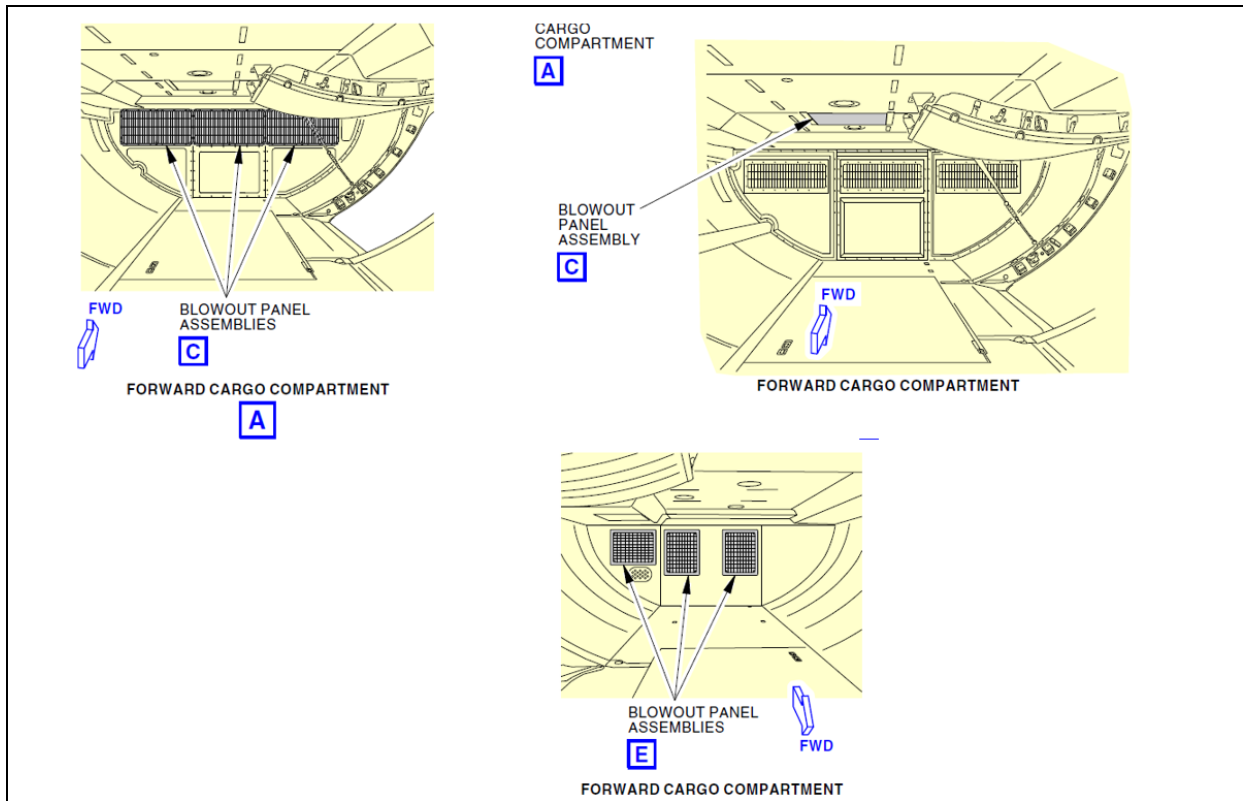
Figure 4. Forward cargo compartment pressure relief panels. (Image Copyright © Boeing. Reproduced with permission.)

In the forward cargo bay, the forward three pressure relief panels, and the center aft panel were displaced. The ceiling pressure relief panel was not displaced. In the aft cargo bay only the forward waste tank enclosure panel was displaced. Both ceiling pressure relief panels were not displaced. Refer to Figures 4 and 5 for relief panel locations. In addition, the cockpit door was observed to be open and the main latch no longer retained the door, consistent with a door latch that operated per design during a significant rapid depressurization event.

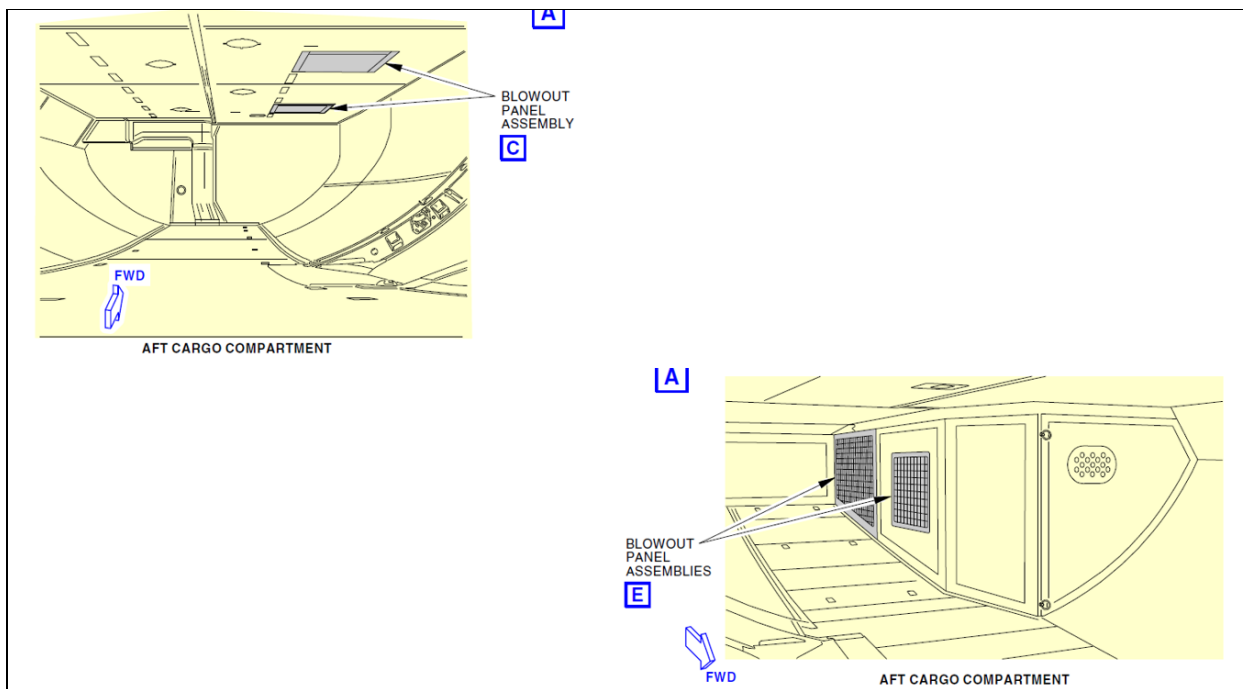
Figure 5. Aft cargo compartment pressure relief panels. (Image Copyright © Boeing. Reproduced with permission.)
