National Transportation Safety Board

DCA20LA138

SYSTEMS

Group Chair's Factual Report

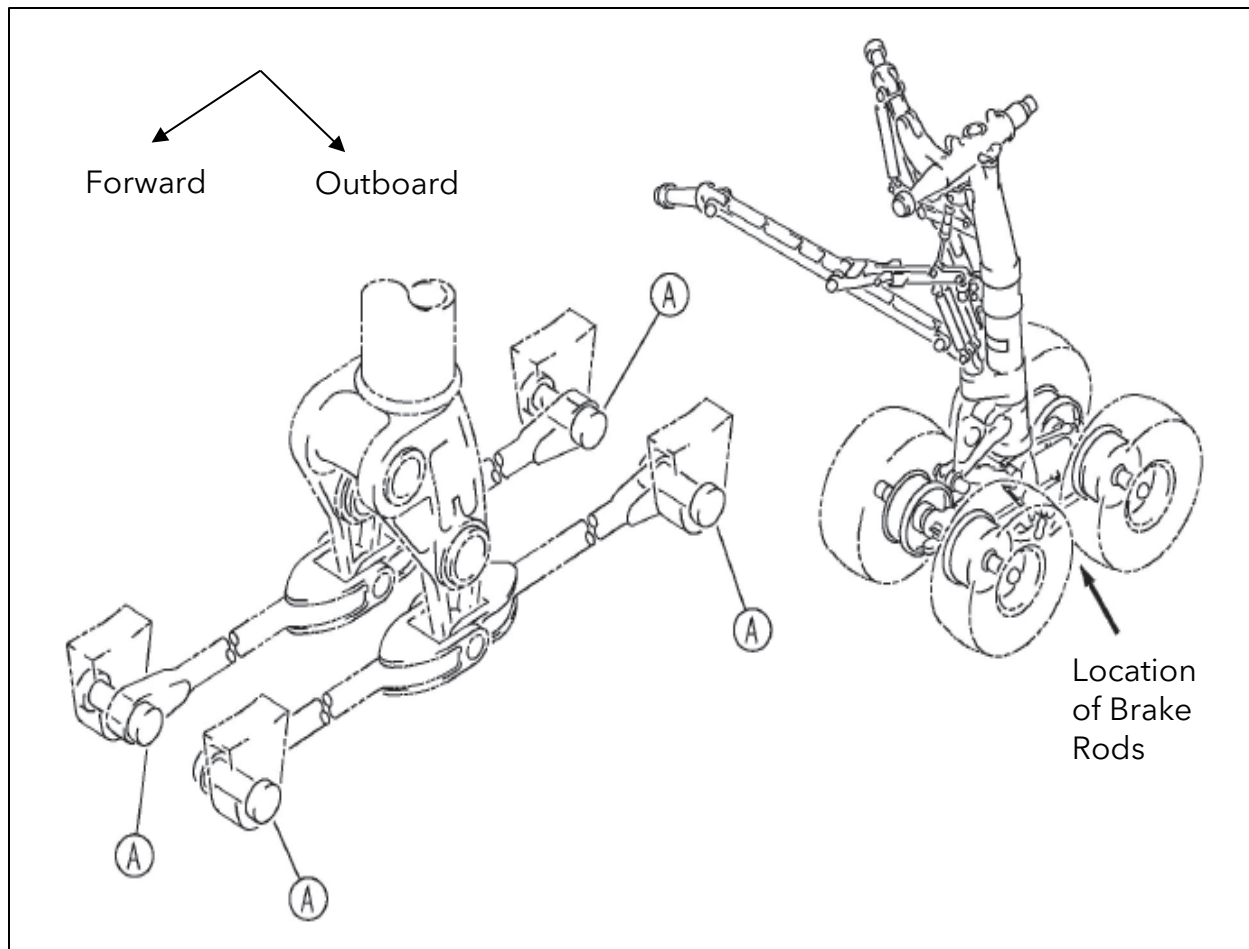
A single brake rod is installed between each brake assembly housing and the shock strut (see Figure 2). The purpose of this brake rod is to transfer the torque generated by the brake to the main gear. The brake rod is connected to the torque arm on the brake assembly housing using a pin, tang washer, retaining bolt, and two lock screws secured by safety wire as attaching hardware (see Figure 3). For the main gear inboard brake rod pin positions, the head of the pins will be in the down direction when the gear is in the up (stowed) position, which could allow the pins to fall out if the retaining bolt and lock screws were not engaged.

Figure 2. Aircraft Maintenance Manual schematic showing brake rods. The lines labeled "A" point to brake rod attaching hardware at the four brake assemblies on the left main landing gear assembly. Copyright © Boeing. Reproduced with permission. Note: schematic has been altered for clarity from original source.

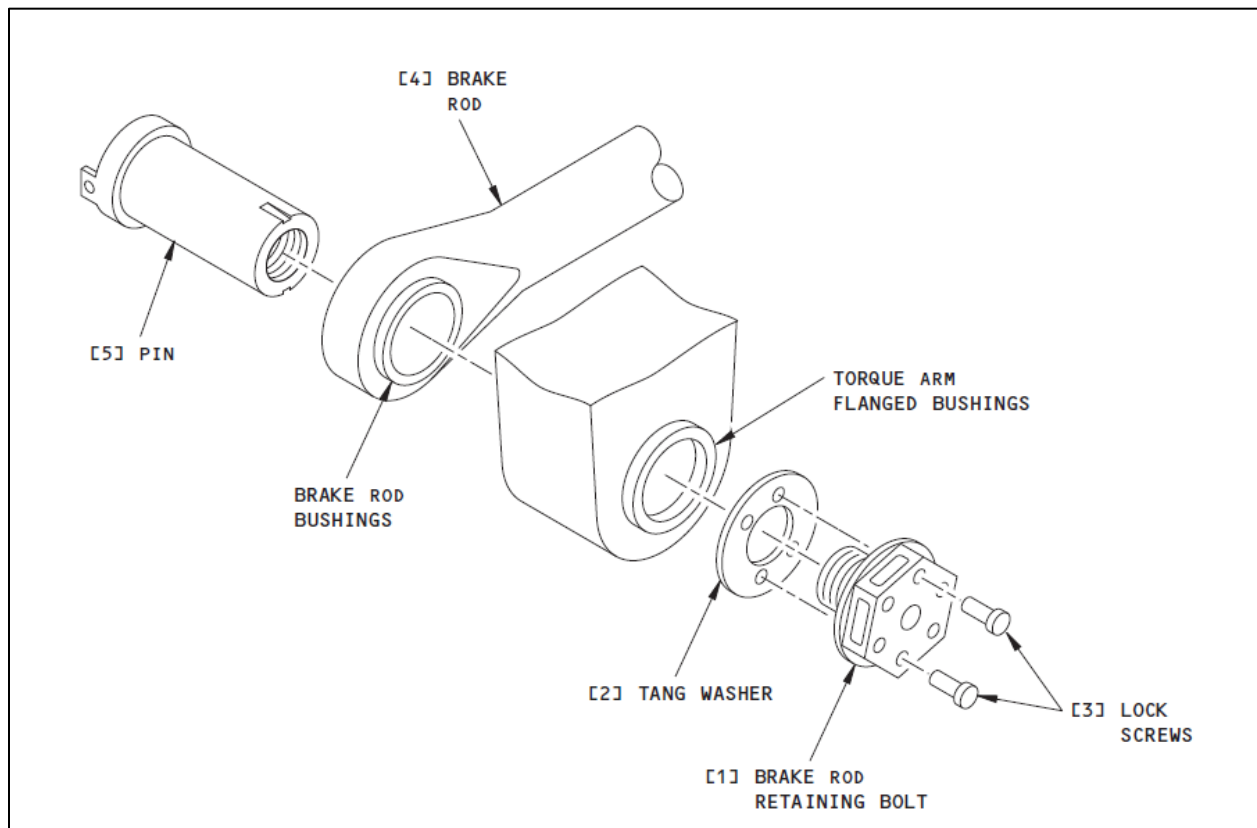
Figure 3. Aircraft Maintenance Manual schematic showing the brake rod attaching hardware at the brake assembly (see Figure 2, callout "A"). Copyright © Boeing. Reproduced with permission. Note: schematic has been altered for clarity from original source.
