NATIONAL TRANSPORTATION SAFETY BOARD
Office of Aviation Safety
Washington, D.C. 20594

System's Group Chairman's Factual Report

NTSB No: CEN20MA044

Operator: Cheyenne Partners LLC
Aircraft: Piper PA-31T, registration number N42CV
Location: Lafayette, Louisiana
Date: December 28, 2019
Time: 0921 Central Daylight Time

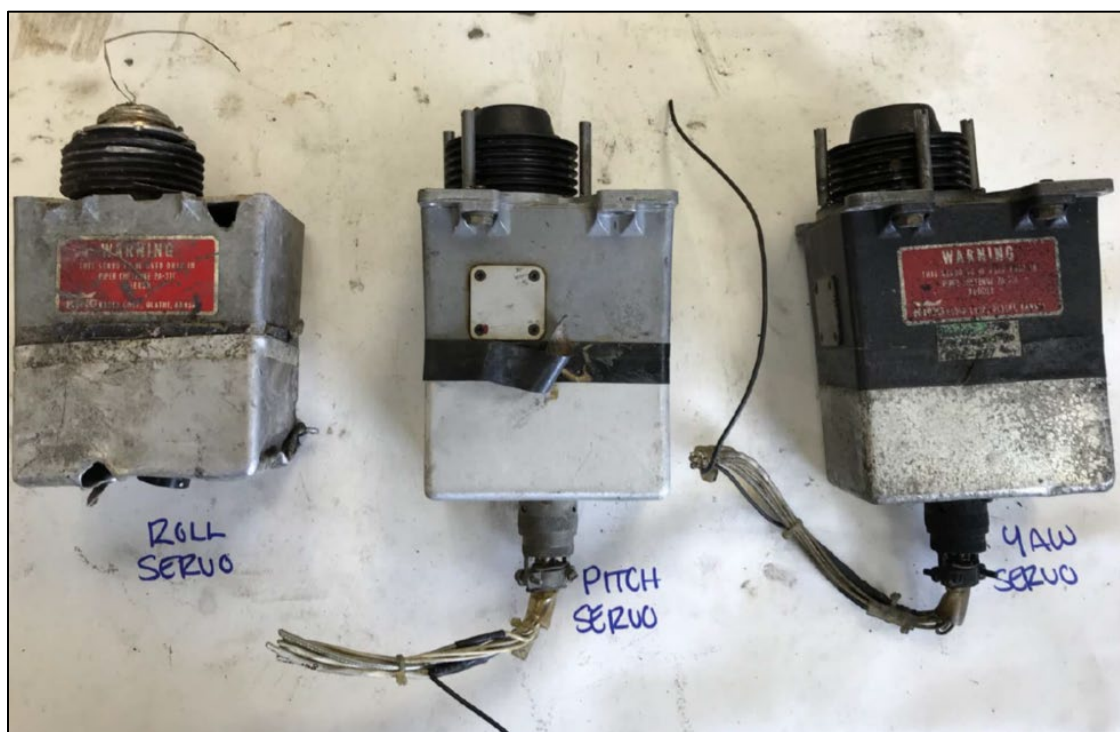
Figure 16 Autopilot Servos

The autopilot pitch, roll, and yaw servos were located and recovered during the wreckage examination (Figure 16). The units were placed in a shipping container and sent to the NTSB for further examination. The units were then shipped to the Duncan Aviation facility in Lincoln, Nebraska, for examination. The shipping box was held in secured storage while at Duncan. Visual inspection revealed the following:

The Pitch Servo was visually examined. The part and serial numbers were confirmed. No visible defects were noted. As part of the visual examination, the wire harness connector was detached; the plug and unit connector look fine, with no defects noted. The protective tape around the servo between the back chassis and the servo body looked fine. The dust cover was removed to examine the internal components; no defects were noted, and the servo was considered testable.

The capstan was removed from the servo. One of the four connecting bolts was missing. The capstan looked okay, no defects noted.

Overall, no defects were noted, and a Duncan Aviation representative indicated the servo appeared to be in an operable state.

No binding was noted on the servo rotating spline. At least two of the metal bars around the capstan were bent; the group could not determine if the bars were bent during the accident sequence or the removal from the airplane. The bearings on the servo mount appeared normal, rotated fine. No torque value was written on the slip clutch.

The group determined that the Roll Servo was too damaged for testing. The outer case was deformed, by the accident sequence, around the actuator chassis. When the outer case was cut and pried away from the chassis, the top circuit card was found pushed down into the second circuit card.

The snap ring was missing; the group assessment was that the ring was detached during the accident sequence.

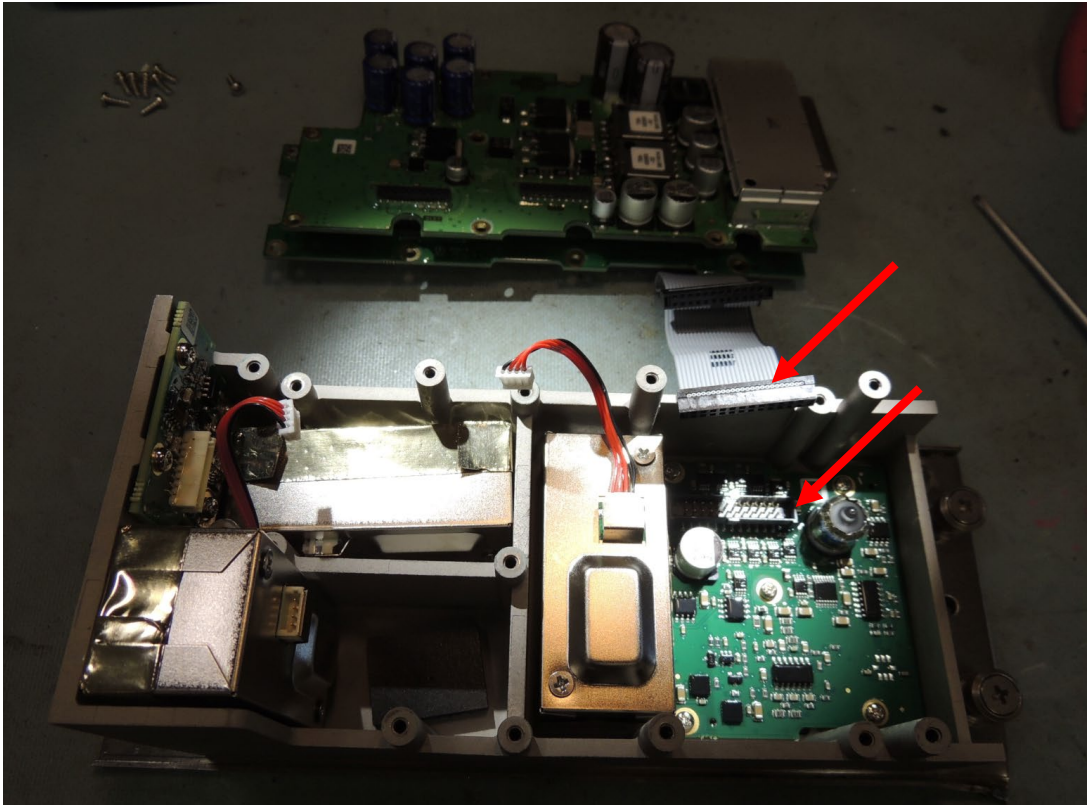
Figure 26 AHRS top circuit boards removed

After receipt of the GRS 77 from Garmin, the unit was re-submitted to the NTSB Recorders Laboratory for another internal examination by the Electronics Engineer. The unit's cover was removed, and the internal components examined. After the top two circuit cards were removed for observation (Figure 26), the connector for the 24-pin ribbon cable (which ran between the top and bottom circuit cards) on the bottom circuit card was noted as, at least, partially disconnected (Figure 27). The ribbon connector was reattached and the unit re-assembled. No other anomalies were noted.

The NTSB also straightened the bent corner of the GRS 77.
