**NATIONAL TRANSPORTATION SAFETY BOARD
OFFICE OF HIGHWAY SAFETY
WASHINGTON, D.C.**

**TECHNICAL RECONSTRUCTION GROUP CHAIRMAN'S
FACTUAL REPORT**

PHOENIX, ARIZONA – HWY21MH008

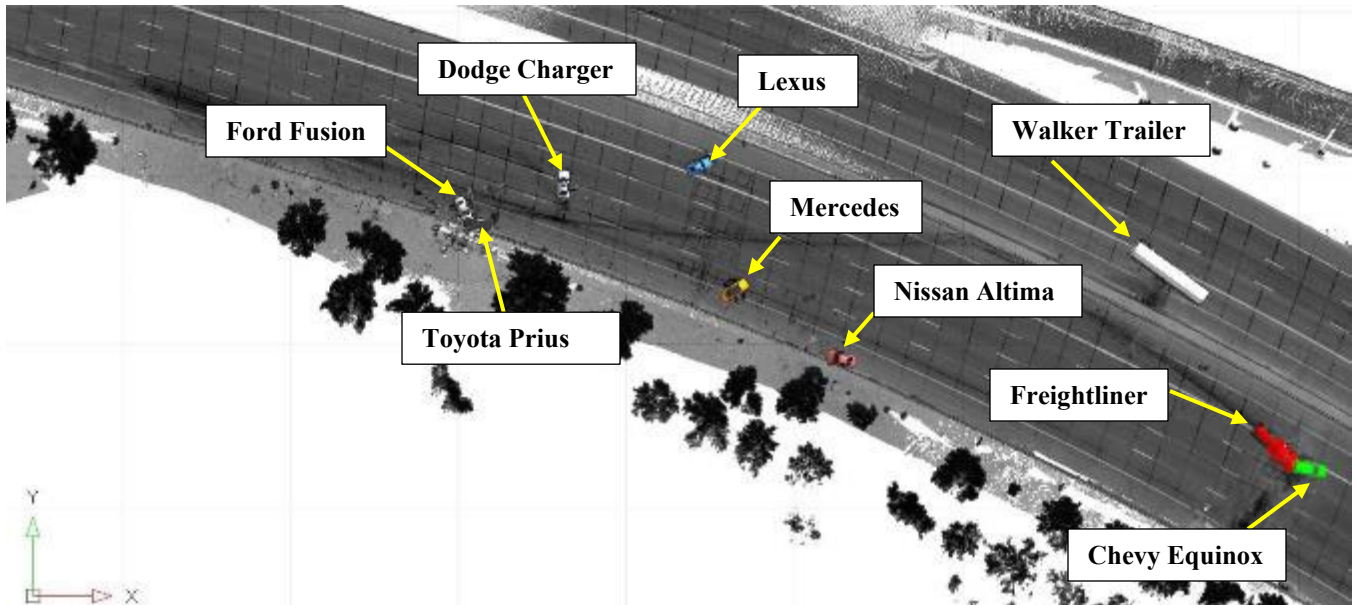
Figure 3: Screen capture from AZDPS 3D scan data with vehicles highlighted for emphasis.

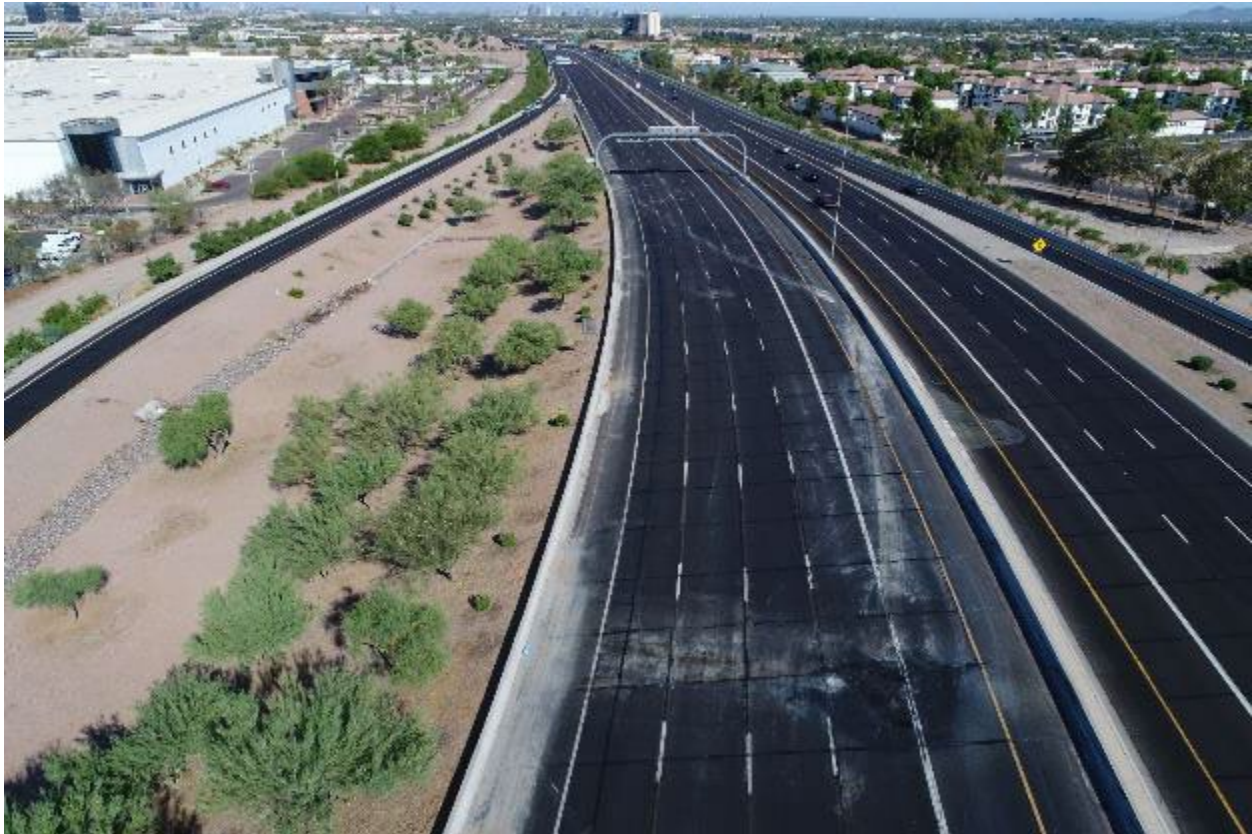
Geo-referenced still imagery was processed using Pix4D photogrammetry software to produce a three-dimensional (3D) point cloud and orthomosaic map of the SR-202 collision site. **Figure 4** is a still image of SR-202 looking in a westbound direction. The image was taken east of the Freightliner and Chevrolet final rest. The post-collision evidence can be seen in the eastbound travel lanes.

Figure 4: Aerial image of the eastbound travel lanes of SR-202 looking westbound.

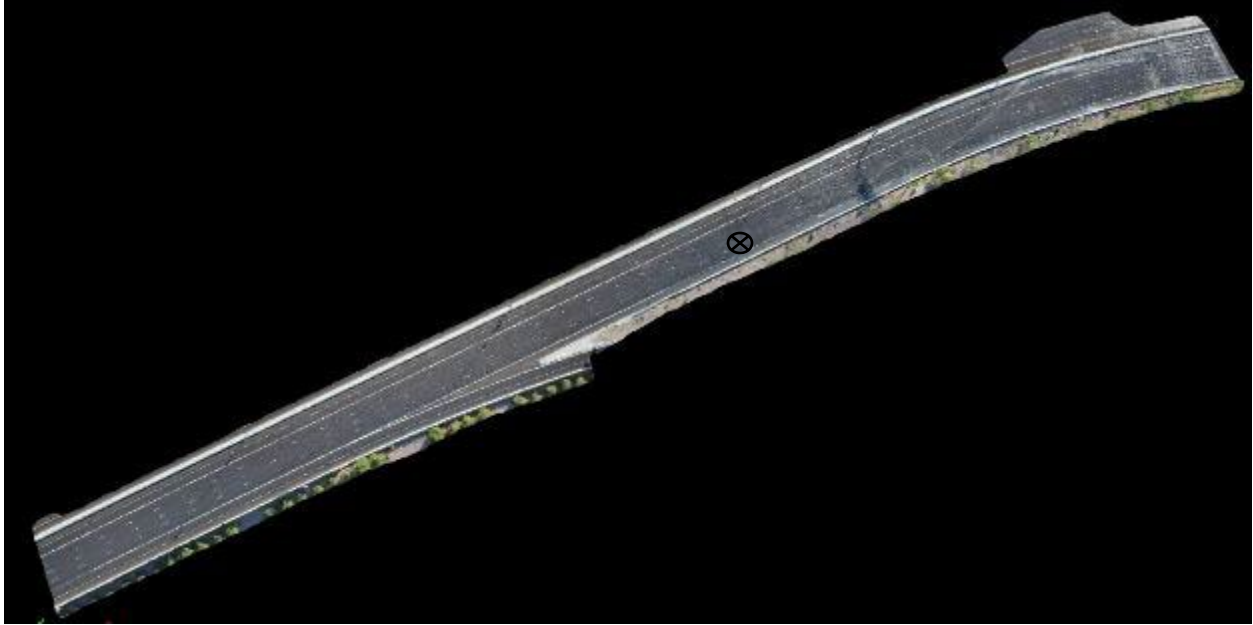
Figure 5 is a screen capture of an overhead view of the rendered 3D point cloud. The NTSB project had captured approximately 1,808 feet of the eastbound travel lanes, the initial area of impact is approximated with the “x”.

Figure 5: Screen capture of NTSB rendered 3D point cloud. The area of impact is approximated by the "x".

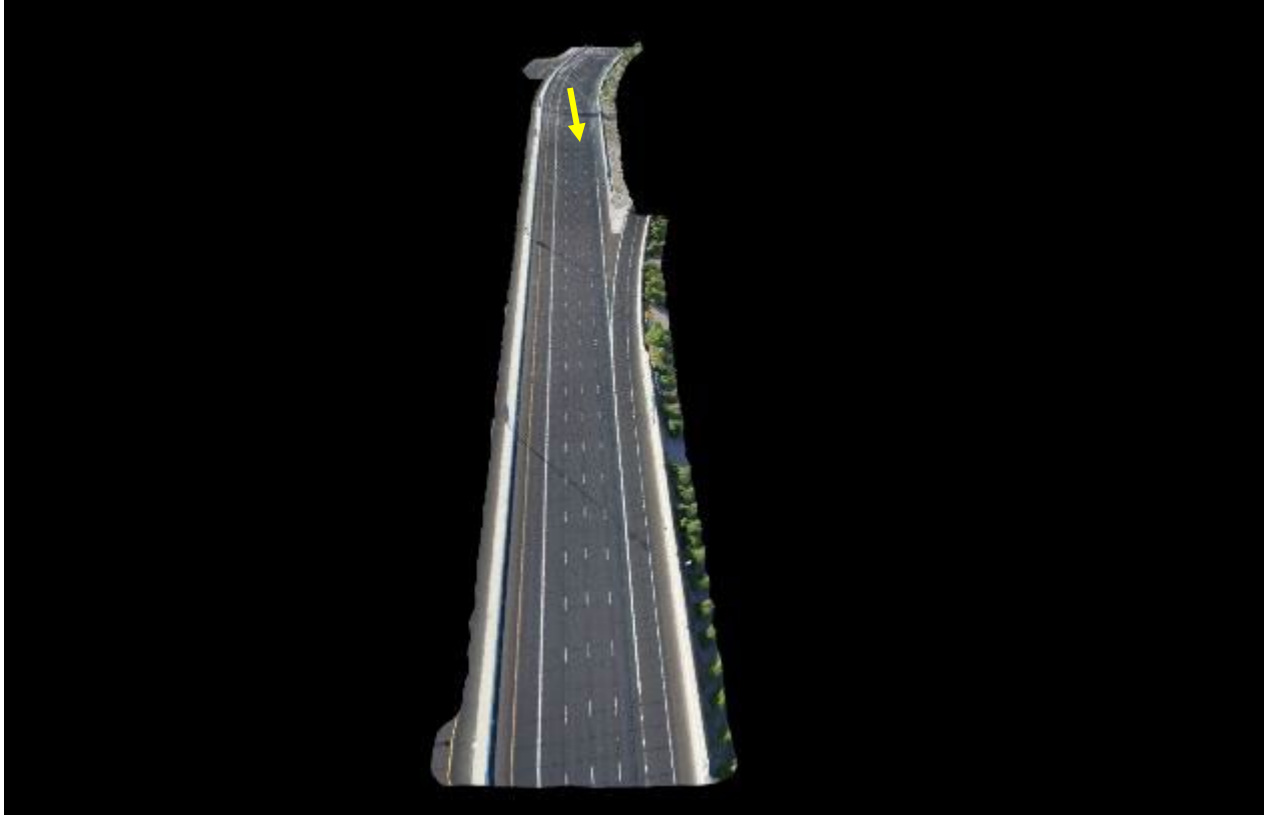
Figure 6 below, is another screen capture of the NTSB rendered 3D point cloud from a different perspective. The initial area of impact is designated by the yellow arrow.

Figure 6: Screen capture of NTSB rendered 3D point cloud with the area of impact approximated by the yellow arrow.

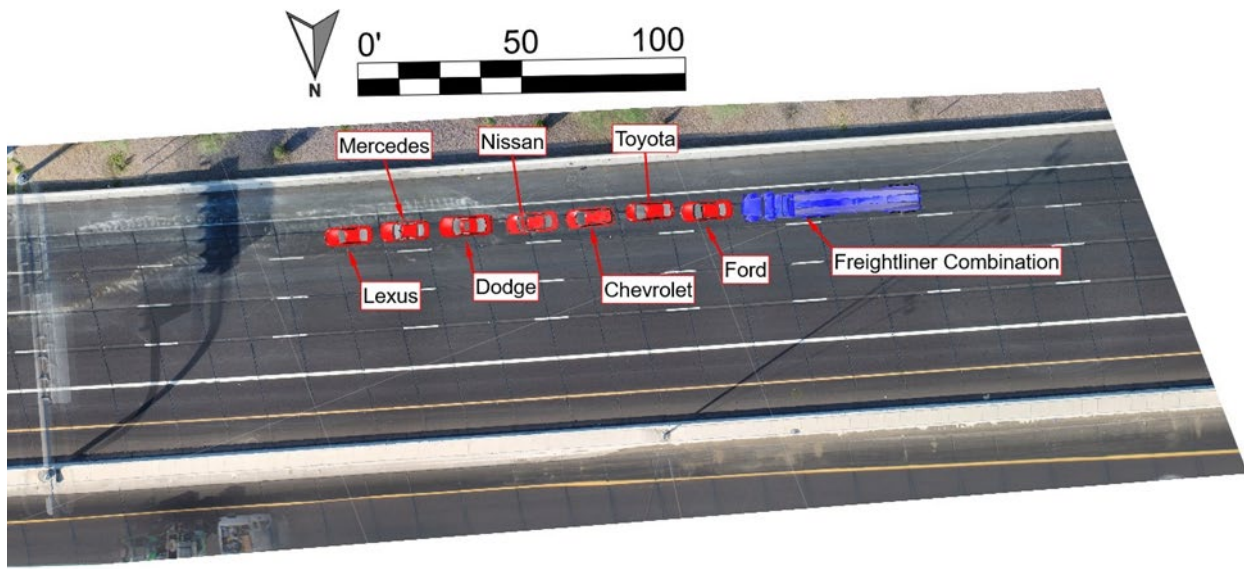
The collision events initiated with a rear-end collision followed by subsequent chain reaction, rear-end events that occurred in succession within the eastbound lanes involving a total of eight vehicles. **Figure 7** is an illustration of the initial positions of vehicles involved in the collision prior to impact.

Figure 7. Depicts likely positions of vehicles involved in collision prior to the initial impact.

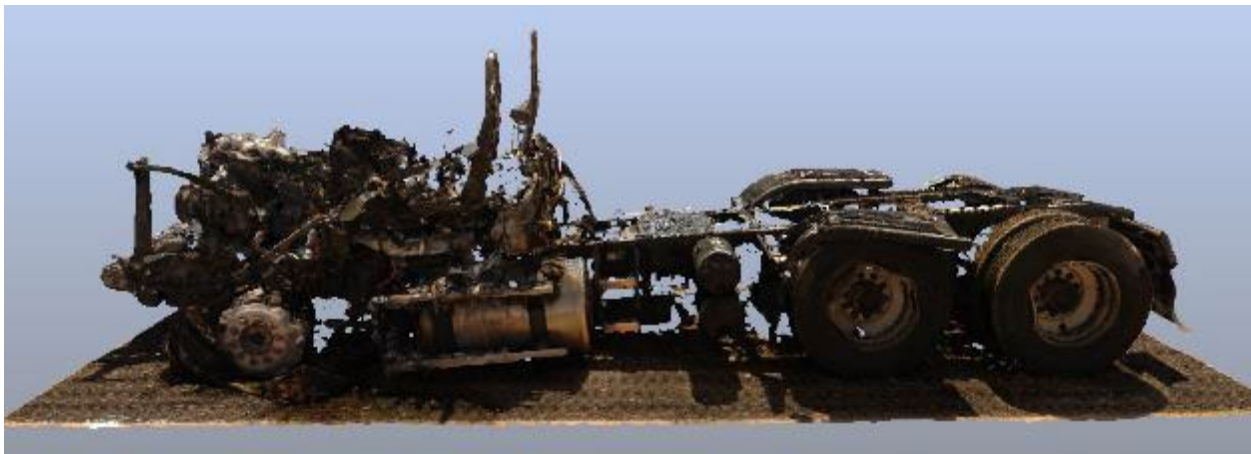
At its position of final rest following all the collision events, the Freightliner was facing eastbound and occupying both lanes 1 and 2 of eastbound SR-202. The left rear tandems were in lane 1. The front, cab portion, of the Freightliner had sustained catastrophic fire damage. The motor, frame rails, and the wire framing of the interior seats were visible. The Freightliner exhibited contact damage to front bumper and left tandems. The fifth wheel rail was also damaged, and the fifth wheel and fifth wheel plate were detached. There was contact damage to the left side tandems, axles two and three. The outer wheel was bent and exhibited scrapes and scratches on the outer edge. The left side plastic fender which covered axle two dual wheels had been dislodged and the front portion had been melted due to the post-crash fire. **Figure 11** depicts an image of the 3D point cloud as rendered from scans of the Freightliner in the FARO Scene software.

Figure 11: Screen capture depicting the Freightliner left side as viewed in the point cloud rendered from the three-dimensional scans through the FARO Scene software.
