**TECHNICAL RECONSTRUCTION GROUP CHAIRMAN'S
FACTUAL REPORT**

HWY14MH012

Location: New Jersey Turnpike (I-95) northbound near Milepost 71.4
Cranbury, Middlesex County, New Jersey

NTSB #: **HWY14MH012**

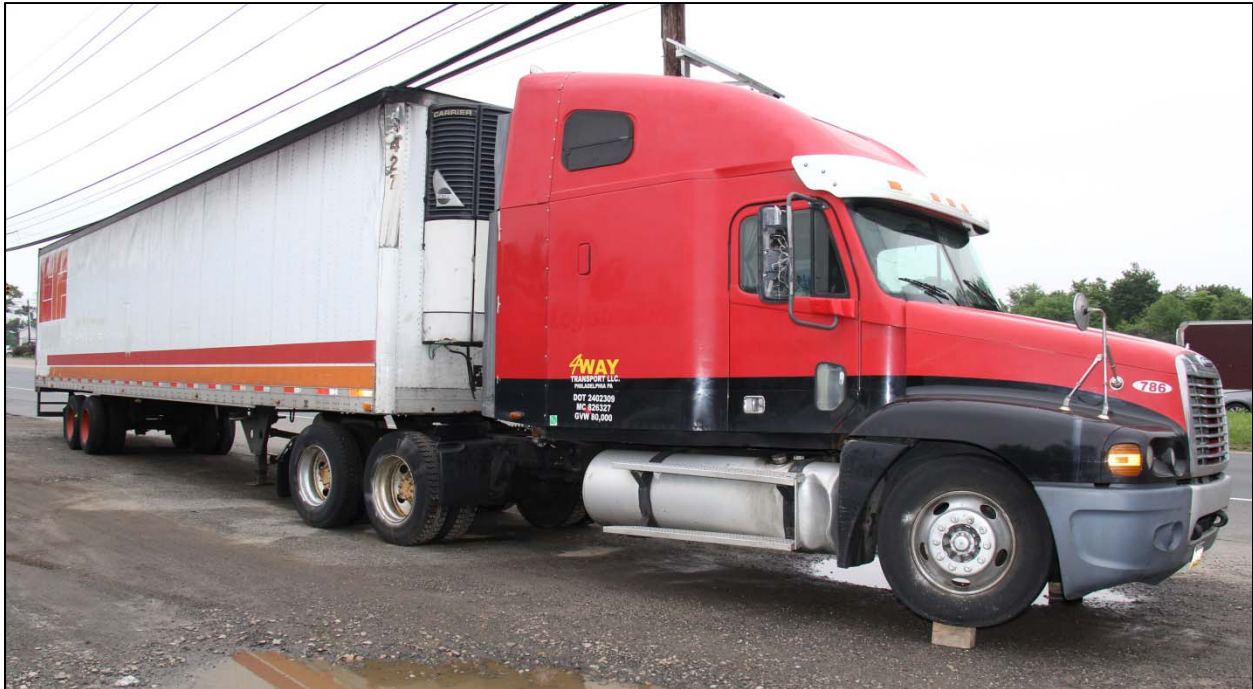
A second combination vehicle involved in the collision sequence was identified as a 2006 Freightliner Century Class CST 120 truck-tractor towing a 2001 Utility VS2RA van body refrigerated trailer. The combination unit was photographed and examined on June 11, 2014. While the vehicle exhibited several areas of damage, the area at the rear of the tractor cab on the left (driver's) side was significant to this collision. Contact evidence and impact damage were located on the left side of the combination beginning around the trailing end of the side fuel tank and continuing rearward to the trailer. Evidence of contact was also observed to the left side tractor drive axle tires and rim flanges. Vertical height of the contact damage ranged from about 2.4 feet (29 inches) at the trailing edge of the fuel tank to about 4.5 feet (50–54 inches) at the rear of the cab. Material transfer and scrapes extended rearward from the leading edge of the trailer rearward for a distance of about 3.3 feet (40 inches). Damage to the trailer extended vertically from the lower edge of the sidewall (~3.8 feet) to about 4.5 feet above the ground.

Figure 14: Photograph of Freightliner-Utility combination depicting passenger side of vehicle.

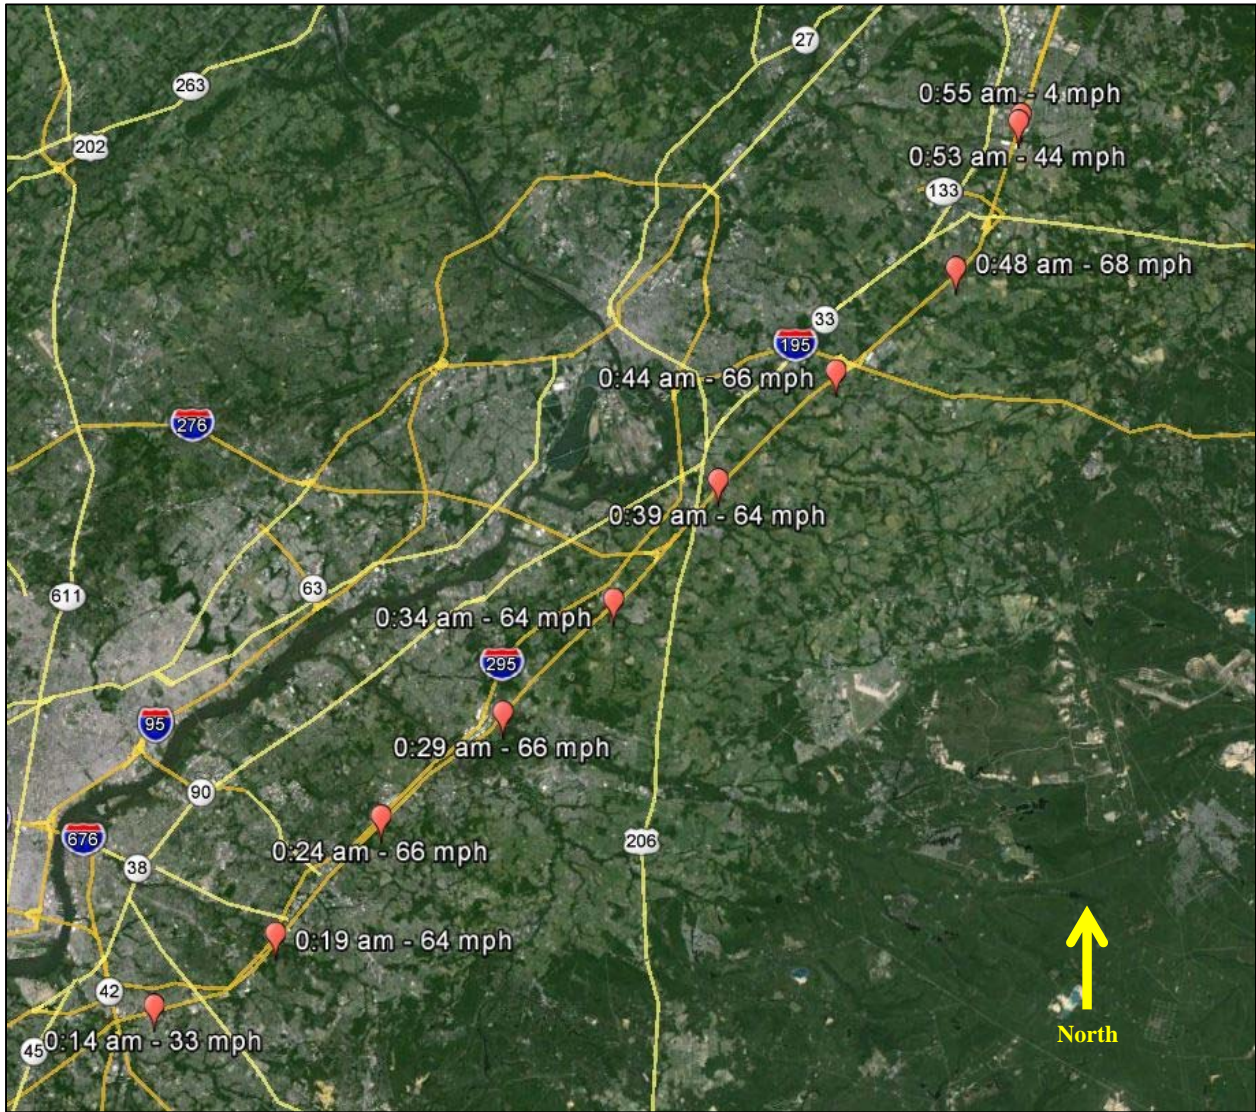
Figure 17 depicts the relative location of certain geographic positions for the Mercedes-Benz (after entering the turnpike) as reported by the Audiovox system. The data were overlaid atop a Google Earth image of the route.

Figure 147: Geographic positions as reported by the Mercedes-Benz limo van system while traveling on the turnpike.

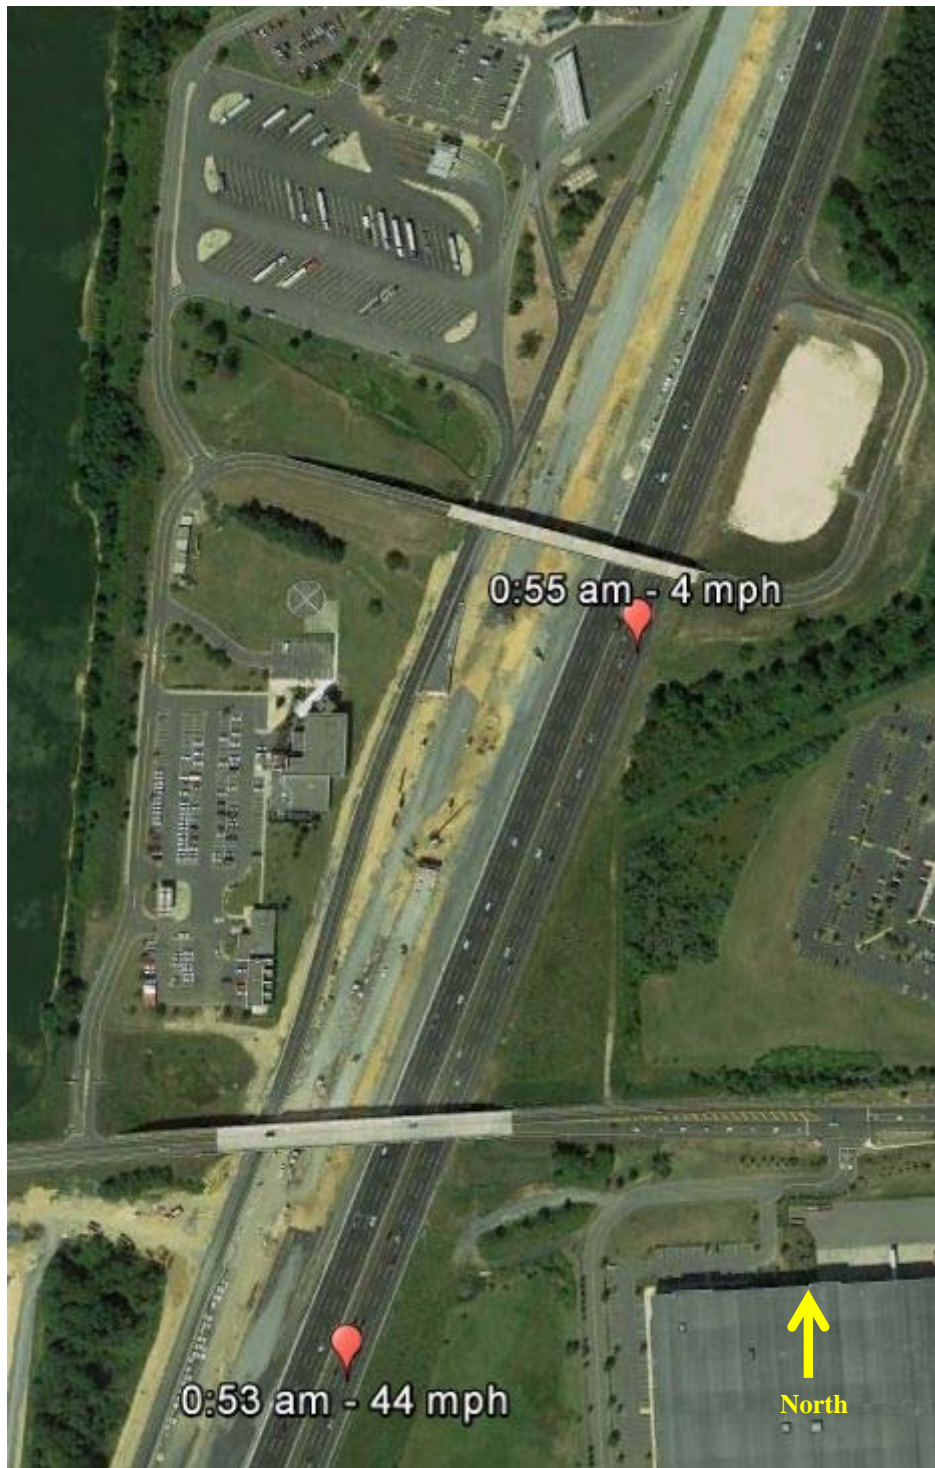
Figure 18 depicts the last two geographic positions of the Mercedes-Benz as reported by the vehicle's GSP system nearest to the area of the collision. The positions are overlaid on a September 2013 Google Earth image.

Figure 158: Final two GPS transmitted geographic positions as reported by the Mercedes-Benz limo van system about the area of the collision.
