Technical Reconstruction Group Factual Report

Avenal, CA

HWY21FH003

**TECHNICAL RECONSTRUCTION GROUP CHAIRMAN'S
FACTUAL REPORT**

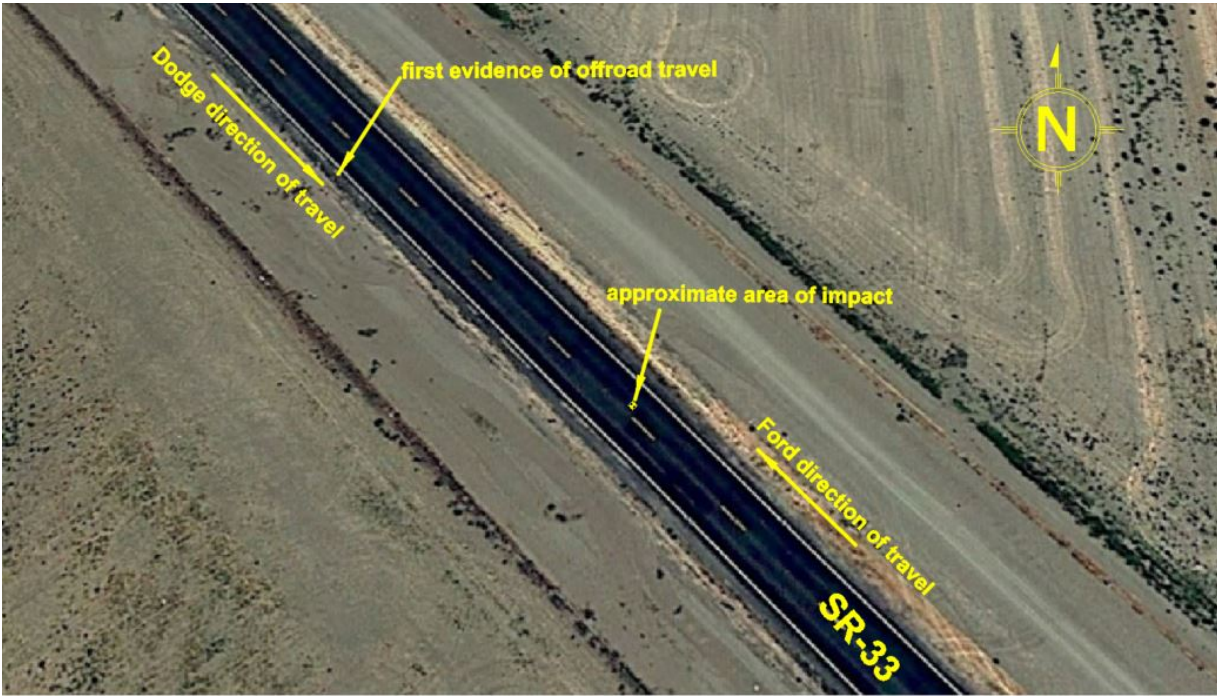
Figure 2: Imagery depicting the section of State Route 33 on which the collision events occurred.

The collision events occurred along a straight segment of roadway just north of FRE 33 MM 1.00³. Following the events, the involved vehicles were in an area around MM 1.00 with the Ford approximately 35 feet north of the mile post marker. Through the area of the collision the roadway had a posted speed limit of 55 miles per hour.

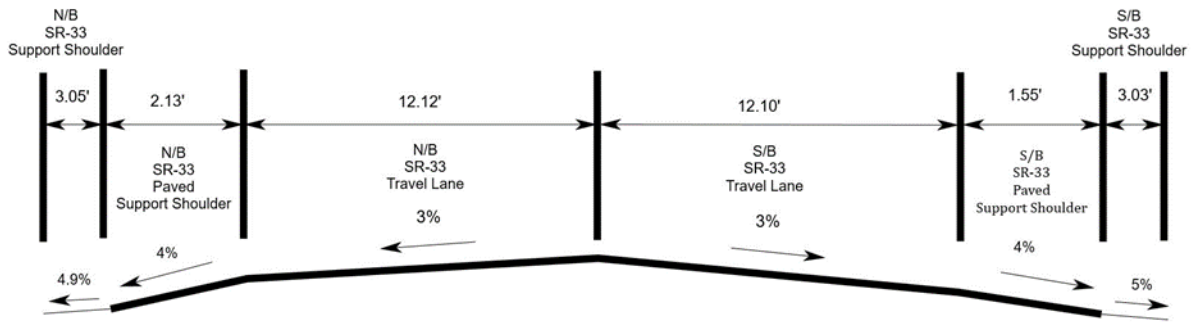
SR-33 was an asphalt paved, two-lane roadway with one lane in each direction. The Dodge was traveling southeast on SR-33 and the Ford was traveling northwest. The asphalt surfaced roadway had a cross section that measured approximately 28-feet-wide. The travel lanes were approximately 12-feet-wide with approximate two-foot-wide paved shoulders. The lanes were divided by a 6-inch-wide dashed yellow center line pavement stripe. The shoulders were delineated from the travel lanes by a 6-inch-wide solid white pavement stripe. There were no rumble strips milled into the edge of the roadway. Where the Dodge departed the roadway there was an approximate 1-inch drop off from the edge of asphalt to the earthen material. Along the north bound side there was an approximately 1.5-inch drop off from asphalt to earthen material. **Figure 3** is a cross section diagram of State Route 33 showing the lane measurements along with changes in elevation. The diagram was generated from the scan data provided by CHP.

Figure 3: Cross-section of SR-33 depicting lane and shoulder widths of northbound and southbound travel lanes. Percent cross-slope is also depicted in the figure.

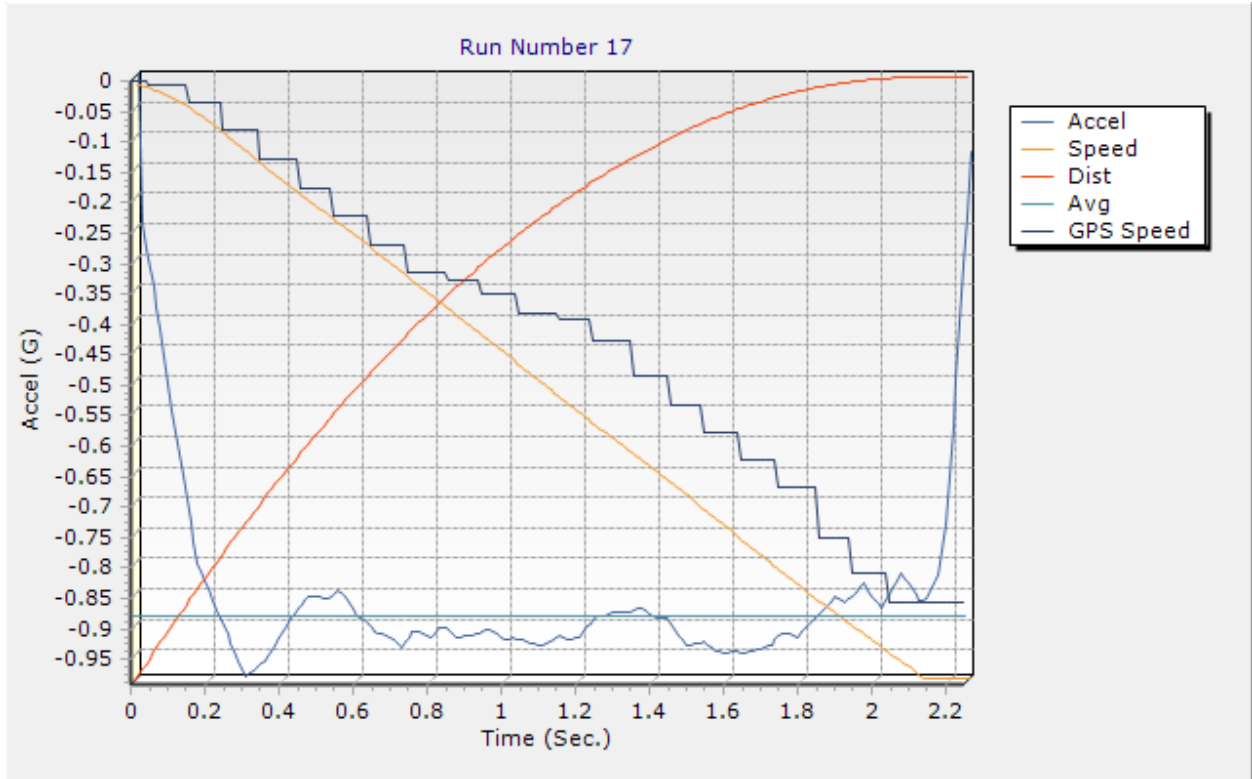
Test Series 1: Roadway ABS activated

Average Table ABS						
Vehicle	Run #	Time Secs	Accel G	Speed MPH	Dist ft.	GPS Speed MPH
548737	16	2.120	-0.878	40.84	64.992	42.67
548737	17	2.130	-0.878	41.03	65.757	41.70
548737	19	2.080	-0.892	40.68	64.050	41.07
Averages		2.110	-0.883	40.85	64.933	41.81

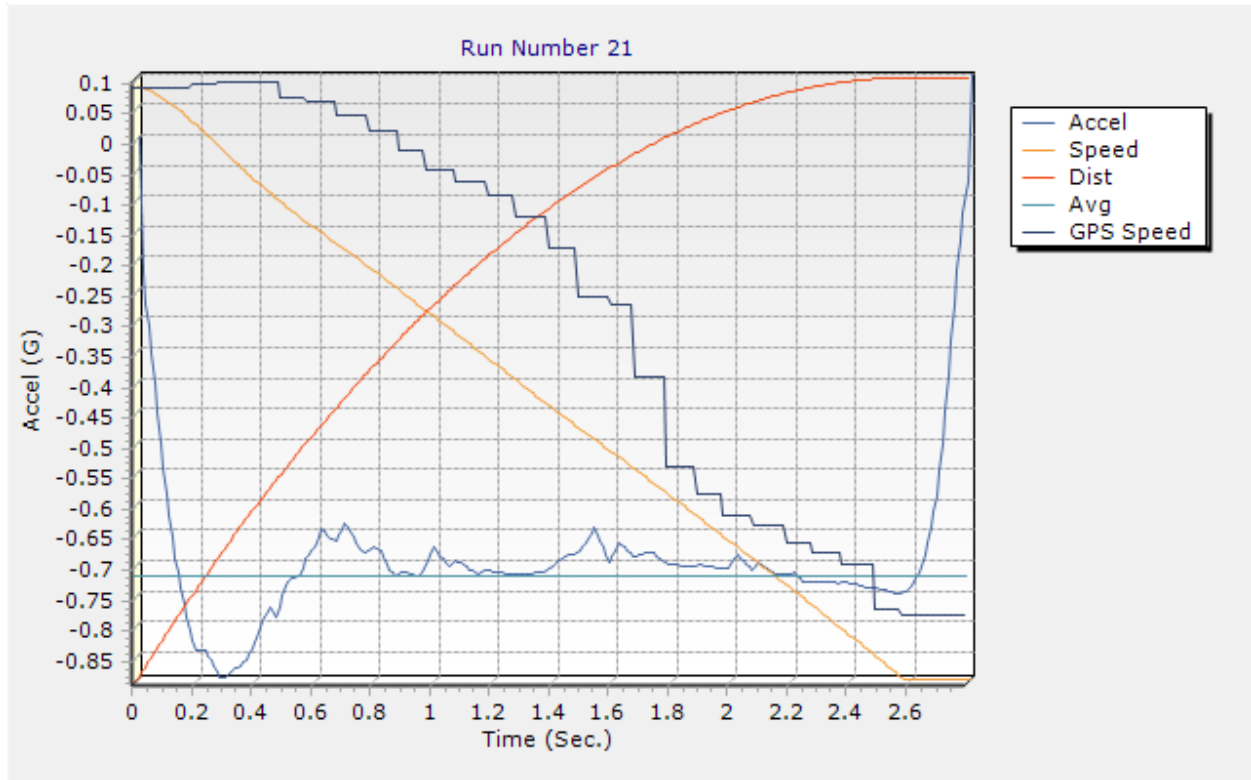
Test Series 2 – Non-ABS

Average Table Non-ABS						
Vehicle	Run #	Time Secs	Accel G	Speed MPH	Dist ft.	GPS Speed MPH
548737	20	2.680	-0.709	41.67	82.612	41.73
548737	21	2.580	-0.711	40.23	76.394	40.59
548737	22	2.580	-0.716	40.52	77.574	40.63
Averages		2.613	-0.712	40.81	78.860	40.98
