Pressure Testing of SPBP Welded Repair Design

Final Report

Prepared for Amplify Energy Corp.

100335-RP02-Rev0-111521

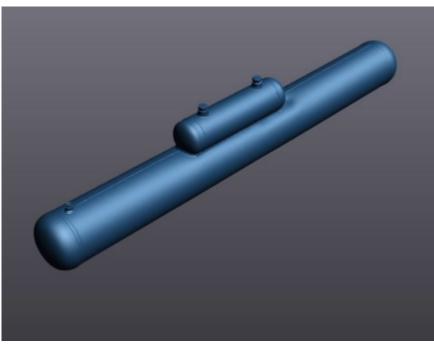
Figure 3-1: 3D rendering of the test vessel received by ADV.

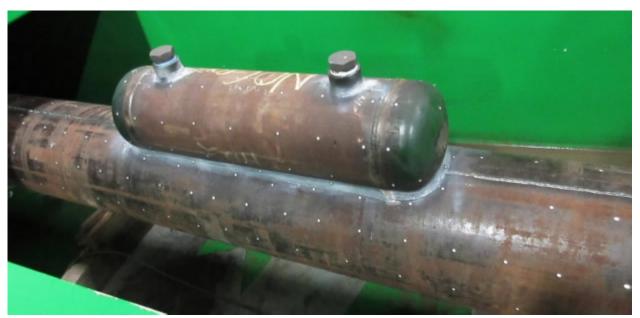
ADV's pressure test plan included several full-scale testing steps, including pressure cycling, an extended pressure hold, and short duration holds at a higher pressure. The pressure was monitored via a pressure transducer fixed to the test vessel's outlet. The calibration certificate is attached in Appendix C. The sample was enclosed in ADV's test chamber, shown in Figure 4-1.

Figure 4-1: Photograph of test vessel enclosed in ADV's test chamber.

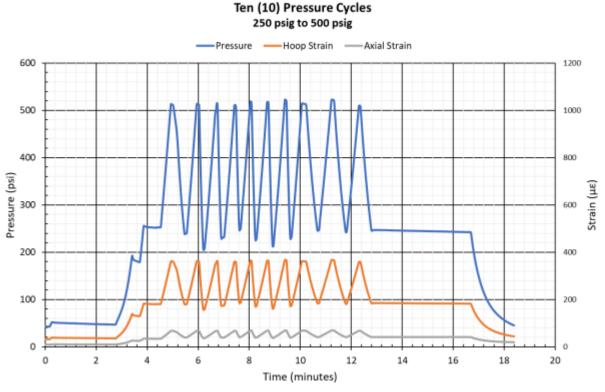
After seal welding the TOR/Bull plugs, the cyclic test program was restarted. Cyclic testing was repeated as shown in Figure 4-2, and then the pressure was increased to 1,440 psig. This pressure was held overnight resulting in a 17.9 hour hold as shown in Figure 4-3. Upon completion of this hold, ADV increased the pressure to find the maximum pressure containing capacity of the temporary repair. At 1,619 psig the pressure within the sample started to decrease. Upon inspection, it was discovered that the temporary repair had begun to experience plastic deformation without an identified leak as shown in Figure 4-4 and further quantified in Section 5.0, Post-Test 3D Scan. Therefore, ADV stopped the testing program. The most significant conclusion from this test was that the test vessel successfully contained pressure for 17.9 hours at 1,440 psig providing confidence in the welded temporary repair's ability to contain pressure and mitigate product leakage.

Figure 4-2: Time vs. Pressure plot during pressure cycling.

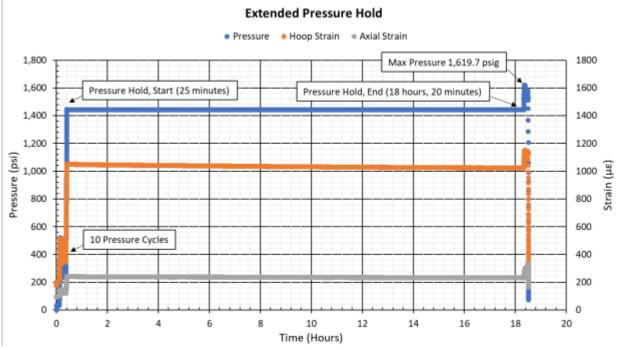
Figure 4-3: Time vs. Pressure plot during 17.9 hour pressure hold.

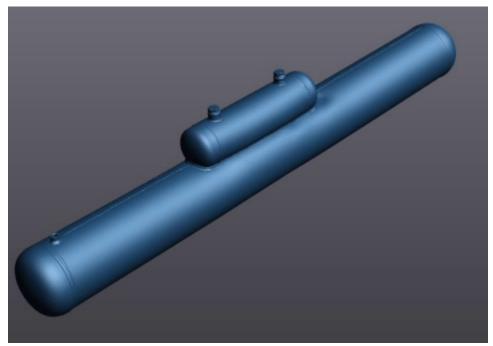
After completion of the full-scale test, ADV scanned the vessel using a Creaform HandyScan 307 with reflective positioning targets applied to the outside surface. A 3D rendering of the test vessel is shown in Figure 5-1. The 3D scan captured the change in the temporary repair diameter as shown in Figure 5-2. To better quantify the change in shape, ADV prepared a virtual cross section through the pipe/repair assembly, shown as green lines in Figure 5-3. The pre- and post-test diameter of the temporary repair at nine (9) locations were tabulated and presented in Figure 5-4. A maximum change in diameter of 0.96 inch between the pre- and post-test measurements was calculated.

Figure 5-1: 3D rendering of sample after testing.

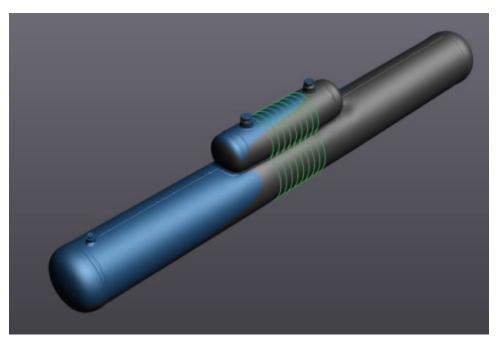
Figure 5-3: 3D rendering showing virtual cross sections through the temporary repair assembly.
