TESLA INSPECTION FACTUAL REPORT

HWY18FH011

**NATIONAL TRANSPORTATION SAFETY BOARD
OFFICE OF HIGHWAY SAFETY
WASHINGTON, D.C.**

Location: Southbound US Highway 101 (US-101) south of North Shoreline Boulevard at the exit ramp transition to State Route 85 (SR-85), milepost 43.38, Mountain View, Santa Clara County, California

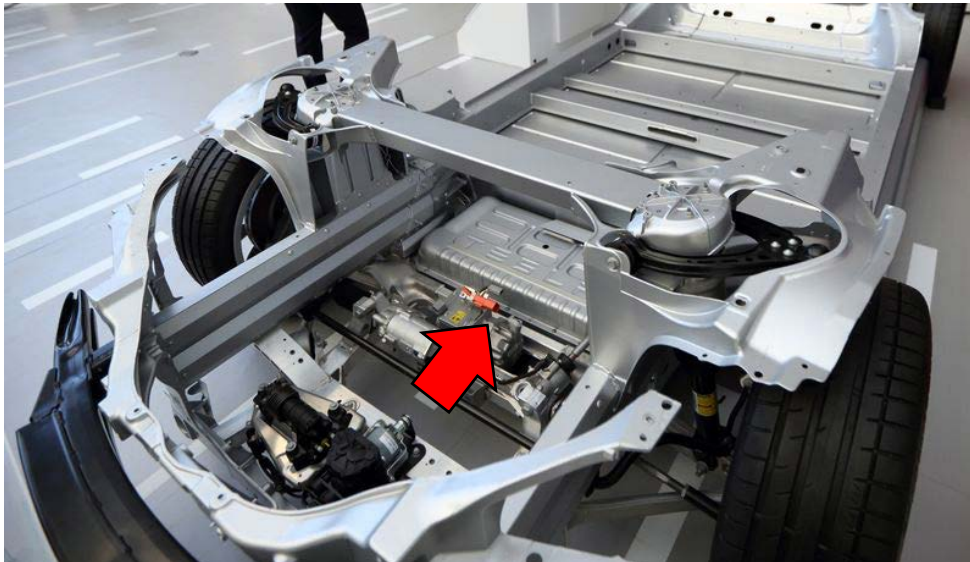
In areas without evidence of impact or thermal damage, the battery was relatively undamaged. Opening a discharge port plug at the rear revealed that water and debris had accessed the auxiliary compartment holding the battery management system (BMS). Figure 3 illustrates the undamaged structure of the Tesla with the front of the battery case identified.

Figure 3. Photo of partial exemplar vehicle with arrow added to depict the leading edge of the battery visible in Figures 1 and 2. Parts of the missing forward structure, drive motor (concealed by arrow), and suspension are shown.

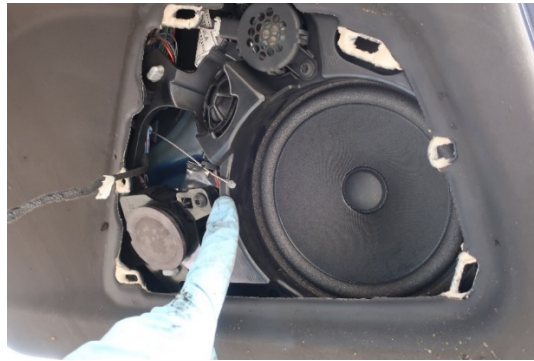
Figure 4. Cable in rear door speaker which needed to be pulled to manually open a rear door after removal of a speaker grill.

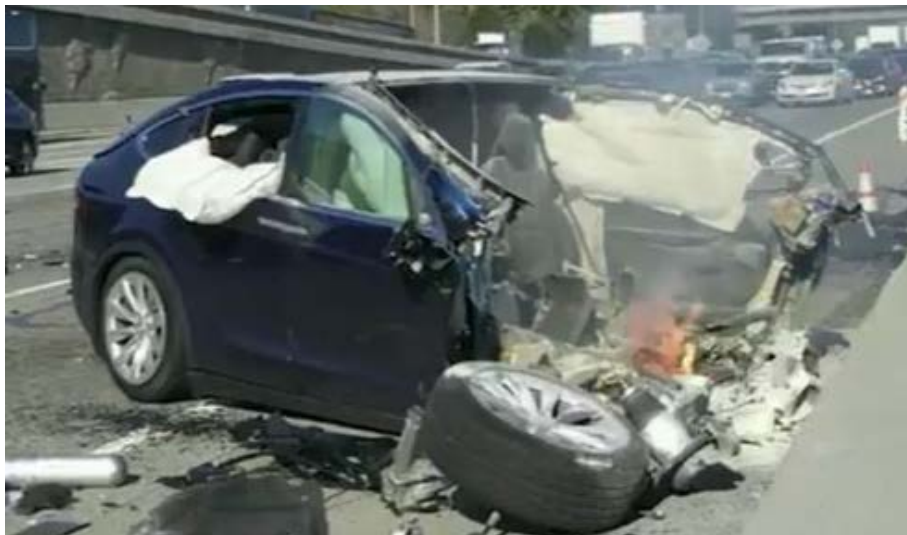
In the cabin, the side airbags were found deployed and the front airbags were missing, consistent with video and images from the scene of the accident posted on the internet, as shown in Figure 5 and 6. All seats were in place and had burned cover materials, except for the two stowed small aft seats in the cargo compartment. Missing cover material exposed the forward foam surfaces of the two front seats.

Figure 5. Still image from internet showing deployed side air bags at the scene of the accident with initial fire in front right of battery, prior to fire burning the seats and plastic interior materials.

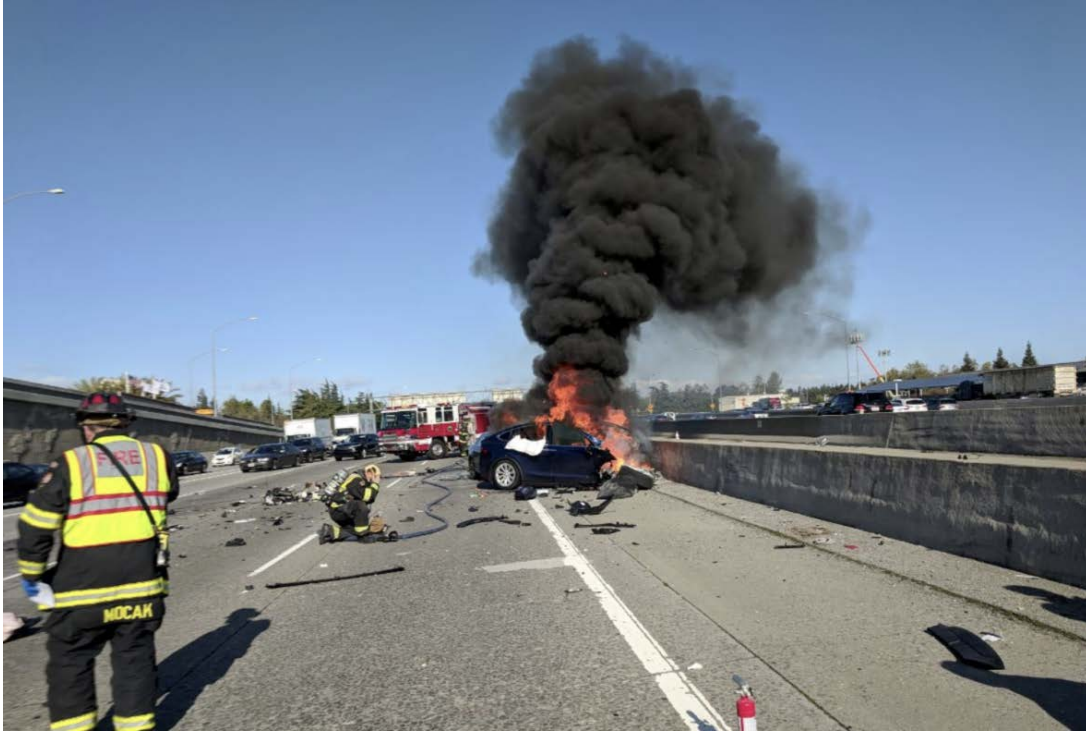
Figure 6. Internet photo showing fire burning the seats and other interior materials.

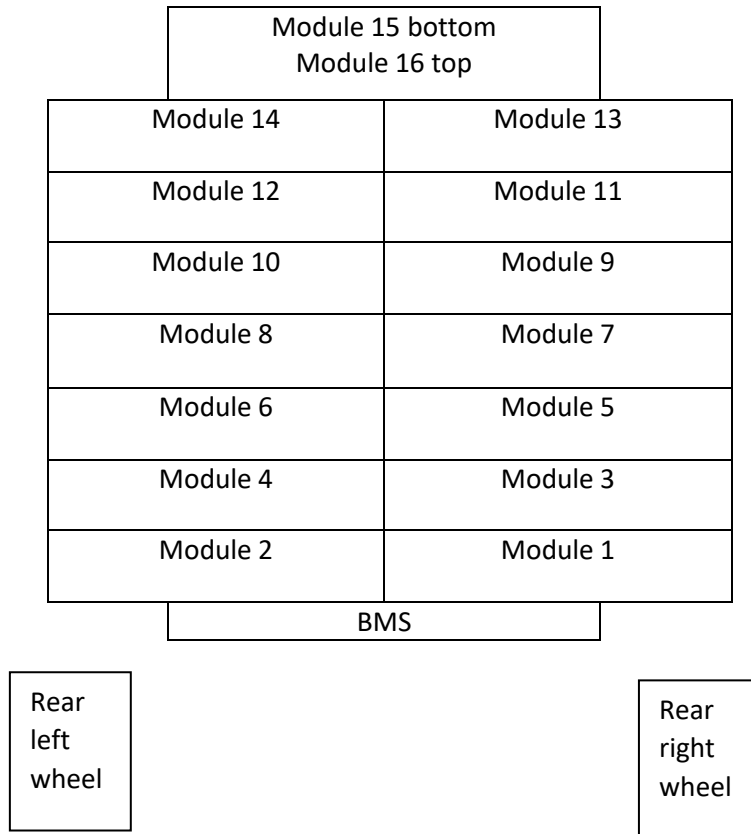
Figure 11. Module numbering in the Tesla High Voltage Numbering Scheme. This view looks down on an assembled battery, with the front at the top of the illustration.

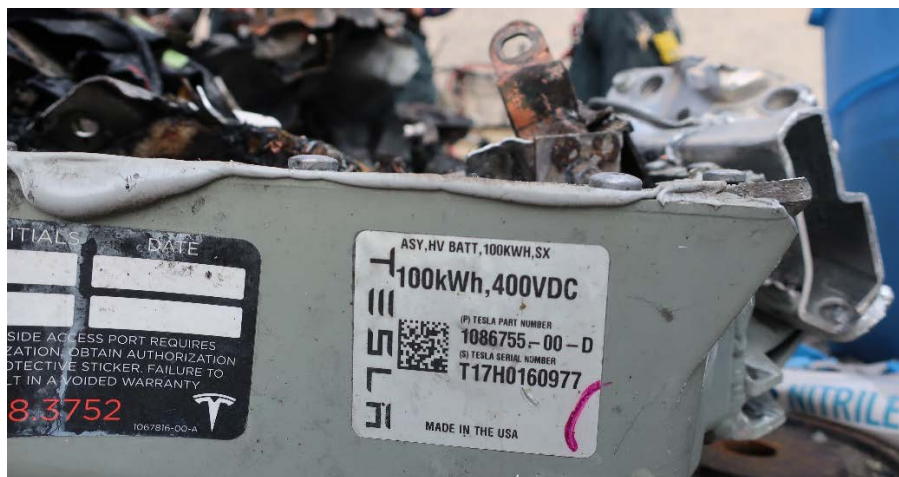
- 100 kWh, 400 VDC
- Tesla P/N 1086755-00-D
- Tesla S/N T17H0160977

Figure 13. Battery identification sticker.

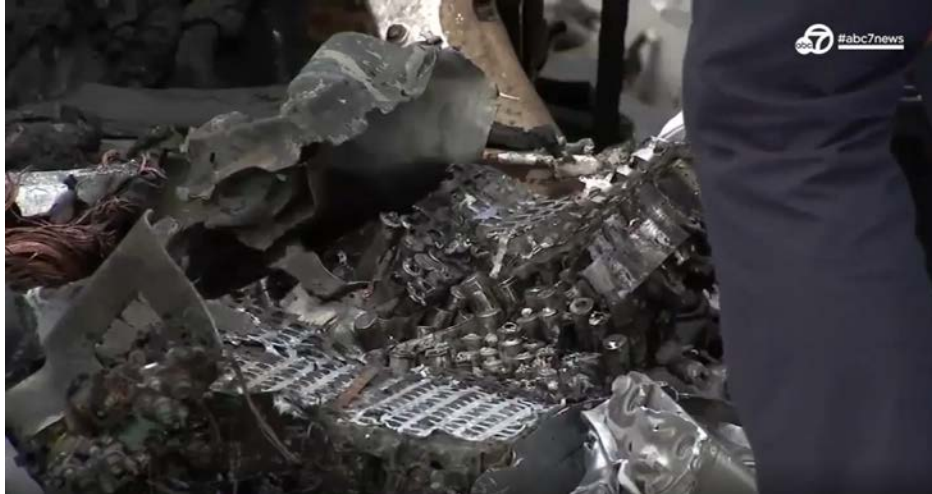
Battery modules 13-16 were extensively damaged. Module 16 was nearly separated from the vehicle, and the top steel surface had been folded back over modules 13 and 14. Video from the scene of the accident showed module 16 being scooped into a large blue bucket. The bucket was with the vehicle when the car was examined in the tow yard, as shown in Figures 14 and 15.

Figure 14. Still image from YouTube video showing remnants of module 16 being lifted to place in blue bucket.

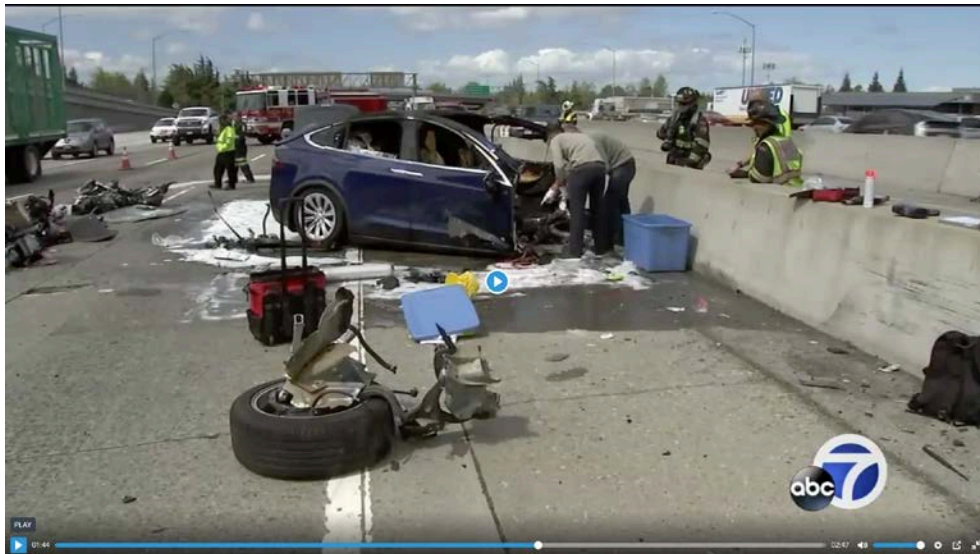
Figure 15. Still image from news video showing blue bucket during removal of module 16 at the scene of the accident.

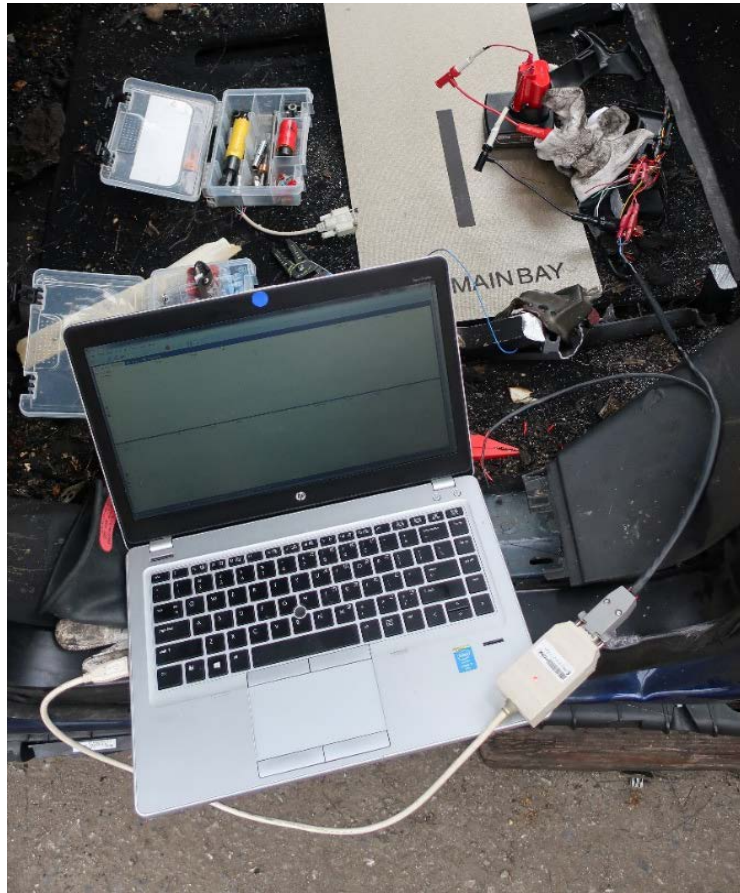
The rear seat was removed from the vehicle by cutting the supporting legs. The carpet and padding under the seat were pulled from the aft surface to expose a small rubber plug and wire harness. After referring to a wiring diagram, the wires of the harness were cut and connectors were attached to the wires as shown in Figure 41. A small battery was used to place power on the bus. The attempt to communicate with the BMS in the wet auxiliary compartment of the vehicle battery was unsuccessful as shown in Figure 42.

Figure 41. Connections between laptop, battery, and wires of the vehicle battery communication bus. The location is the floor inside of the left rear door, beneath where mid seat had been removed.
