**TESTING OF PRESSURE RELIEF
VALVE "RV1919"**

**OFFICE OF PIPELINE &
HAZARDOUS MATERIALS SAFETY
NATIONAL TRANSPORTATION
SAFETY BOARD
Washington, DC**

STRESS ENGINEERING SERVICES, INC.
Houston, Texas

Subject: Report Entitled "Testing of Relief Valve 1919"

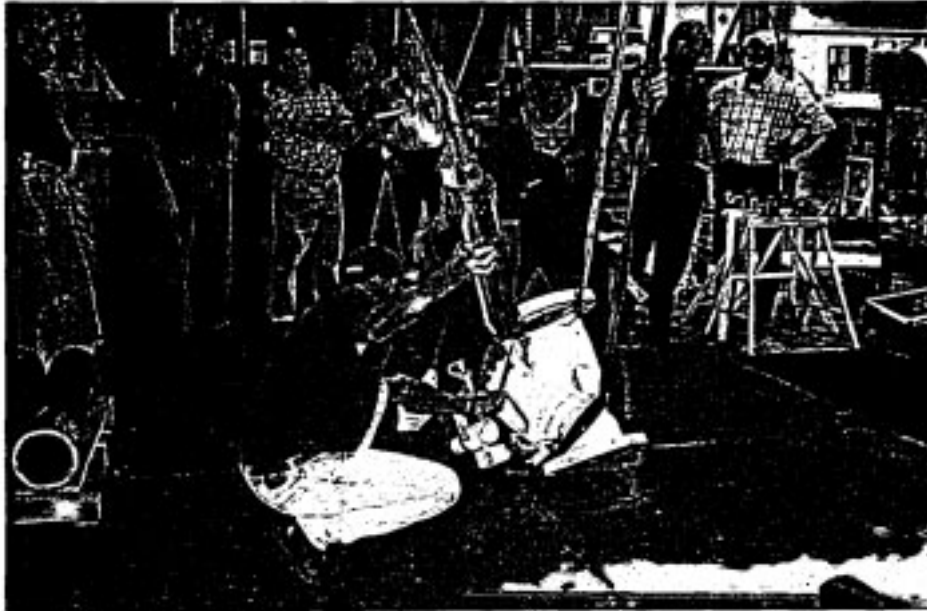
Figure 2.15 Draining Gasoline from Cylinder Head

All of the lines and components were examined with the optical probe. There were no debris or blockages found. All of the lines and the strainer were clean. During the examination, a significant amount of gasoline, approximately 5 quarts, was drained from the cylinder head. Figure 2.15 shows the gasoline being drained ~~from~~ the cylinder head. Figure 2.16 shows the gasoline that was drained. The gasoline was discolored, but appeared ~~free~~ of debris. Figures 2.17 through 2.19 show the optical probe inspection.

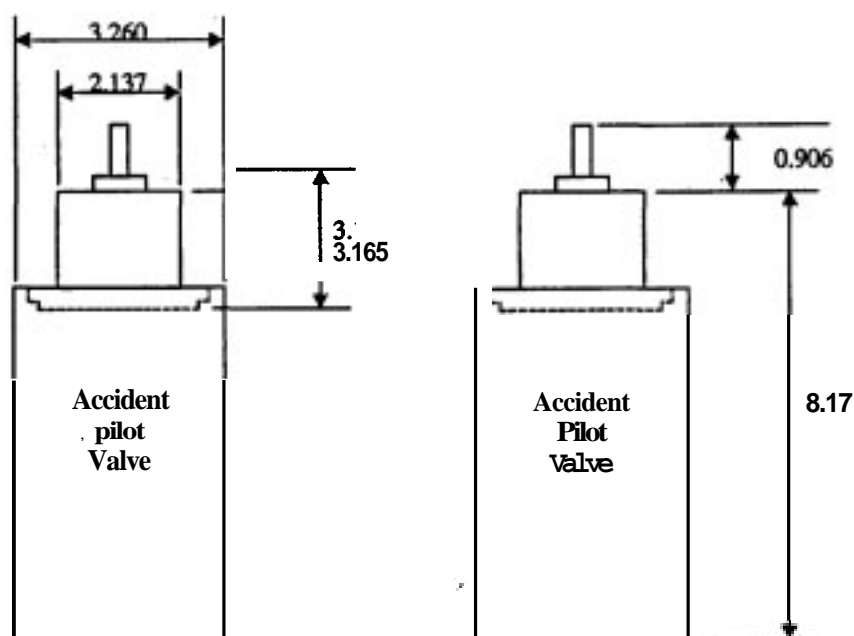
Figure 4.4 Outside Dimensions of Accident Pilot Valve

It was noted that the dimension taken at the top of the piston, 1.3665 inches, does not match the 1 13/64 inch dimension in the available literature (i.e., the pilot spring selection table).

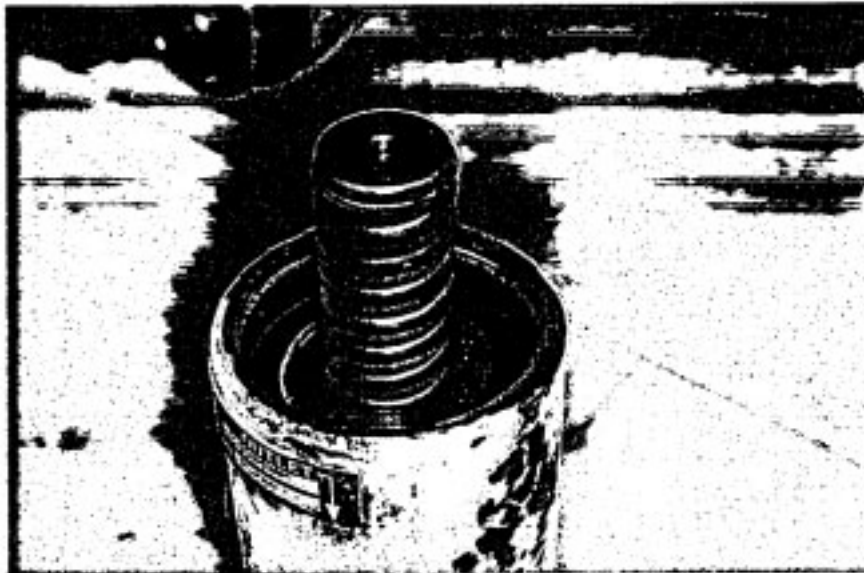
Figure 4.7 Accident Pilot Valve with Cover Removed

The next step in the disassembly process was to remove and inspect the spring cover. There **was** no apparent damage to the O-ring in the spring cover. The O-ring was brown in color and had no cuts or tears. The O-ring groove was clean. There **was** no visible damage to the inside of the cover. However, there was a sticky residue on the piston seating surface of the inside cover.

The piston, inside the cylinder, **was** then examined. There was some black residue on the inner mating surface of the cover and the cylinder and some slight corrosion on the same surface. **This** region **was** wiped with a cotton swab and the swab retained in a plastic bag labeled "A". There **was** also some slight residue on the top of the piston (i.e., the spring side).

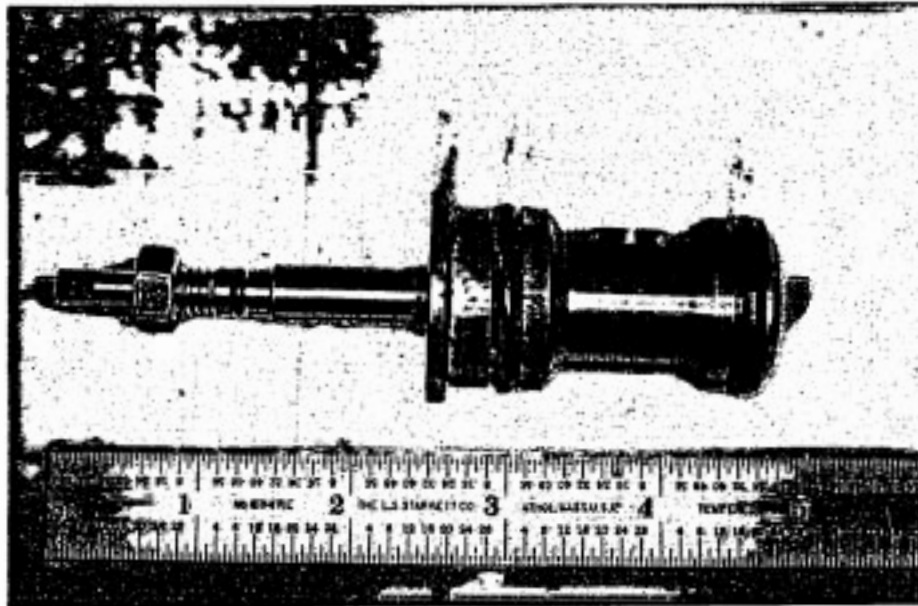
Figure 4.10 Pilot Valve Poppet Assembly

The damper spring was then removed. **This** was followed by the removal of the cage retainer ring, the cage assembly, and the poppet. In the opinion of the Fischer-Rosemount representatives, the poppet moved normally inside the cage assembly.

Finally, the poppet retaining ring and the poppet were removed. The inside of the cage was clean and the poppet o-ring in place. Figures 4.7 through 4.10 show some selected photographs taken during the disassembly of the accident pilot valve.

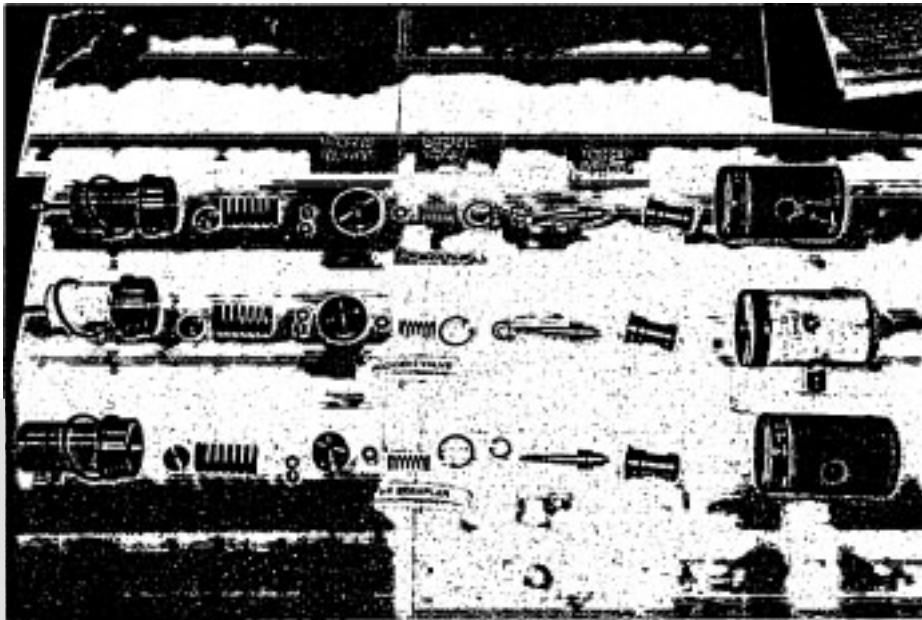
Figure 5.5 Disassembled Pilot Valves

The components from **all** three of the pilot **valves** were examined or damage and **wear**. The **only** notable observations were:

1. There was some possible scoring observed on the poppet valve stem of the LP exemplar pilot valve
2. There **was** some possible wear observed on the poppet valve stem of the accident pilot valve.
3. The poppet valves from **all** three pilot valves opened and closed freely.

Neither possible scoring on the poppet valve stem of the LP exemplar pilot valve nor the possible wear observed on the poppet valve stem of the accident pilot valve appeared to be severe enough to affect the operation of the pilot valve. The pilot valves were boxed-up for the night so that photographs of the poppet valve stems could be taken the next morning.

In summary, other than the difference in damping spring lengths, the components from the LP exemplar pilot valve appeared to be the same as those from the accident pilot valve. In addition, no wear or damage which would affect the operation of the pilot valves was observed.
