## Air Safety Investigations Aircraft Incident/Accident Technical Report

Aircraft Incident/ Accident Information	Year: 1975	Make: Cessna	Model: 414
	Serial number: 414-0603		Registration: N1996G
Location: Monongahela, PA		Date: 06-19-22	Time: 1304 EDT
Aircraft Owner		Aircraft Operator	
Caiolinn Chelsea Ertel [REDACTED] Spokane Valley, WA 99037-8543		Same as Aircraft Owner	
Report Information			
Senior Air Safety Investigator: Ernest C. Hall		Report #: ASI-22-BN-T	Report date: 09-06-22

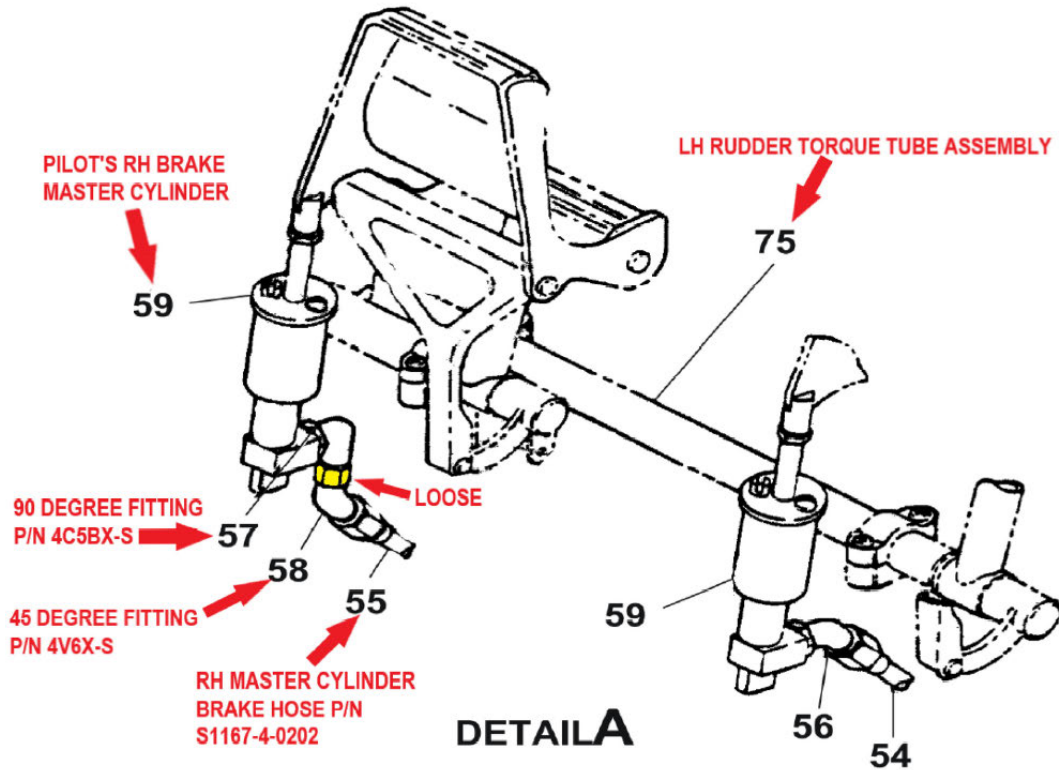
Extract From IPC 32-40-00-09 – Brake System

The brake hose found installed was a different part number, 111417-4S0520, than what is called out in the applicable aircraft model IPC. According to S1167 specification, it indicates: "Hose shall conform to MIL-H-8794. Approved sources & hose designation: Aeroquip, Type 303 & Stratoflex, Type 111." The installed hose assembly appeared to be similar standard MIL and AN style spec fitting hose assembly. Review of the aircraft logbook, two brake hose's part number 111417-4S0520, LH & RH, were installed on 10-15-12.

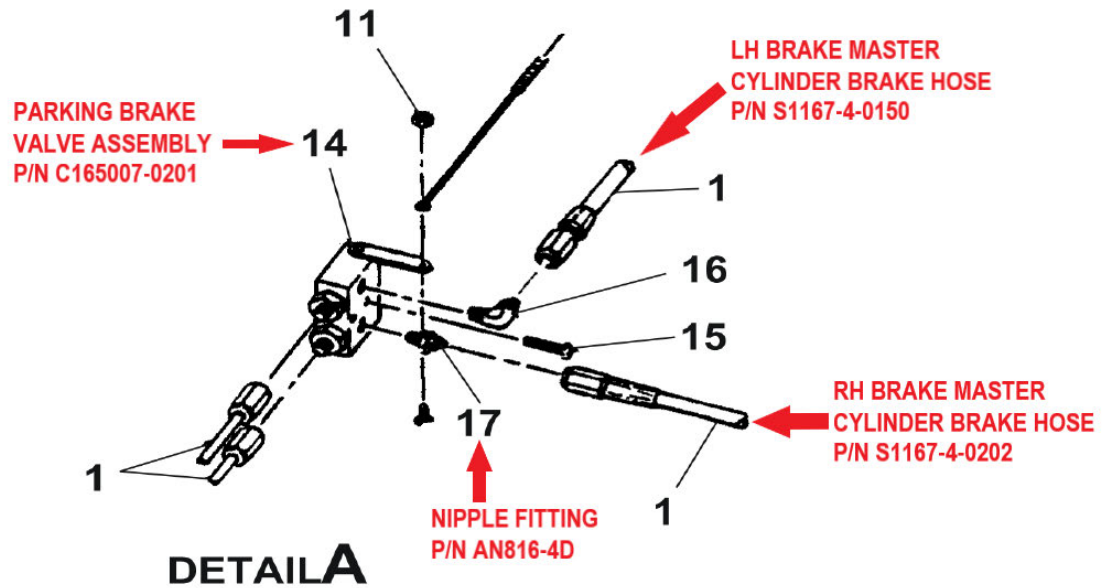
Extract From IPC 32-40-00-11 – Parking Brake Installation

The pilot's RH brake master cylinder hose was removed from the aircraft and examined. The 45° fitting was reinstalled to the brake hose and tightened. The nipple fitting, part number AN816-4D, that attaches to the parking brake valve assembly and the brake hose was removed and reinstalled on the removed brake hose. The end with the 45° fitting was capped with an aluminum plug fitting and a tygon clear tube was connected to the nipple fitting. An undetermined amount of air was applied to the hose and no air leakage could be heard.
