# **NATIONAL TRANSPORTATION SAFETY BOARD**

**RRD22LR003**

**Contractor Roadway Worker Fatality**

**TRACK & ENGINEERING FACTUAL REPORT**

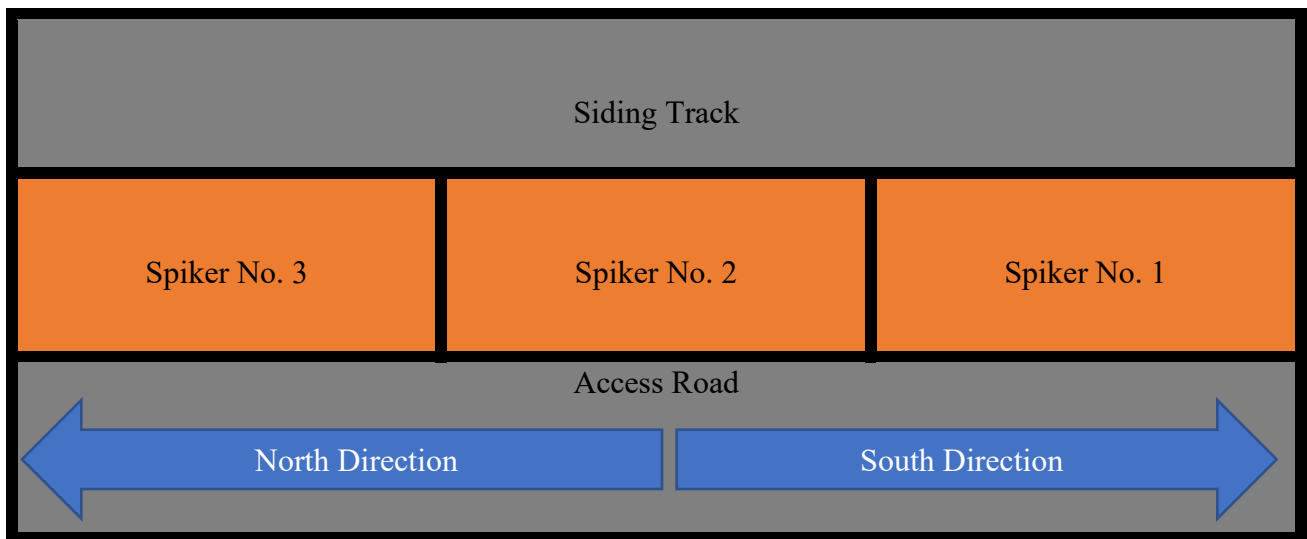
After the old rail was removed, and the new rail was installed, the accident spiking machine (known as spiker No. 2) was installing cut spikes to secure the newly installed continuous welded rail (CWR) to the cross-ties. At the time, Spiker No. 2 was working in a southward direction, and was situated between two other working spiking machines to the front and rear.
