# Car Damage Report

3-12-15  
DGT-004  
Rev 4

Date of Derailment 1-8-77

Location BNSF Oklahoma TX  
Pinard 1987

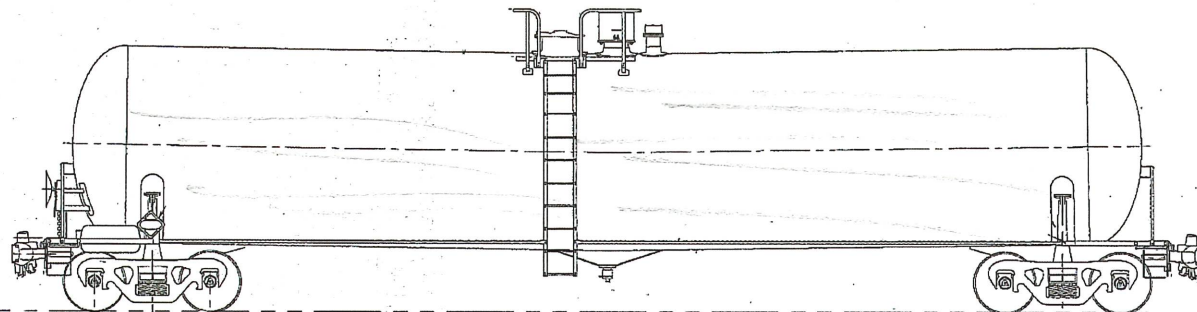
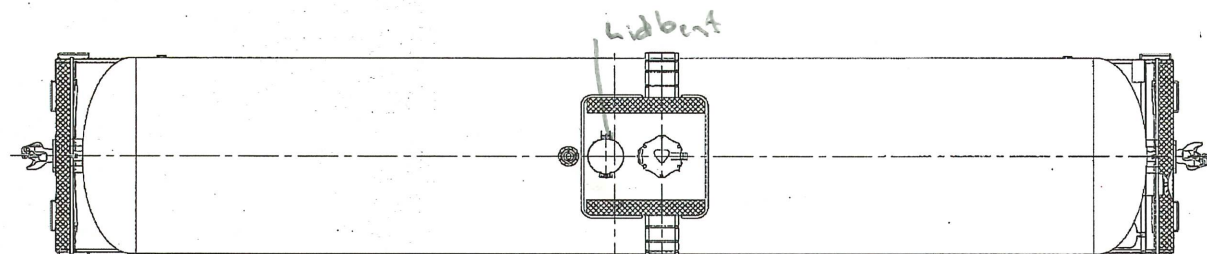
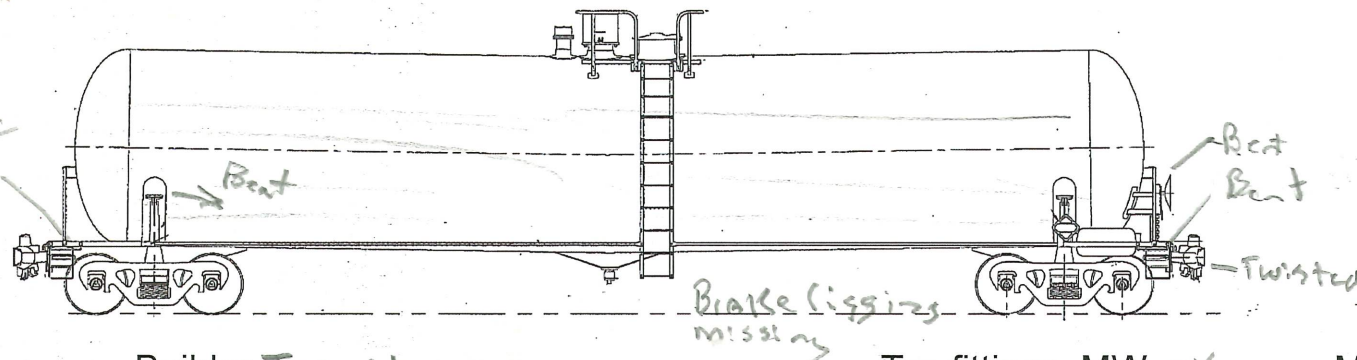
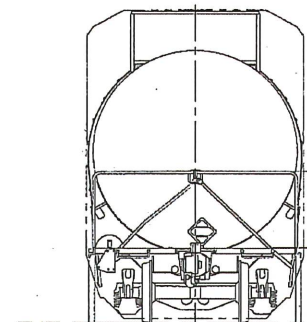
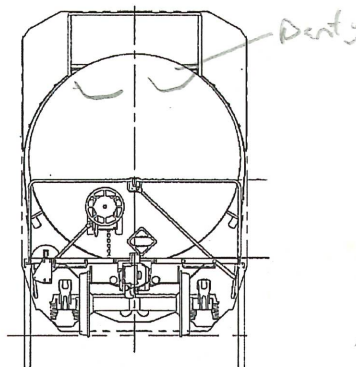
Car Number TILX 731 777

Valves -Leaked / Sheared No

Top fittings MW OK MH OK

Bottom Outlet Leg OK Handle DT OK

Breach- Thermal Tear No Mech Tear No

Draft Sill A Twisted B Twisted

Head Shield A OK B Bent

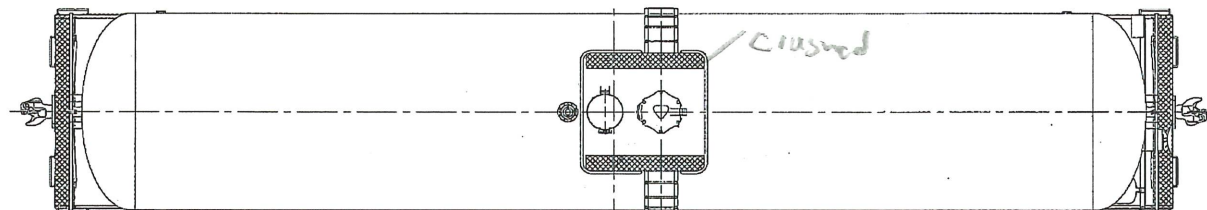
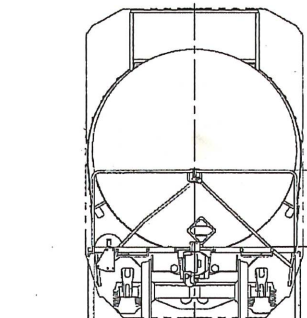
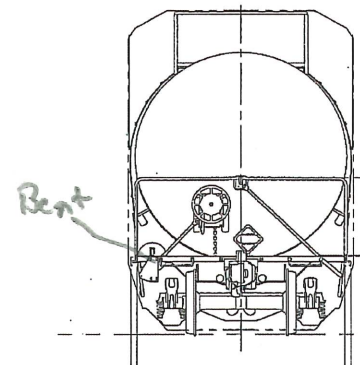
Car Number T1LX731779

Top fittings MW OK MH OK  
 Bottom Outlet Leg Sheared Handle DT Bent ok  
 Breach- Thermal Tear No Mech Tear No  
 Draft Sill A OK B OK A Coupler Sheared  
 Head Shield A OK B OK  
 PRD Functioned- Yes No  
 SK:d OK

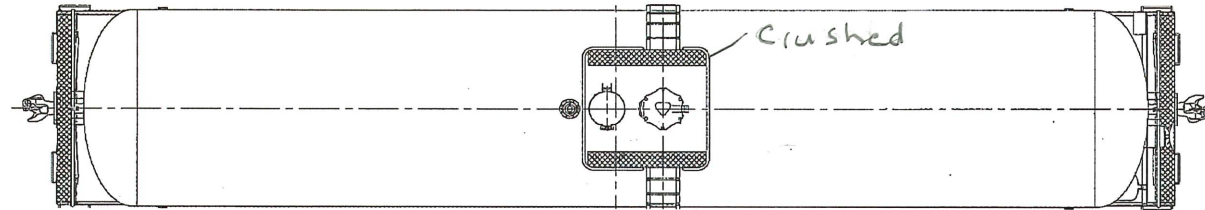
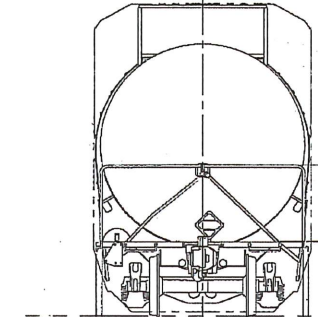
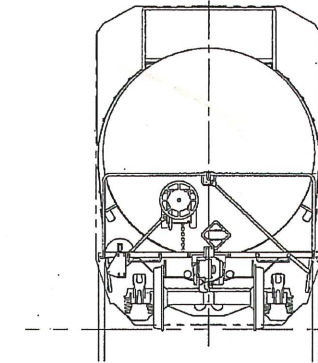
Top fittings MW OK MH OK  
 Bottom Outlet Leg Sheared Handle DT Bent  
 Breach- Thermal Tear No Mech Tear No  
 Draft Sill A OK B Twisted Left  
 Head Shield A OK B OK  
 PRD Functioned- Yes No  
 Skid OK

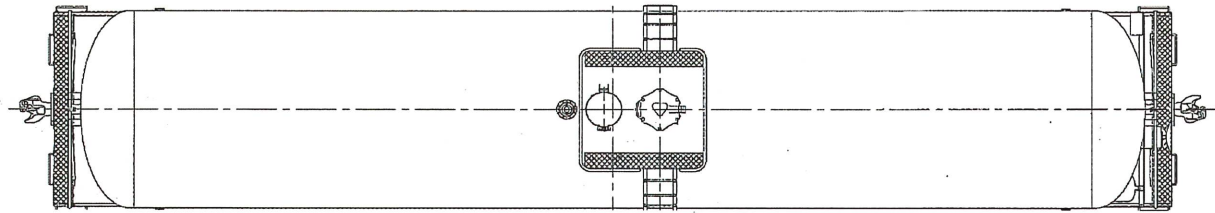
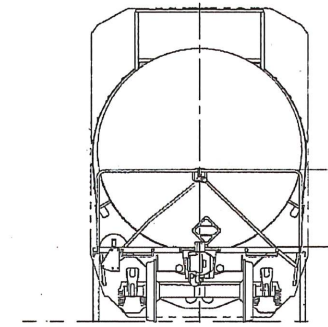
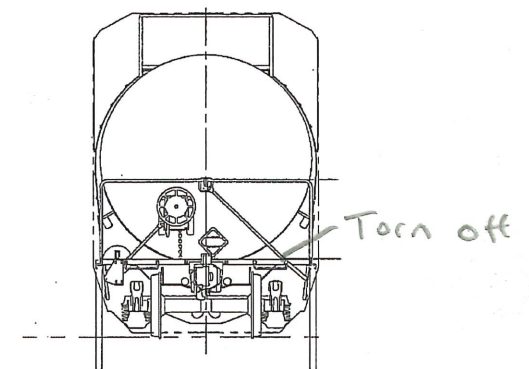
Top fittings MW OK MH OK  
 Bottom Outlet Leg Sheared Handle DT Torn off  
 Breach- Thermal Tear No Mech Tear No  
 Draft Sill A Twisted B OK  
 Head Shield A OK B OK  
 PRD Functioned- Yes No  
 SKid OK

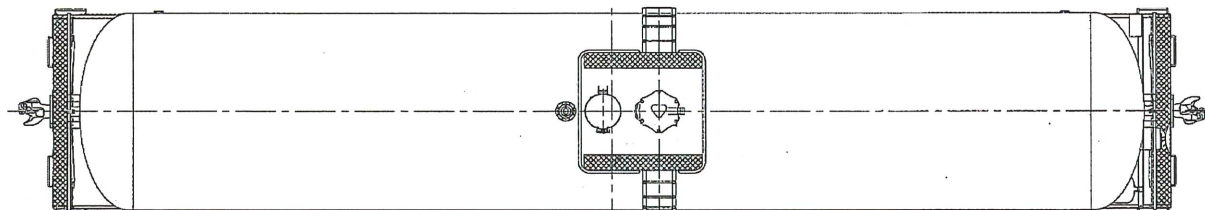
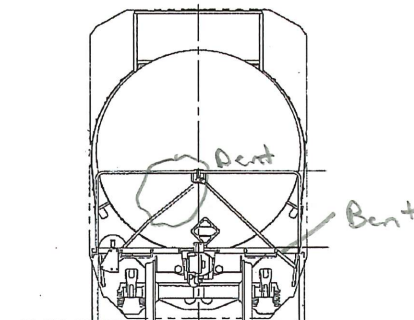
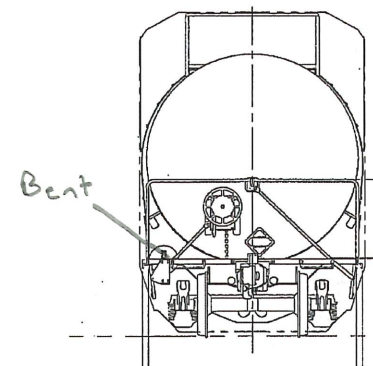
Top fittings MW OK MH OK  
 Bottom Outlet Leg Sheared Handle DT OK  
 Breach- Thermal Tear No Mech Tear No  
 Draft Sill A OK B Twisted torn  
 Head Shield A OK B OK  
 PRD Functioned- Yes No  
 Skid OK

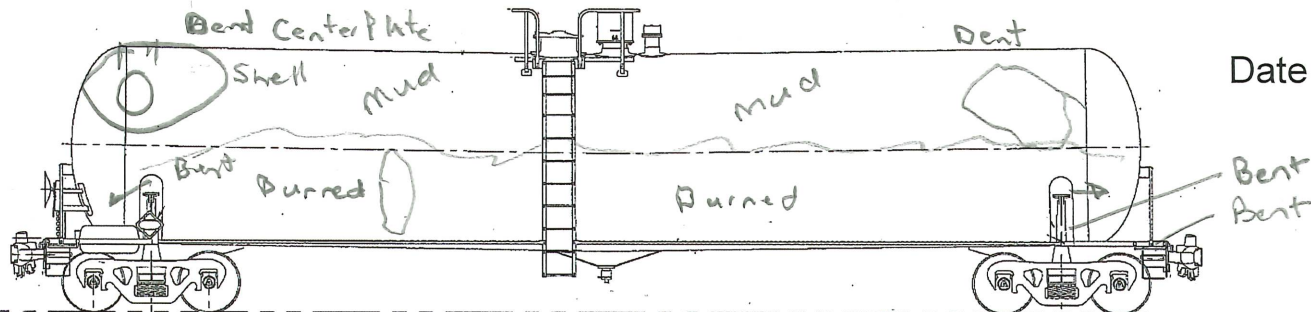
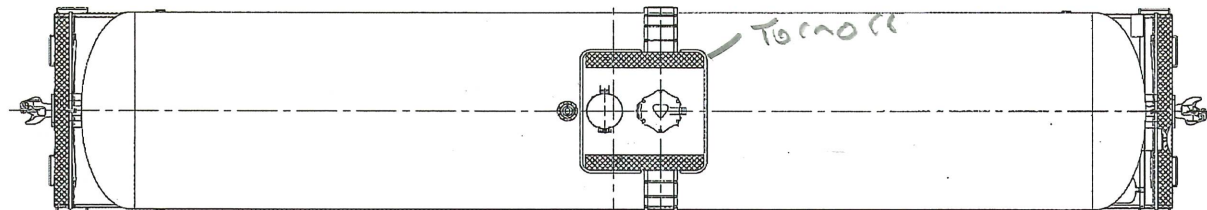
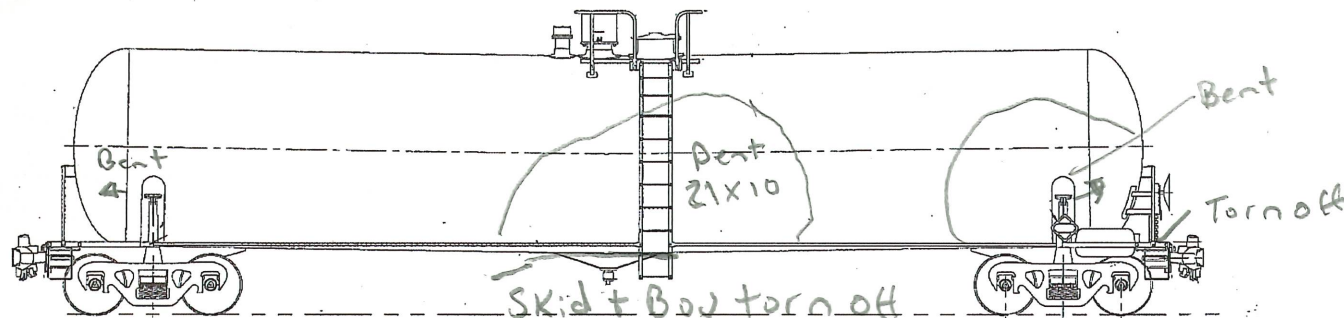
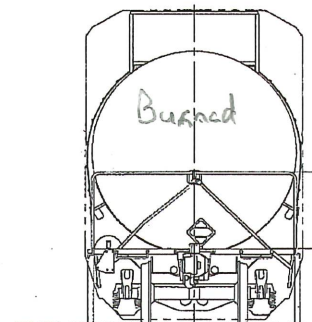
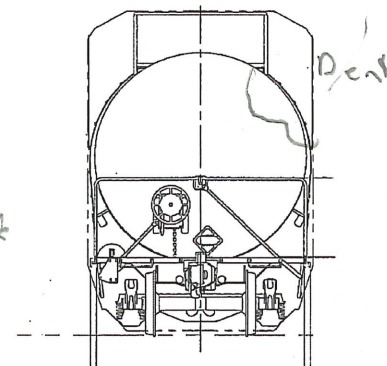
Valves -Leaked / Sheared off

Head Shield A OK Burned B Bent

Skid missing BOV sheared

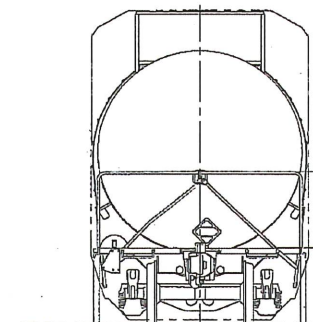
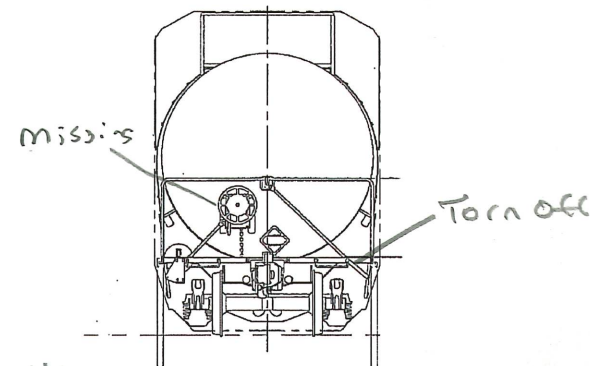
Top fittings MW <sup>2 Eye bolts bent over</sup> MH Bent  
 Bottom Outlet Leg Sheared Handle DT Torn off  
 Breach- Thermal Tear No Mech Tear No  
 Draft Sill A Bent torn B Twisted  
 Head Shield A OK B OK  
 PRD Functioned- Yes No  
 Skid Damaged Stem bent

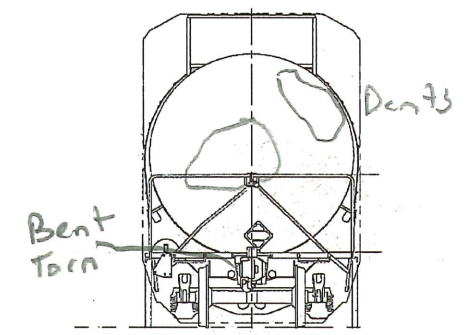
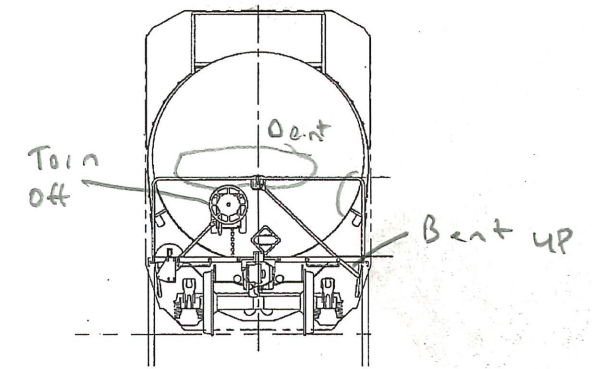
Top fittings MW OK MH Bent OK  
 Bottom Outlet Leg OK Handle DT OK bent  
 Breach- Thermal Tear No Mech Tear No  
 Draft Sill A Bent torn B OK  
 Head Shield A Dents B Dent  
 PRD Functioned- Yes No  
 SKid OK

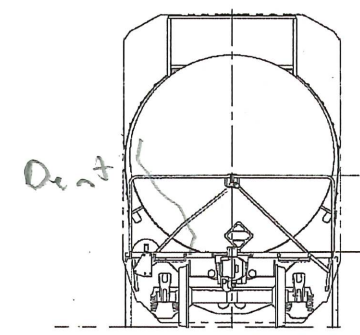
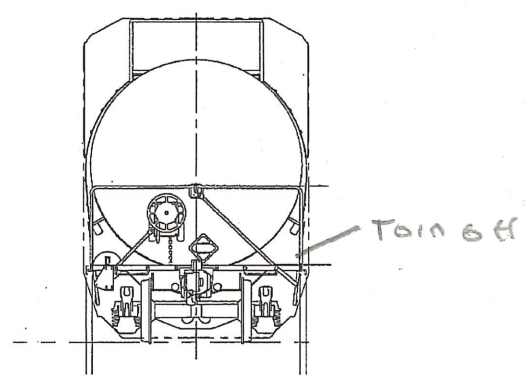
Builder Trinity  
Built Date 12-4-15  
DOT 117 J100W  
File# T15038  
Loss of Commodity (Yes) / No  
Valves -Leaked / Sheared

Top fittings MW OK MH OK  
Bottom Outlet Leg Sheared Handle DT bent  
Breach- Thermal Tear No Mech Tear No  
Draft Sill A Bent B Bent Coupler torn off  
Head Shield A Dent B OK  
PRD Functioned- (Yes) No  
SKid bent BDU hit

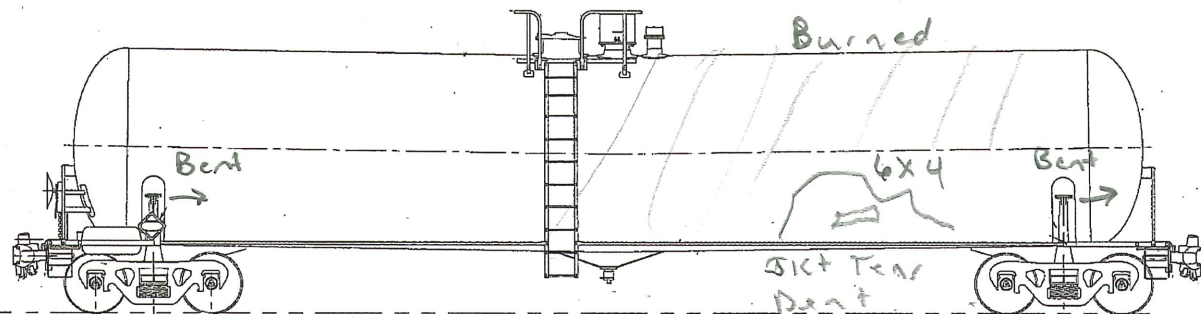
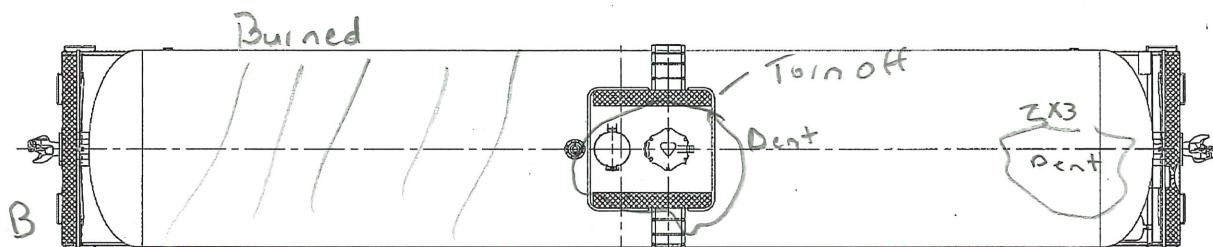
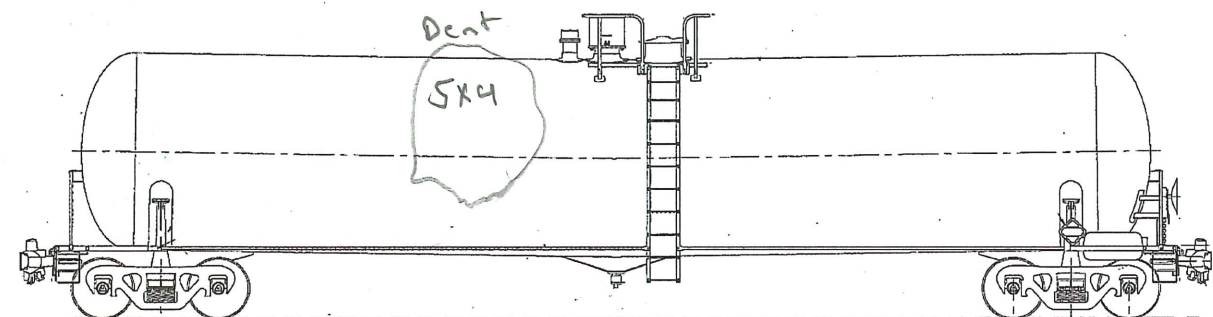
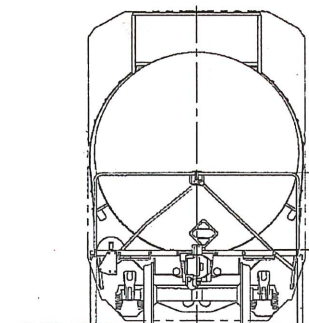
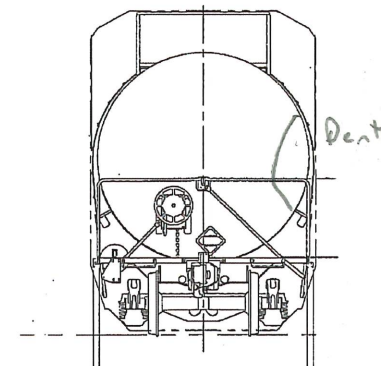
Valves Leaked / Sheared 3"

PRD Functioned- Yes No Burned

SKid Damaged BOU hit

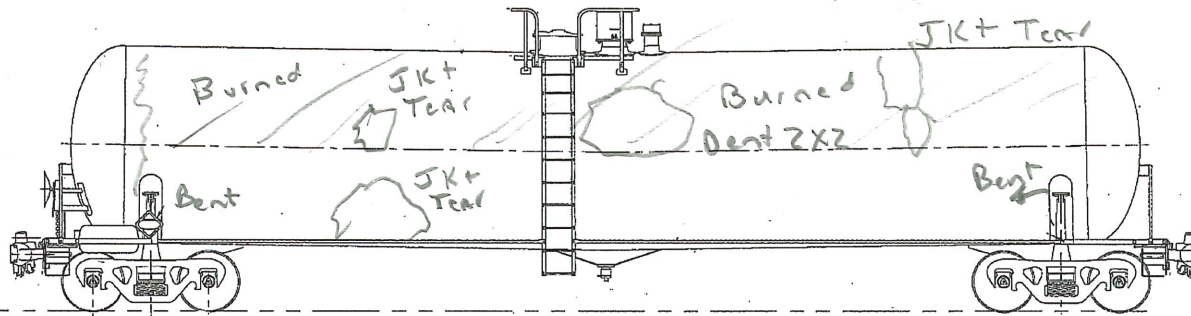
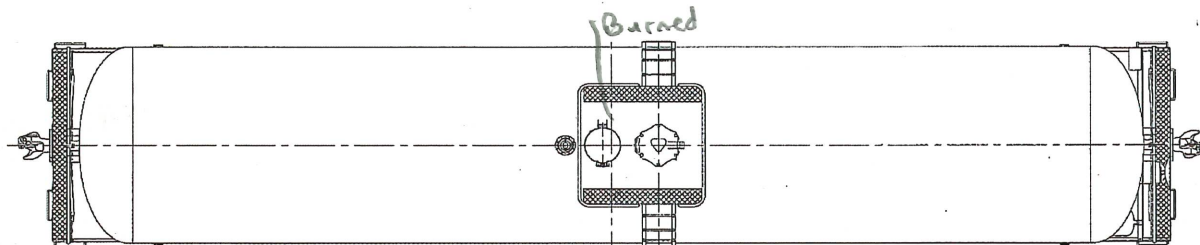
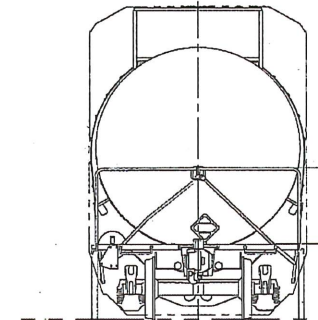
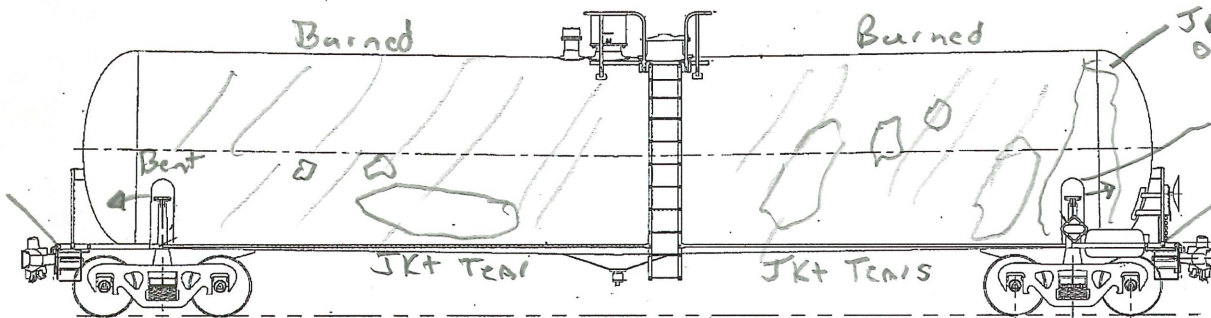
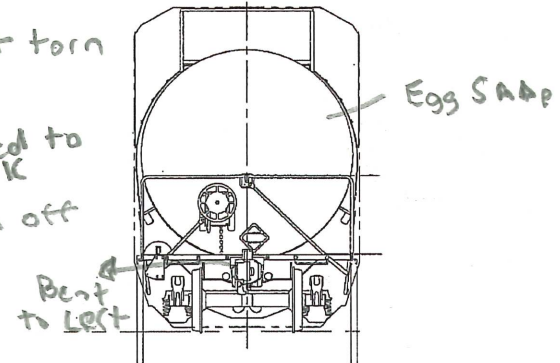
Valves -Leaked / Sheared BOV?

Bottom Outlet Leg Sheared Handle DT Missing

Skid Damaged

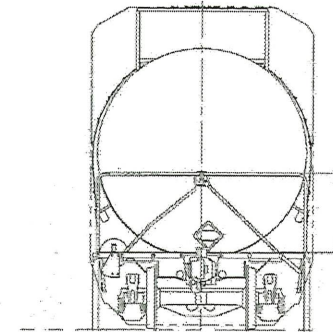
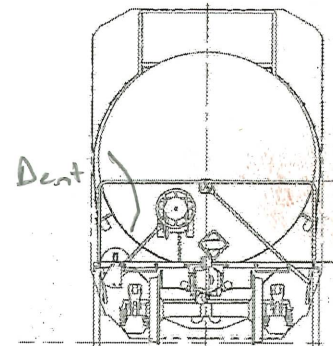
Stub Sill  
Torn off  
@ HB  
inspect  
Empty  
Hold

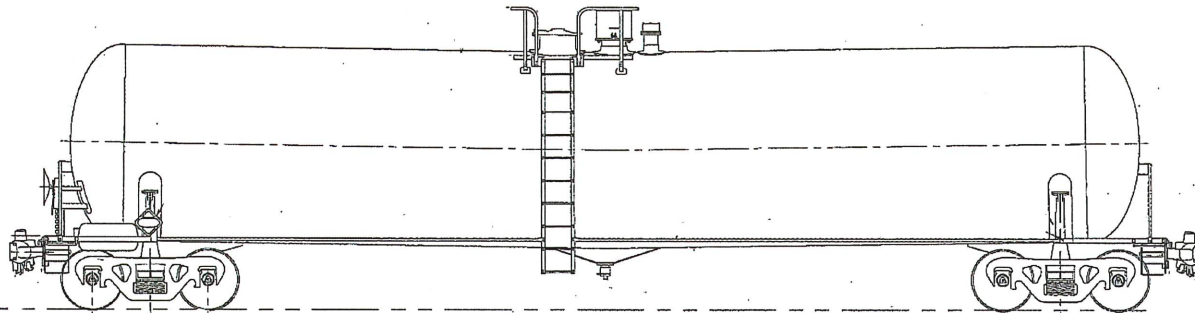
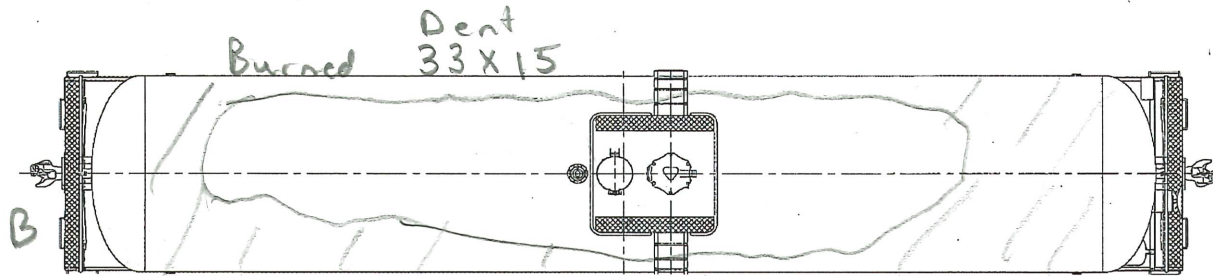
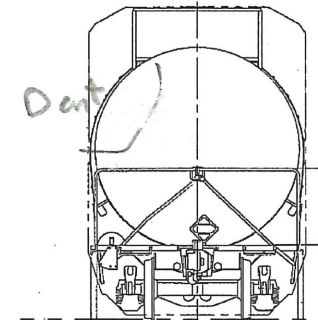
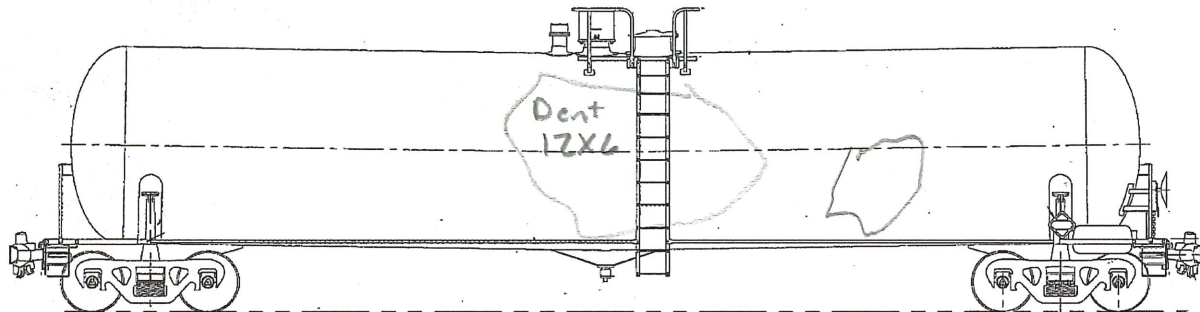
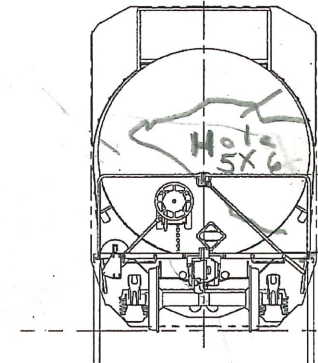
See Pic  
TANK Shell  
Head  
Shield  
Torn off

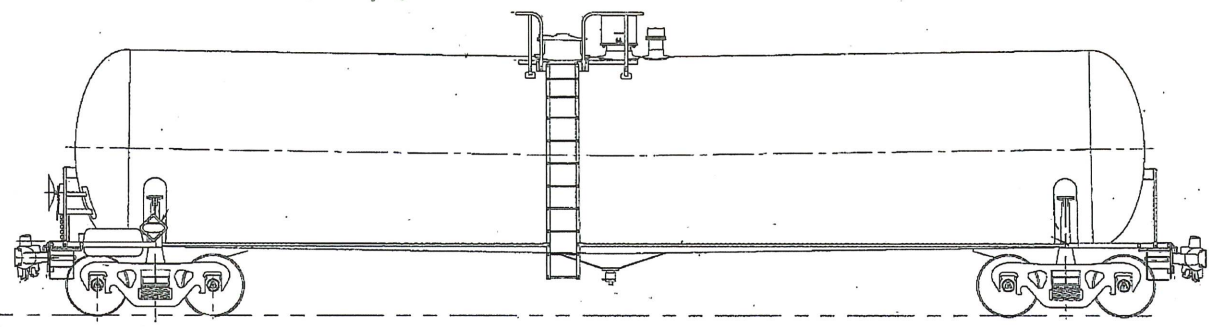
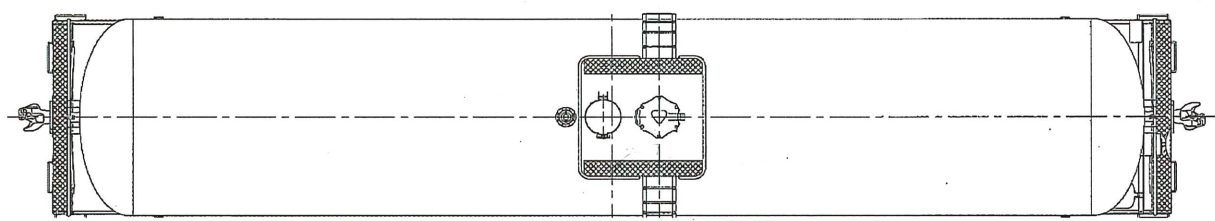
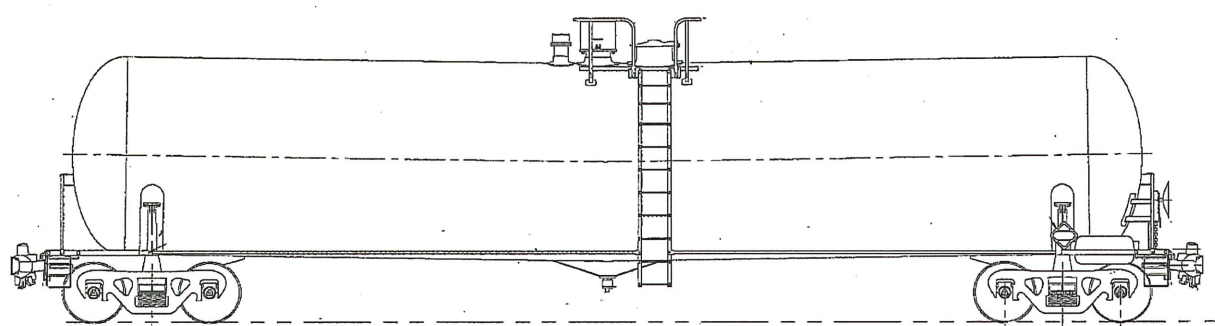
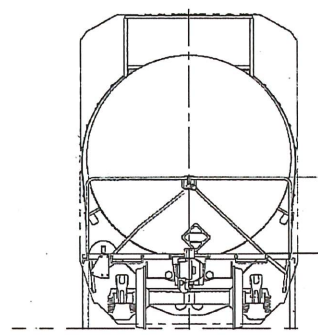
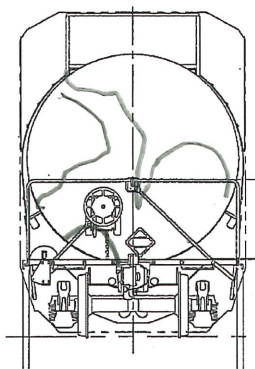
Head torn  
Several Directions

Head brace  
to Sill 14 mm

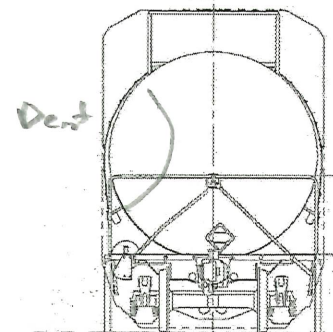
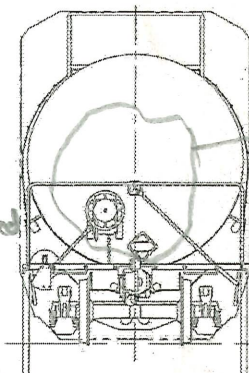
Top fittings MW Leaking MH OK  
Bottom Outlet Leg Sheared Handle DT torn off  
Breach- Thermal Tear No Mech Tear No  
Draft Sill A torn off B HB crack to pad torn off  
Head Shield A Dent B Dent 6x6  
PRD Functioned- Yes No  
SKid Bent  
1 Eye bolt Sheared

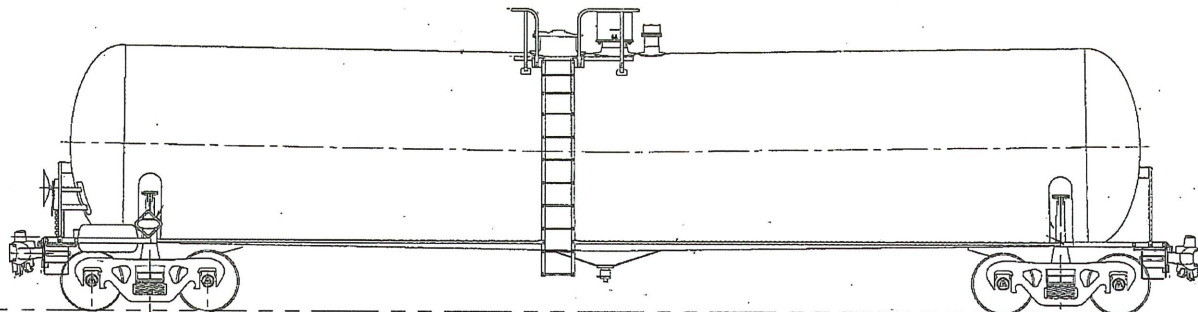
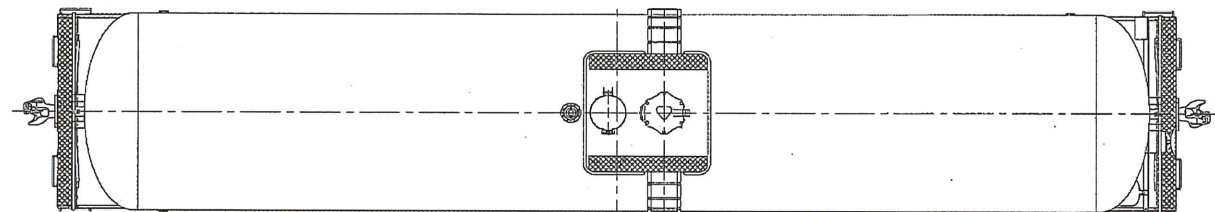
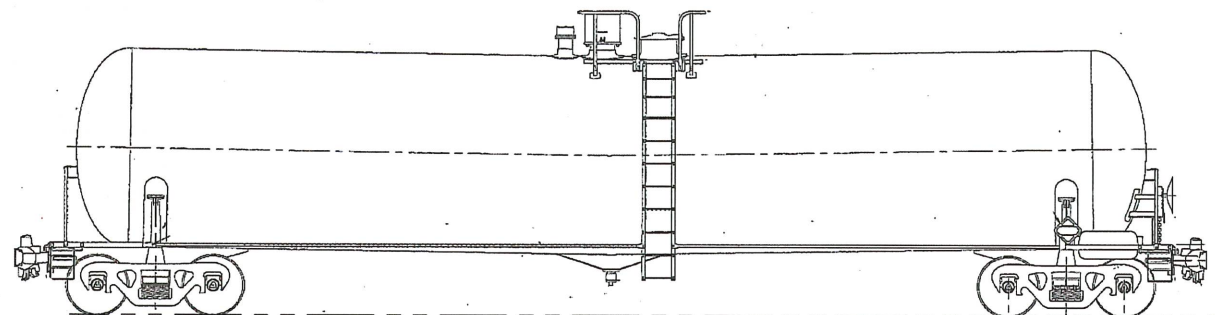
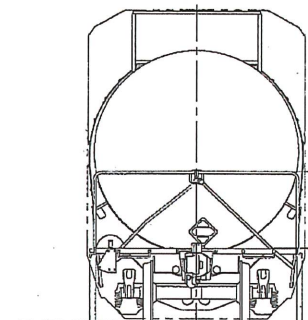
Pad Separated  
1" from weld  
Bent in w Dent  
Dent

28" weld separation

HB crack  
3 1/2"  
to PAD AT TOP

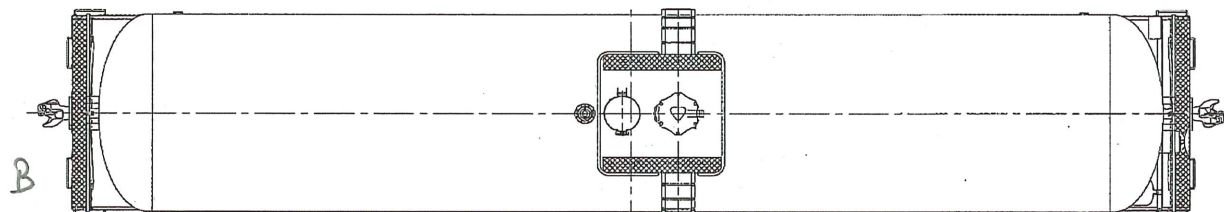
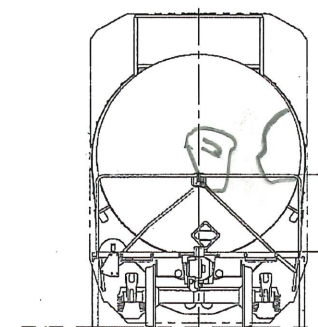
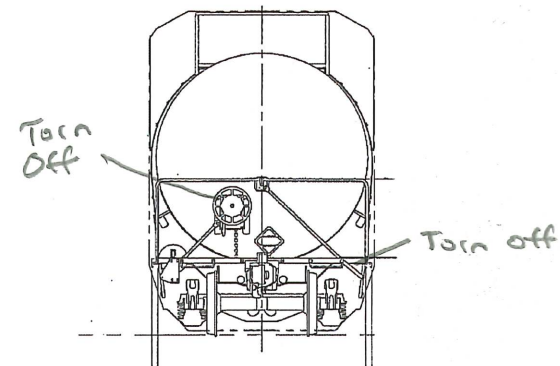
Top fittings MW OK MH OK  
 Bottom Outlet Legs sheared Handle DT torn off  
 Breach- Thermal Tear No Mech Tear AR Shell Breach  
 Draft Sill A Bent B Bent  
 Head Shield A Dents B OK  
 PRD Functioned- Yes  No  
 Skid bent Lock fouling skid

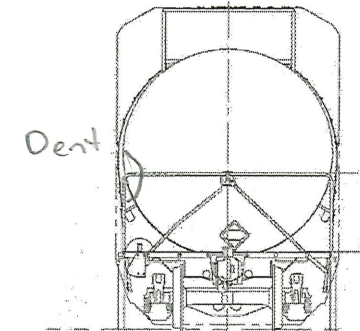
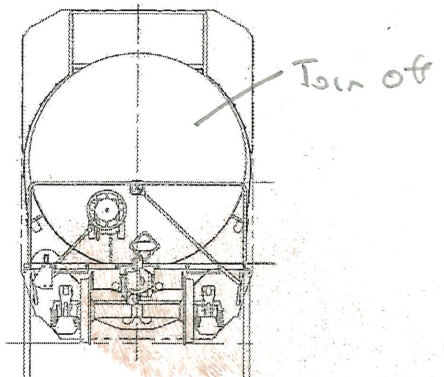
Top fittings MW OK MH Bent  
 Bottom Outlet Leg sheared Handle DT bent  
 Breach- Thermal Tear No Mech Tear No  
 Draft Sill A OK left sheared B torn off  
 Head Shield A Dent B Torn off  
 PRD Functioned- Yes No  
 Skid OK

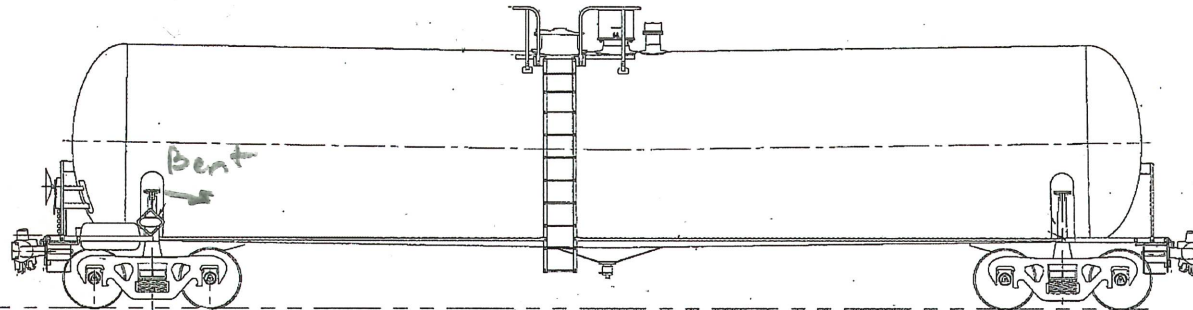
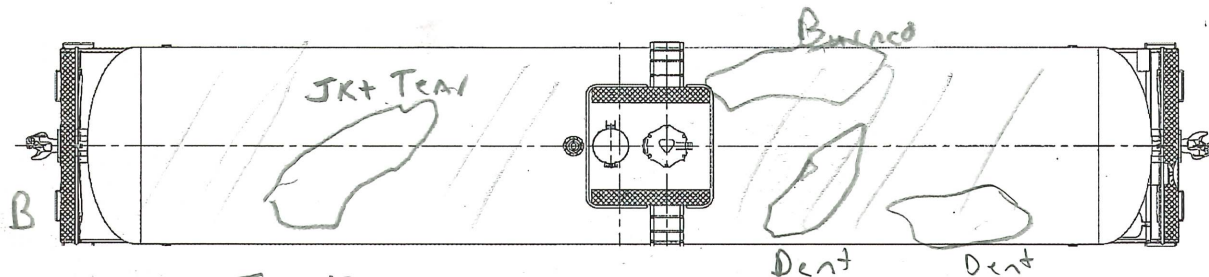
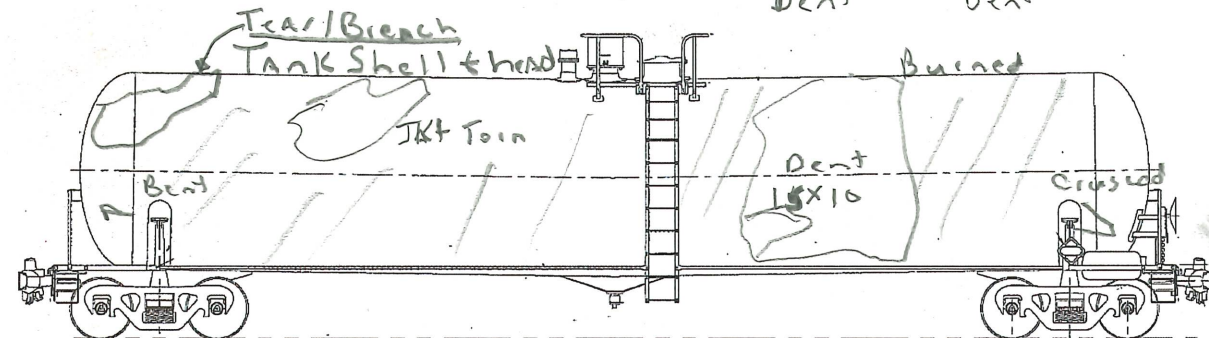
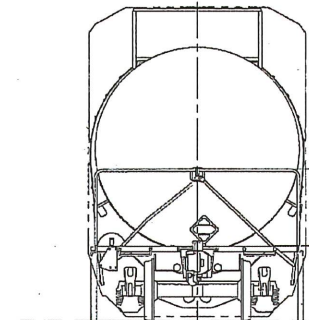
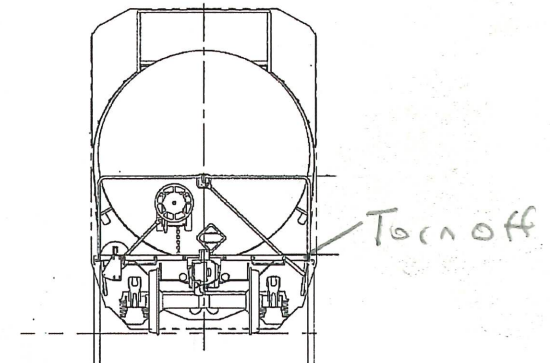
Valves -Leaked / Sheared BOV

SKid Damaged torn BOV sheared off

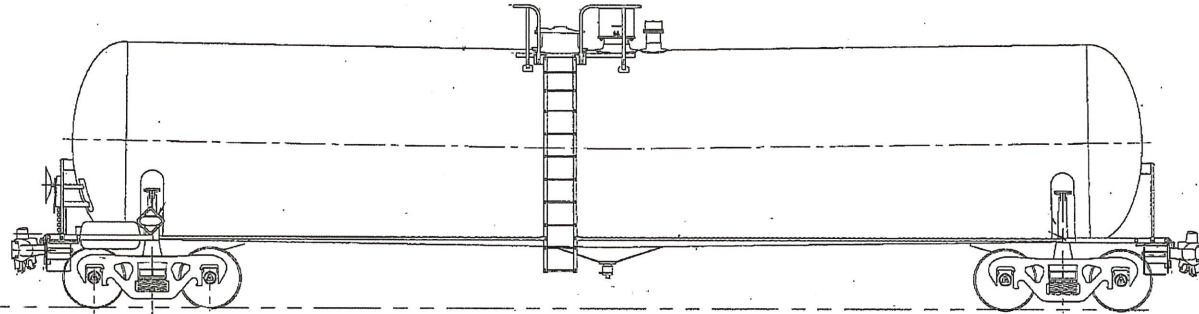
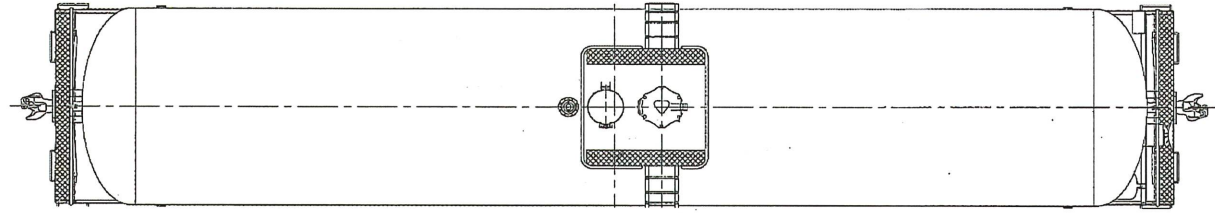
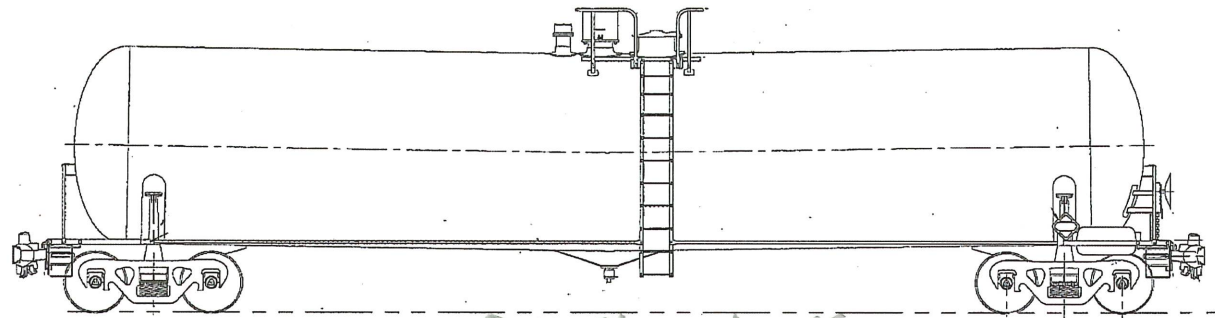
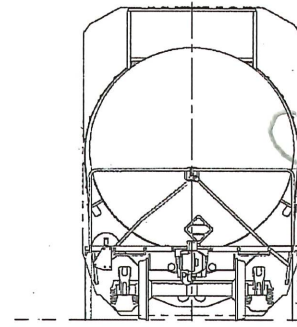
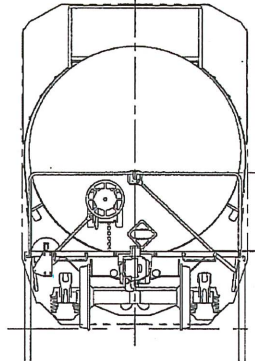
A Head removed  
Head + shell  
torn  
12' x 20"

BOU Sheared off

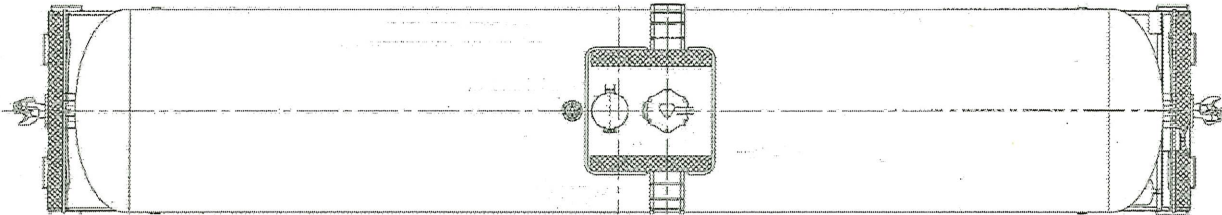
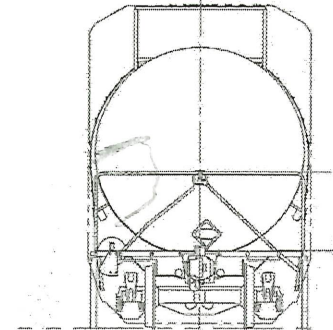
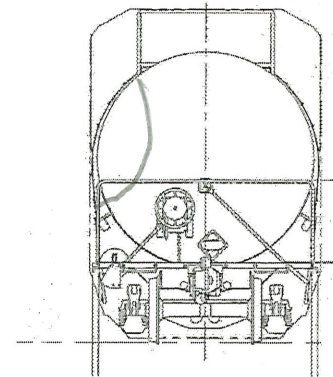
Builder Trinity  
 Built Date 10-14-20  
 DOT 117J100W  
 File# T19039  
 Loss of Commodity Yes / No  
 Valves -Leaked / Sheared ?

Top fittings MW OK MH OK  
 Bottom Outlet Leg ? Handle DT ?  
 Breach- Thermal Tear No Mech Tear No  
 Draft Sill A OK B Bent  
 Head Shield A Dent B Dent  
 PRD Functioned- Yes No  
 Skid buried ?

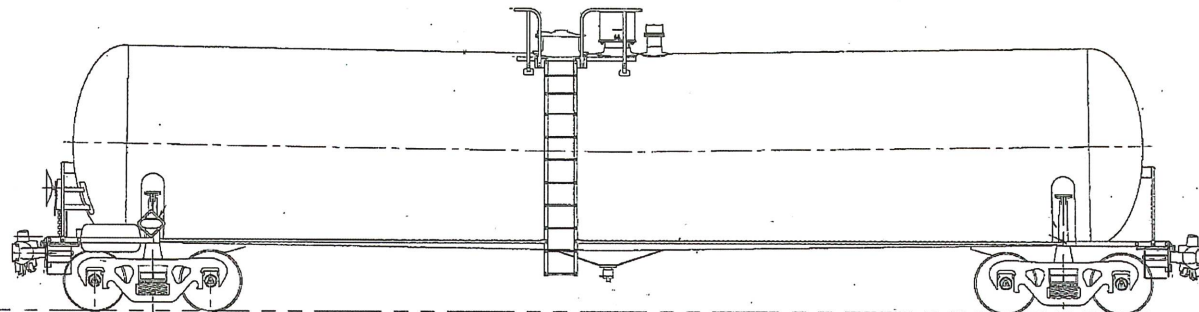
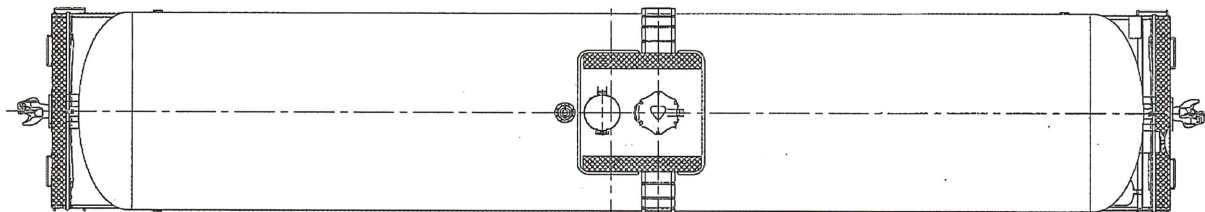
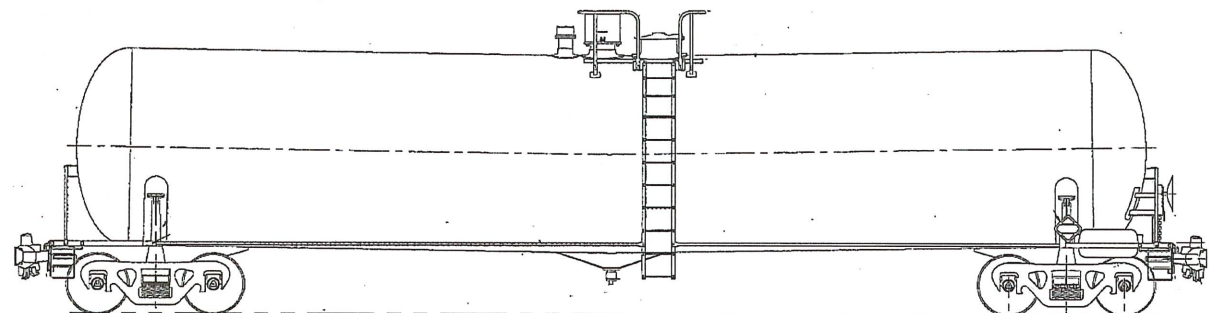
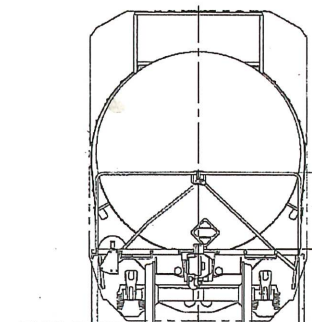
B head R-rod

Head Pad  
Head brace  
Welds OK  
3 PASSES

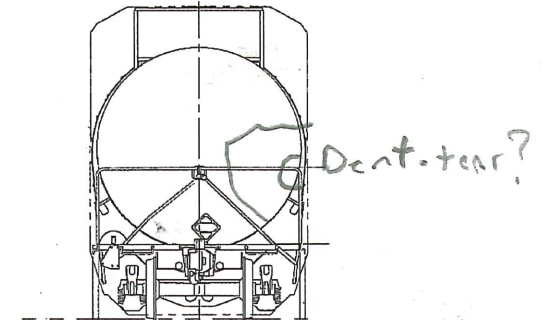
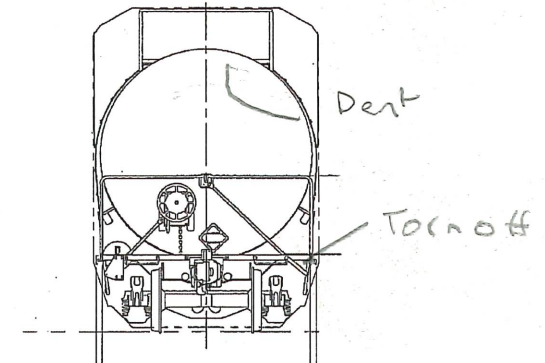
Builder Trinity  
 Built Date 11-26-15  
 DOT 1175100W  
 File# T15038  
 Loss of Commodity (Yes) / No  
 Valves -Leaked / Sheared  
BOV Dripping

Top fittings MW OK MH OK  
 Bottom Outlet Leg OK Handle DT Bent  
 Breach- Thermal Tear No Mech Tear No  
 Draft Sill A Bent Cplc Shear B OK  
 Head Shield A Dent B OK  
 PRD Functioned- (Yes) No  
SKid OK

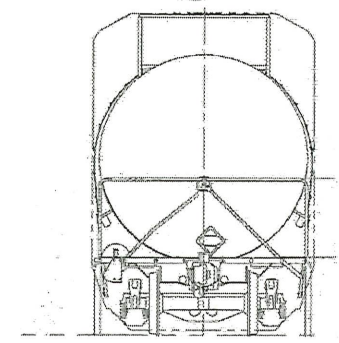
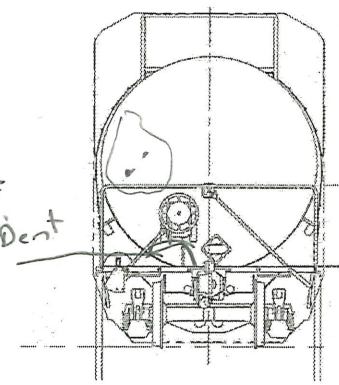
Builder Trinity  
 Built Date 12-7-15  
 DOT 117J100W  
 File# T19039  
 Loss of Commodity Yes / No  
 Valves -Leaked / Sheared No

Top fittings MW OK MH OK Dent  
 Bottom Outlet Leg 3 Buried Handle DT Bent  
 Breach- Thermal Tear No Mech Tear No  
 Draft Sill A Bent B Twisted  
 Head Shield A OK B Dent  
 PRD Functioned- Yes No  
 Skid buried

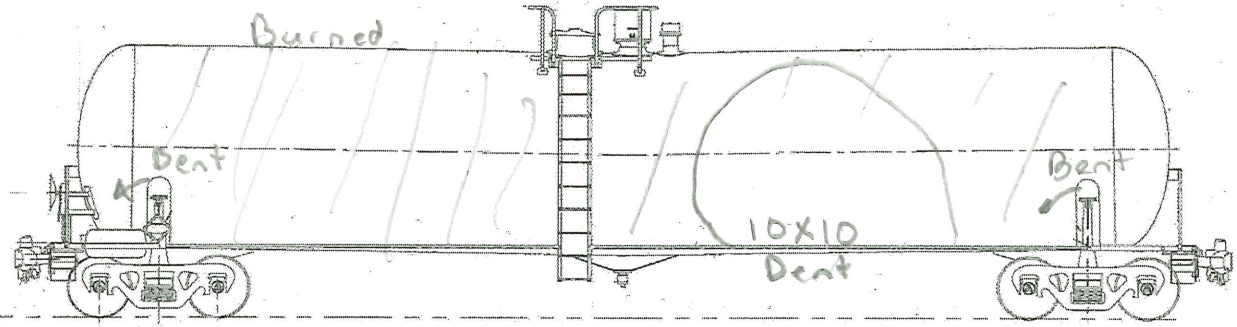
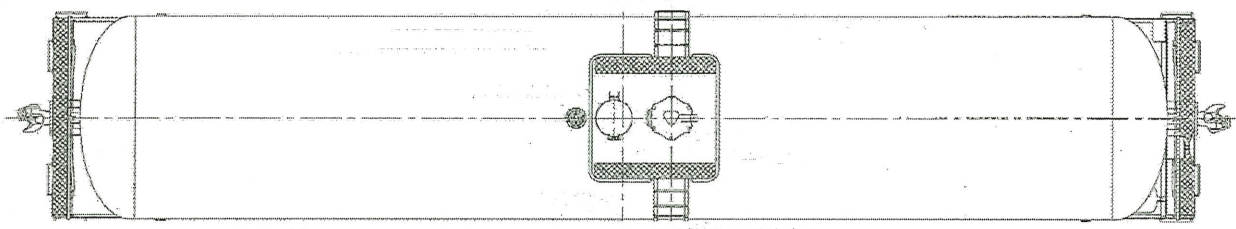
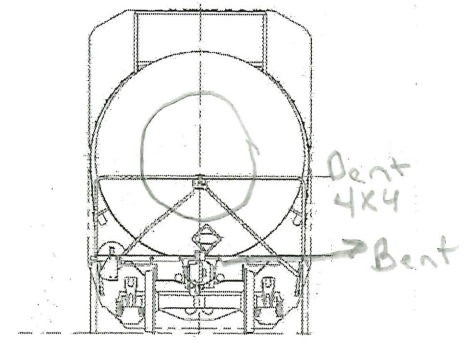
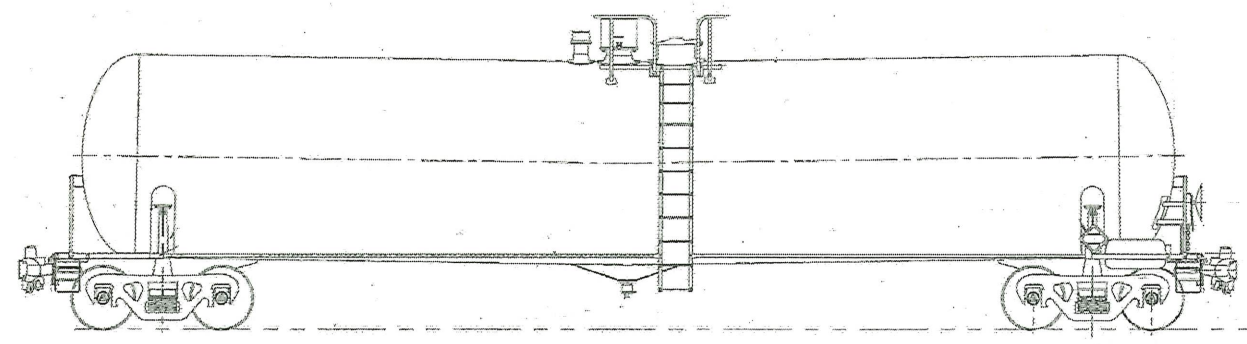
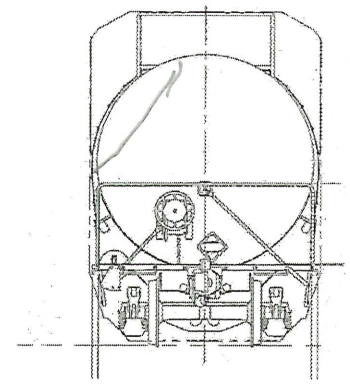
Loss of Commodity Yes / No BOV Leaking

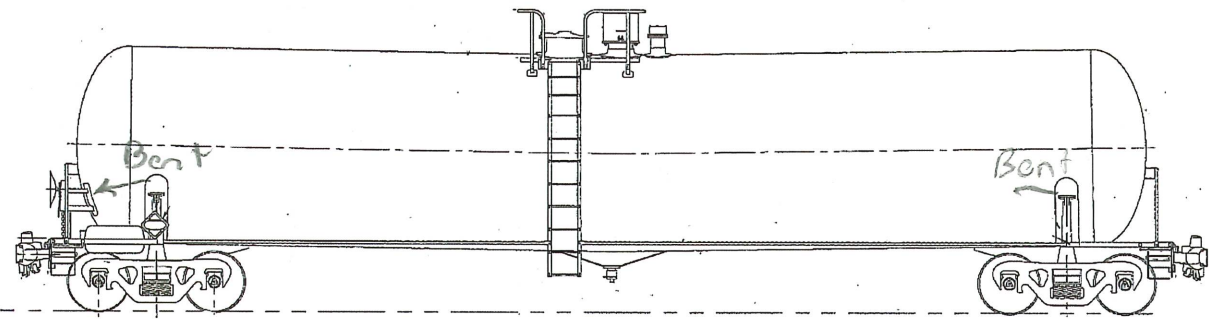
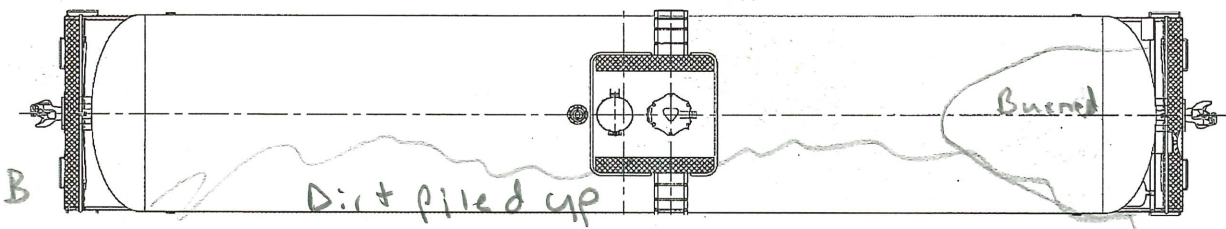
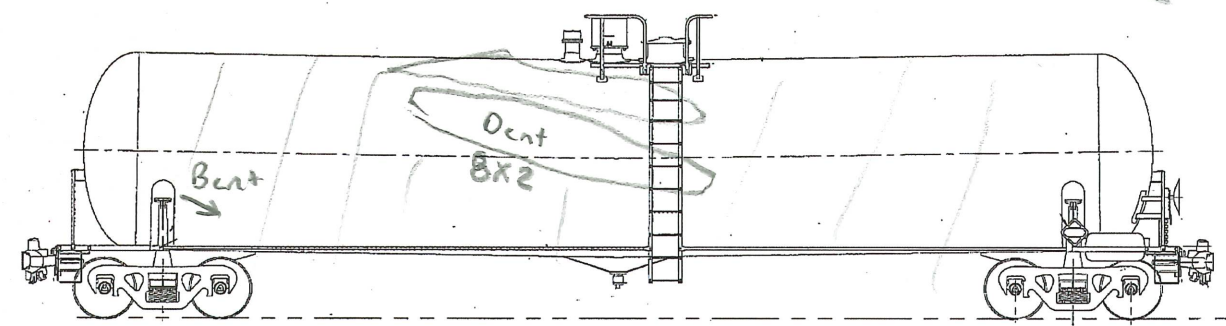
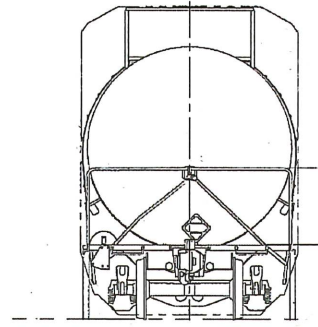
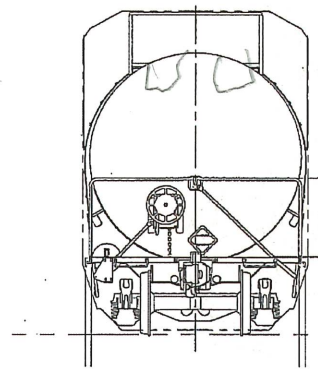
on side Dirt Piled up

Bottom Outlet Leg Sheared Handle DT

Draft Sill A Bent B bent

Head Shield A B Bent

Torn off

Hold  
inspect BR  
& BOU

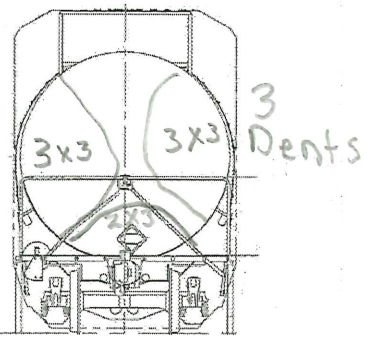
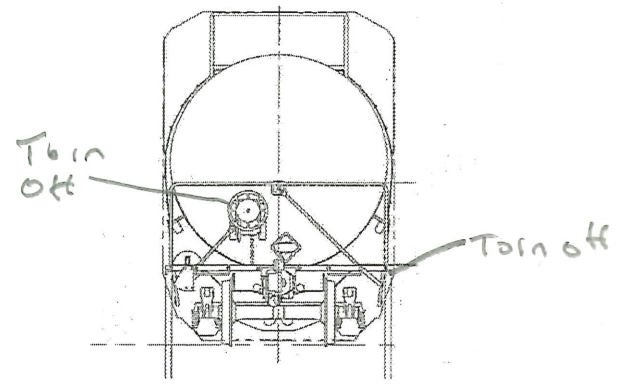
Hold  
HB torn  
from pad  
Top of  
cut out  
torn tank shell  
A+top

HB torn from  
PAD

Top fittings MW OK MH OK  
Bottom Outlet Leg OK Handle DT bent  
Breach- Thermal Tear No Mech Tear Yes @ A and HB  
Draft Sill A torn open B OK Cplr head sheared  
Head Shield A 2 Dents B OK  
PRD Functioned- Yes No  
SKID OK

Hold  
A End  
Stub Sill + Pad

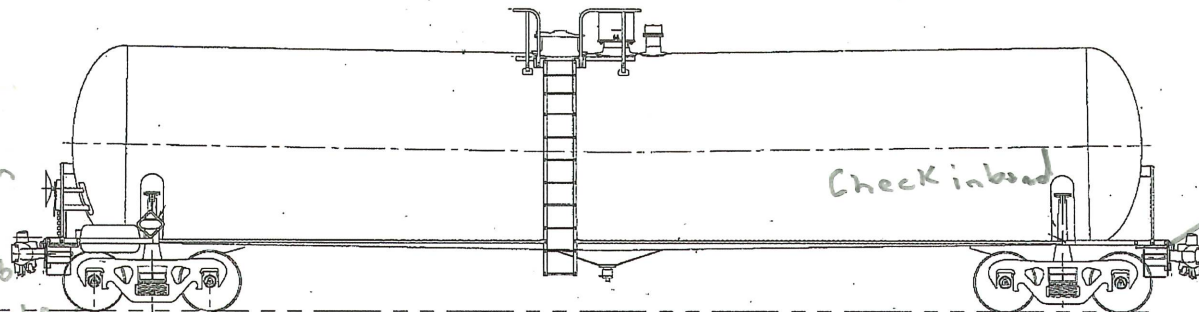
Section  
of A  
End Stub  
Sill + Head Pad

Pealed open  
Top turn open  
Left side  
Peel back  
65X88  
12" over  
Dent

69' x 70"  
60" x 8" Deep  
32 3/4" vert  
to Head Pad  
tear
