# Car Damage Report

3-12-15  
DGT-004  
Rev 4

Date of Derailment 1-8-77

Location BNSF Oklahoma TX  
Pinard 1987

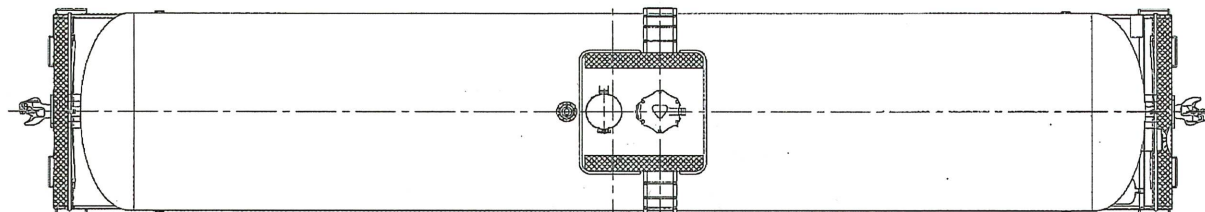
A End  
Head Pad  
Pulled from  
HB 6"

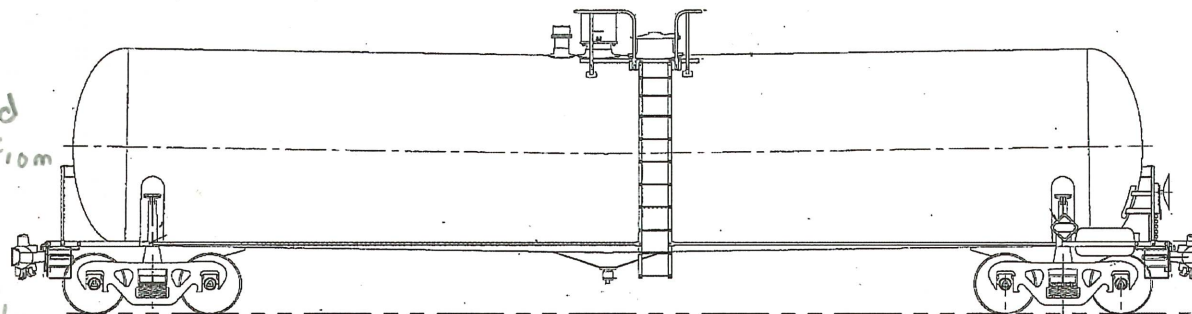
Head Pad  
webs 1/2" 3PASS

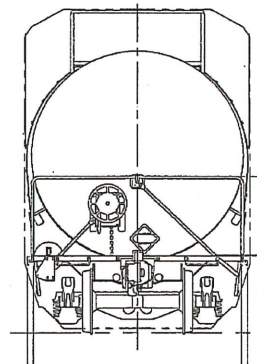
Top of HB 4"  
to top of Pad

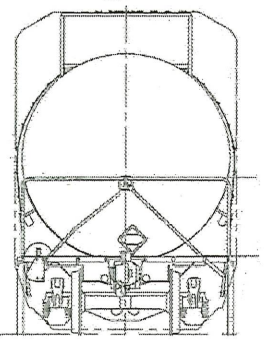
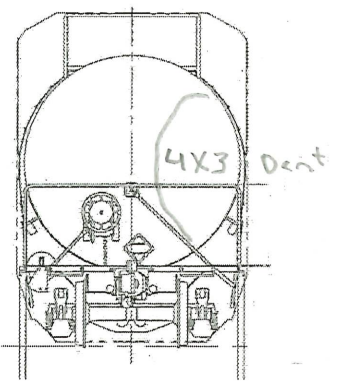
Top fittings MW OK MH OK  
Bottom Outlet Leg Sheared Handle DT OK  
Breach- Thermal Tear No Mech Tear No  
Draft Sill A torn off @ HB B OK Cplr Sheared off  
Head Shield A OK B OK  
PRD Functioned- Yes No  
SKD OK

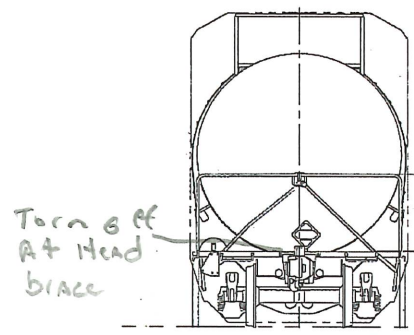
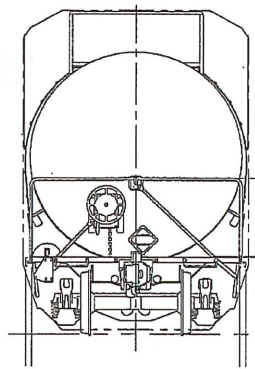
Turn off  
AT Head  
brace

Sill bent to AL  
Side  
Stub Sill torn  
off @ HB  
Head Pad has  
2" crack AR  
Cut out

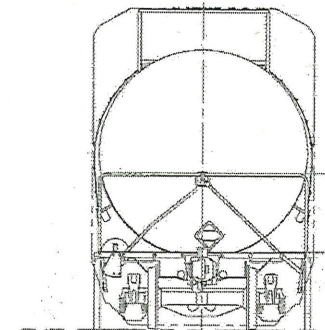
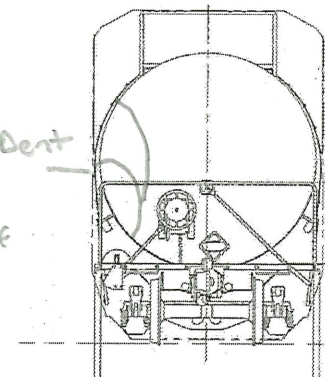
Top fittings MW OK MH OK  
 Bottom Outlet Leg OK Handle DT OK  
 Breach- Thermal Tear No Mech Tear No  
 Draft Sill A twisted B OK Coll Sheared  
 Head Shield A OK B Dent  
 PRD Functioned- Yes No  
 Skid OK

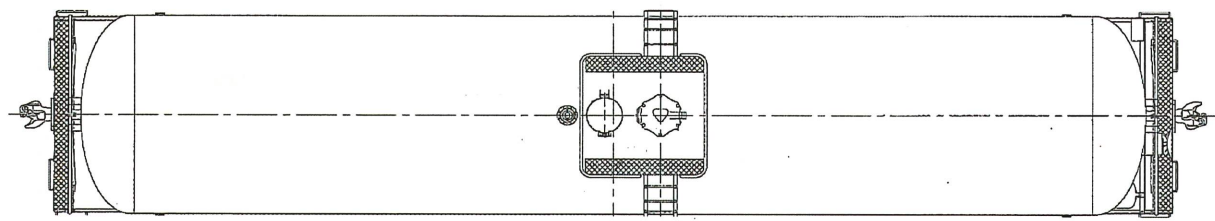
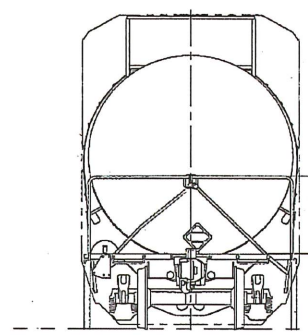
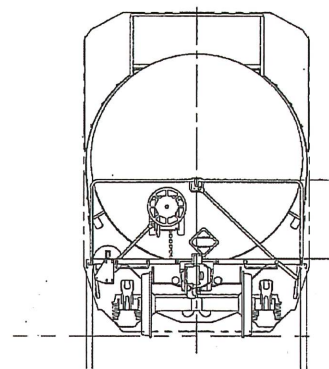
A End head  
Sill twisted  
to right side

No CRACK

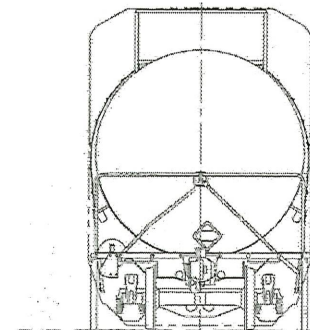
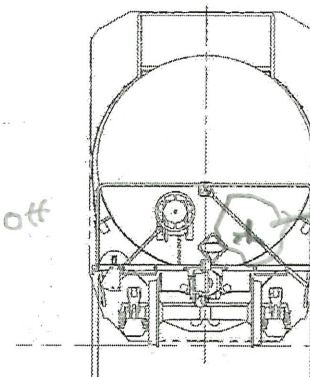
Top fittings MW OK MH OK  
Bottom Outlet Leg OK Handle DT Bent  
Breach- Thermal Tear No Mech Tear Yes Head + shield  
Draft Sill A Bent torn B Bent  
Head Shield A OK B Punctured  
PRD Functioned- Yes No  
SKid OK

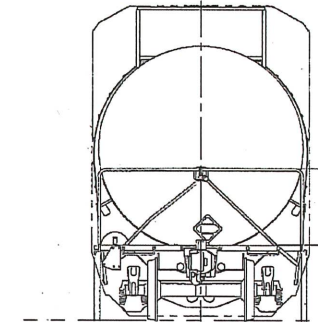
Crack in  
4 1/2" weld  
OK

2) (1)NTSB (1)Trin  
3X3 Coupons  
Removed  
for testing  
A  
End

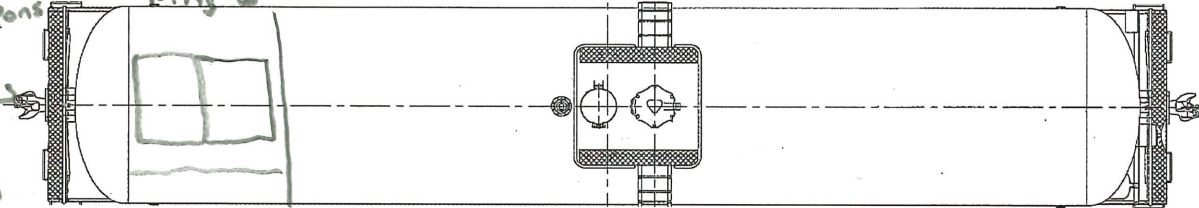
B head  
Dent 36" x 39"  
Puncture 6"  
16" from bottom

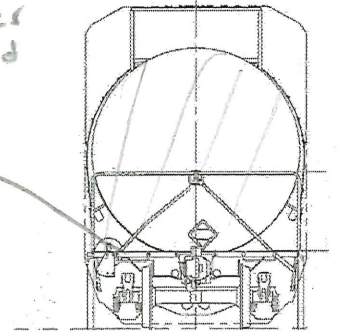
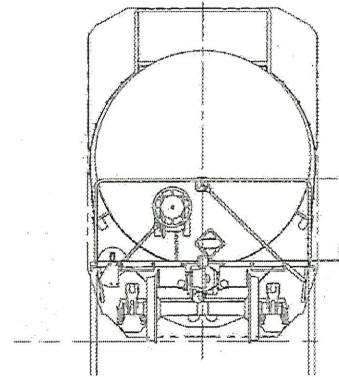
Twisted  
Coupler  
Sheared

Platform  
missing

Top fittings MW OK MH OK  
 Bottom Outlet Leg OK Handle DT OK  
 Breach- Thermal Tear No Mech Tear No  
 Draft Sill A Twisted B OK  
 Head Shield A OK B OK  
 PRD Functioned- Yes No

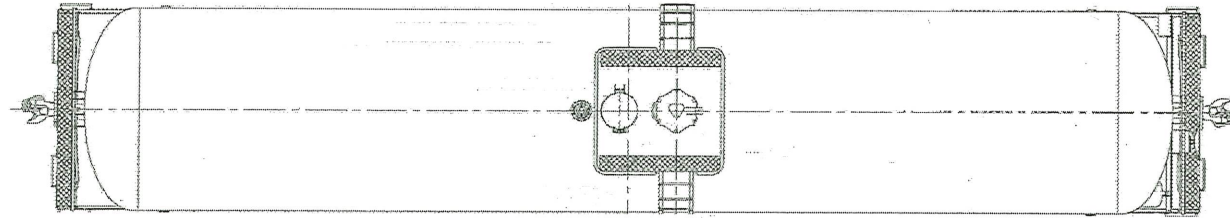
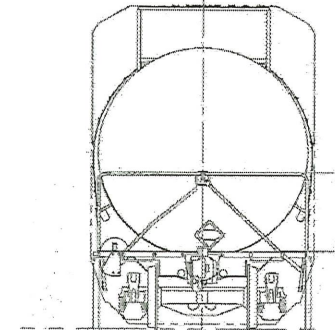
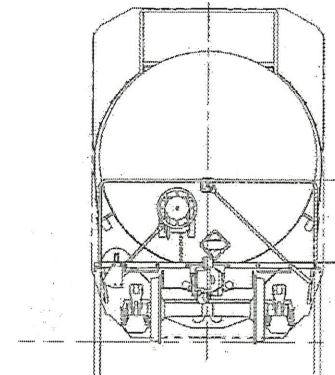
Burned  
Brake hoses  
Valves  
Bench  
Adaptors etc

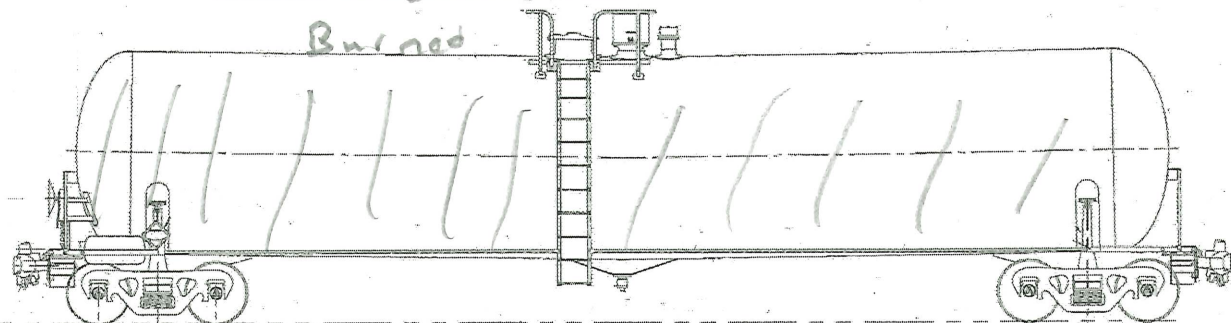
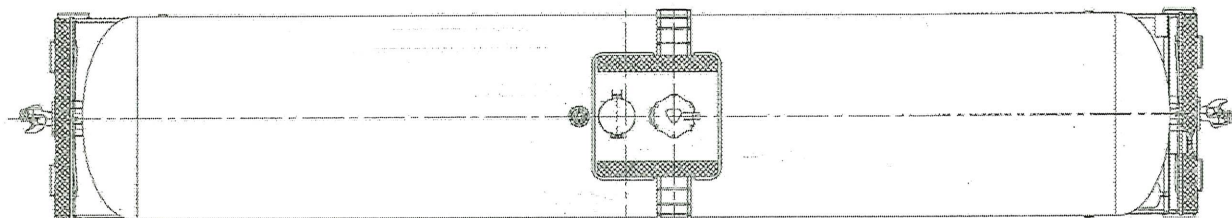
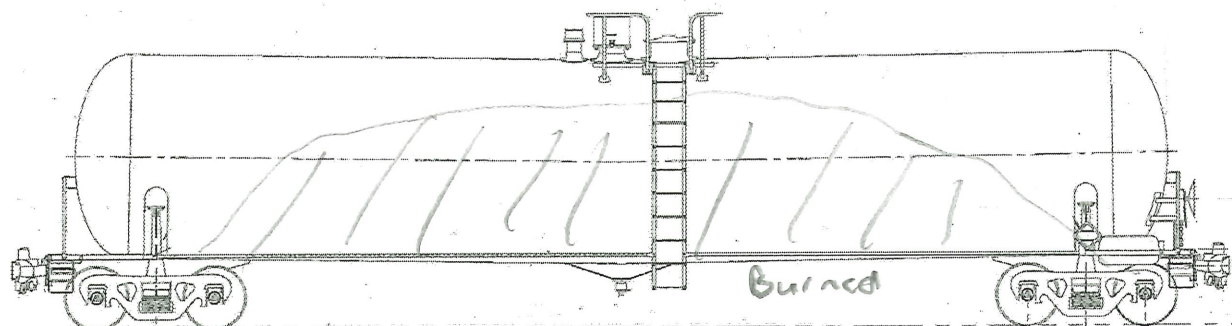
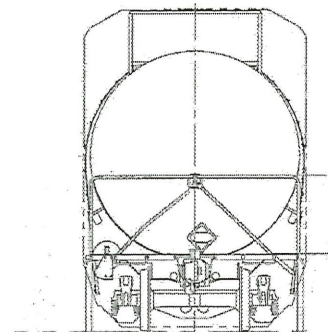
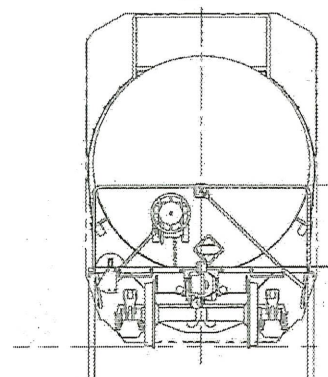
All Brake  
Components  
melted  
Bearings + Axle

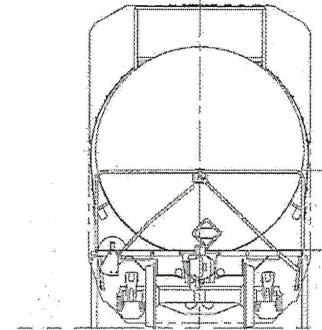
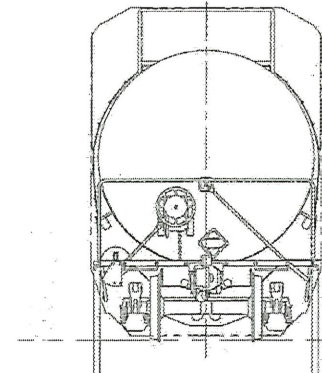
All components  
burned/melted

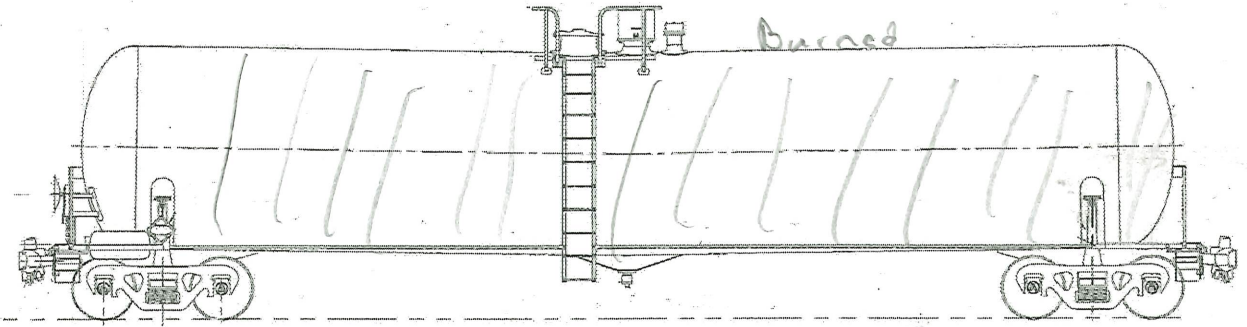
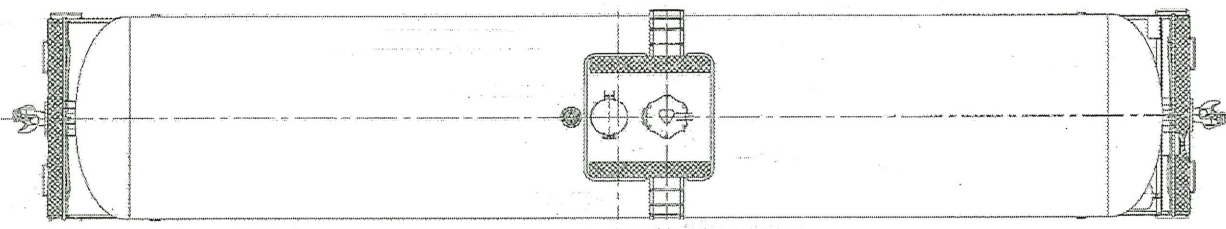
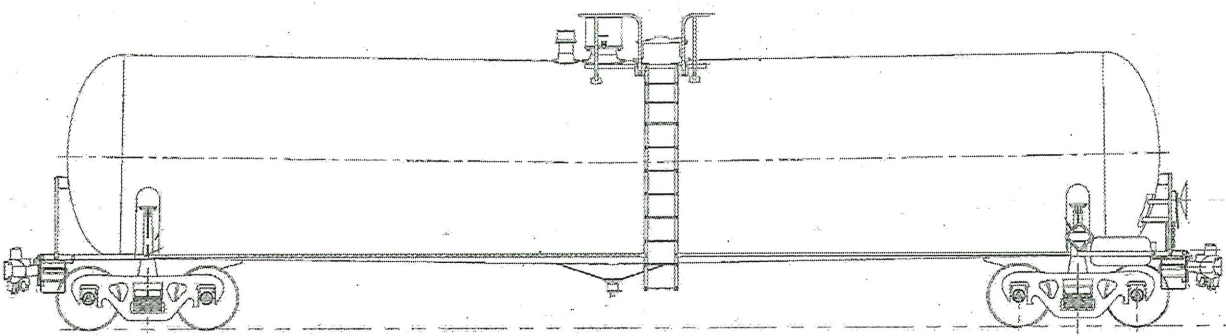
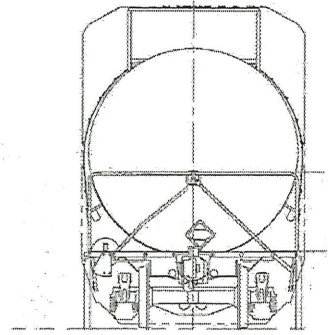
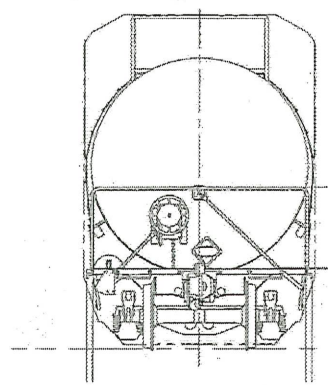
Builder Trinity  
Built Date 10-16-20  
DOT 117 J100W  
File# T19039  
Loss of Commodity Yes / No  
Valves -Leaked / Sheared No

Top fittings MW OK MH OK  
Bottom Outlet Leg OK Handle DT OK  
Breach- Thermal Tear No Mech Tear No  
Draft Sill A OK B OK  
Head Shield A OK B OK  
PRD Functioned- Yes No
