NATIONAL TRANSPORTATION SAFETY BOARD  
Office of Aviation Safety  
Washington, DC 20594

**SURVIVAL FACTORS SPECIALISTS' FACTUAL REPORT**

Operator : Peninsula Aviation Services Inc.  
Airplane : Saab 2000 [N686PA]  
Location : Unalaska, AK  
Date : October 17, 2019  
Time : 1740 Alaska daylight time (ADT)<sup>1</sup>  
NTSB # : DCA20MA002

On October 17, 2019, about 1740 Alaska daylight time, Peninsula Aviation Services Inc. d.b.a. PenAir flight 3296, a Saab 2000, N686PA, was landing at Unalaska Airport (DUT), Unalaska, Alaska, when the airplane overran the end of the runway, passed through the airport perimeter fence, crossed a road, and pitched down over shoreline rocks with its nosewheel in Dutch Harbor. Of the 42 airplane occupants, 1 passenger sustained fatal injuries. The airplane was substantially damaged. The airplane was operating as a regularly scheduled passenger flight under the provisions of Title 14 Code of Federal Regulations (CFR) Part 121. Visual meteorological conditions prevailed at the time of the accident. The flight had departed from Ted Stevens Anchorage International Airport (ANC), Anchorage, Alaska, at 1523.

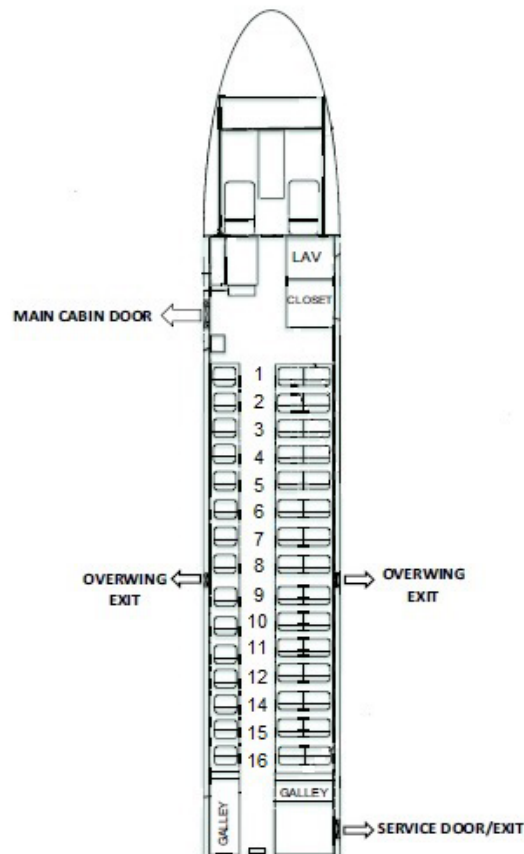
**Figure 1. Interior Diagram of N686PA.**

The accident airplane was configured with a center aisle and 15 rows of passenger seats, numbered 1-16 (omitting row 13). A single seat on the left side of the cabin was designated A and the two seats on the right side of the cabin were designated D (aisle) and F (window). The cabin had one, aft-facing flight attendant (F/A) jumpseat equipped with a four-point restraint forward of the main cabin door. In addition to the main cabin door, the airplane had an aft service door on the right side of the airplane, and two overwing emergency window exits at row 9 (see figure 1).

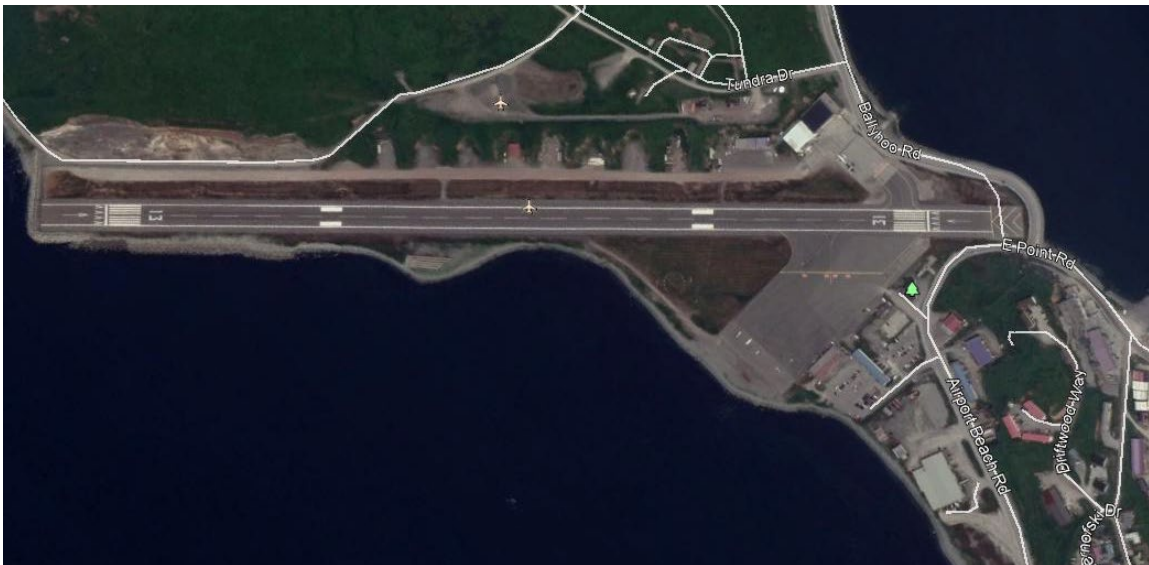
**Figure 3. 2019 Google Earth image of DUT.**

At the time of the accident facilities at the airport included a single 4,500’ x 100’ grooved asphalt runway (13/31), two taxiways, two aprons, a passenger terminal (owned by the City of Unalaska), a seaplane ramp, aircraft hangars, and airport maintenance and overhaul facilities. The airport was a commercial service airport certificated under Class I of 14 *Code of Federal Regulations (CFR) Part 139* and received scheduled air carrier service with a Saab 2000 operated by PenAir.

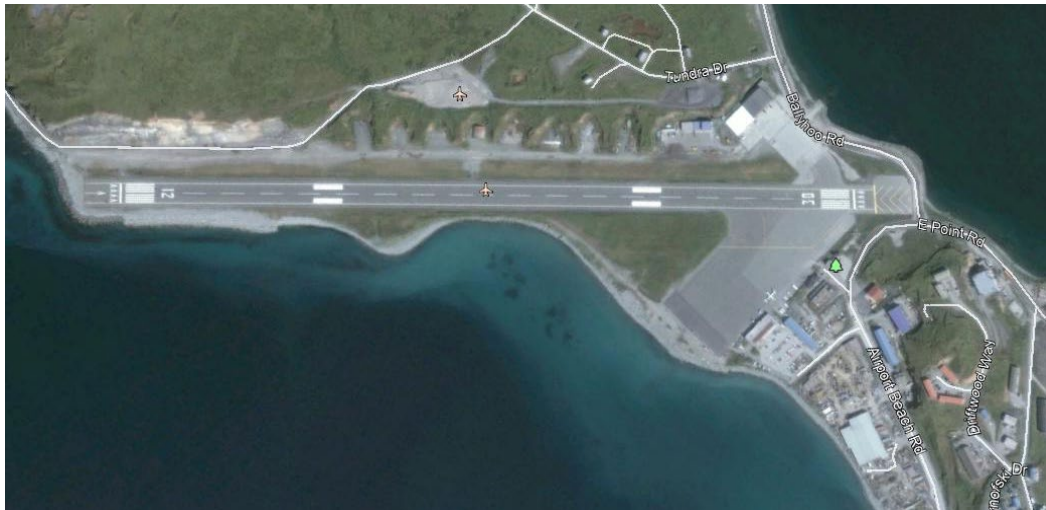
**Figure 4. 2005 Google Earth image of DUT (prior to construction project).**

Because DUT was categorized as an ARC B-II airport, AC 150/5300-13, Change 15 specified that RSAs were to be 150 feet wide, centered on the runway centerline, and were to extend 300 feet beyond each runway end. The RSAs at DUT measured only 100 feet in length at the approach on runway 30 and 200 feet in length at the approach end of runway 12 and, therefore, did not meet FAA design standards.

ADOT&PF contracted for RSA practicability study (completed in October 2010) to provide the FAA with an analysis of potential solutions for improving the RSAs at DUT. At the time, both Ballyhoo Road and Airport Beach road were close to the Runway 30 approach end, necessitating a 100-foot displacement of the landing threshold and vehicle control gates on the road. The shore of Unalaska Bay was approximately 40 feet from the approach end of Runway 12, which had a 200-foot displacement (see figures 4 and 5).

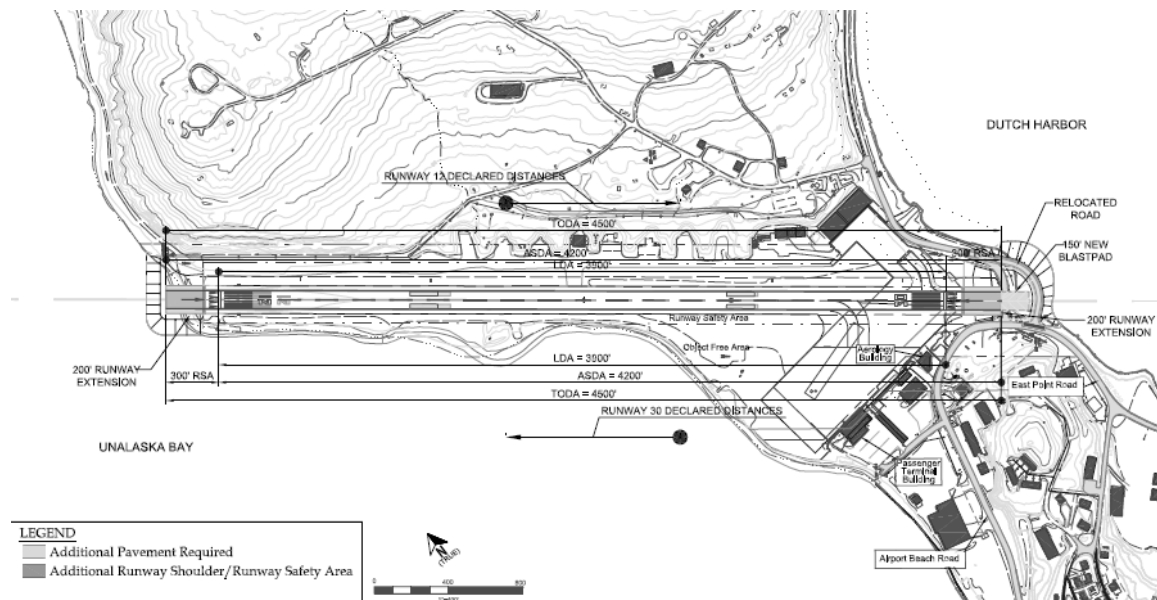
**Figure 6. Modifications to DUT’s RSAs and published distances obtained through the declared distances alternative.**

In this alternative, the end of pavement at the northwest (Runway 12 approach) end of the runway was to be extended by 200 feet to the northwest and the Runway 12 landing threshold was to be moved 200 feet to the northwest. The southeast (Runway 30 approach) end of the runway was to be extended to provide an additional 200 feet for RSA, and an additional 150 feet of separation from the road would be provided by including a smaller blast pad (150 feet as recommended for ARC B-II). Ballyhoo Road was to be rerouted around the end of the runway and new blast pad. The RSA pavement at each end of the runway would be displaced runway pavement and, as such, also be used by aircraft taking off, thus increasing the runway available for takeoff to 4,500 feet.

According to the report, after analyzing all options, the provision of full RSAs through the use of declared distances allowed DUT to meet the B-II standard at the lowest cost and was found to be the most practicable solution.

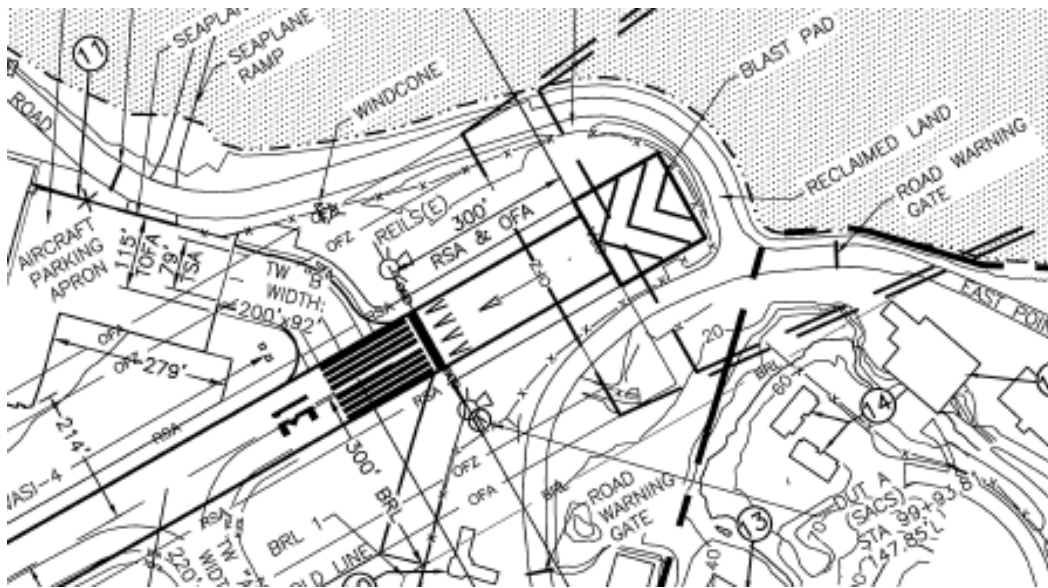
**Figure 7. Post-construction view of the approach end of the runway 31 from DUT’s Airport Layout Plan (ALP).**

ADOT&PF provided a copy of DUT’s current ALP which indicated that the post-construction views shown in figures 6 and 7 accurately depicted the pavement and RSA configuration at DUT on the day of the accident (see photo 13).

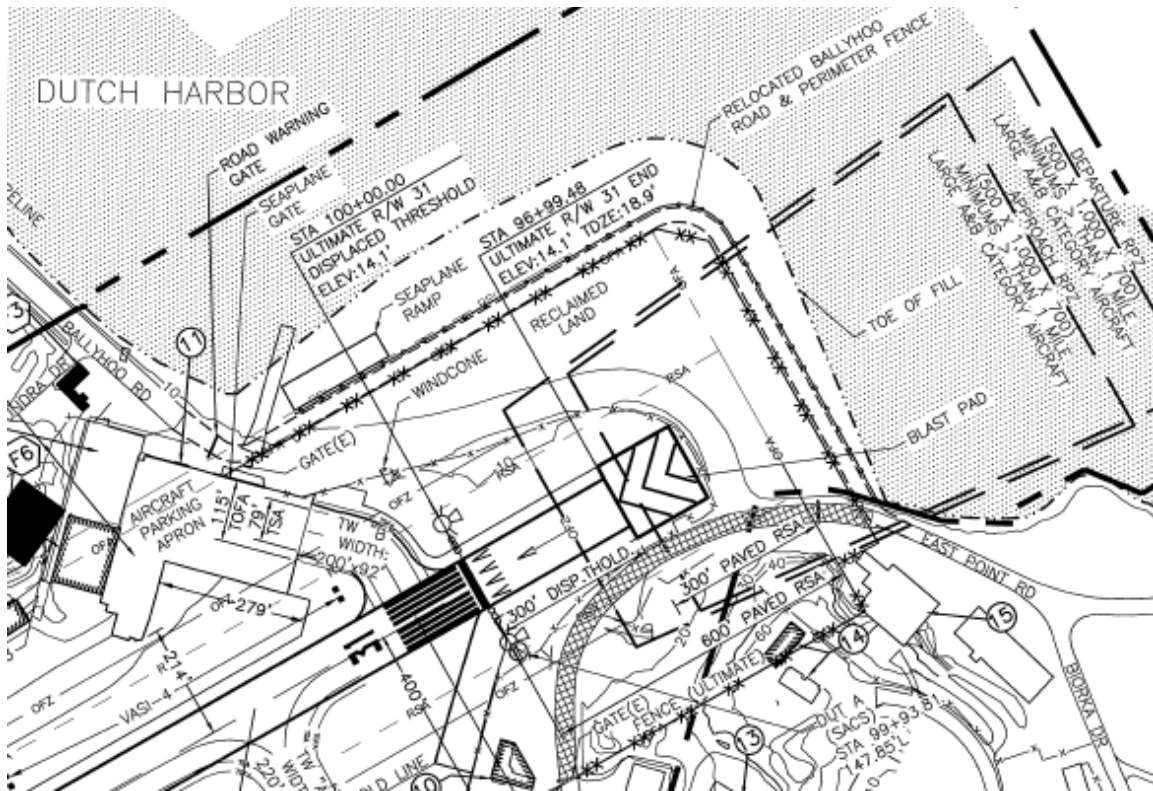
**Figure 8. DUT's ultimate configuration ALP for the Runway 31 approach end.**

The ALP also included a diagram showing the airport's ultimate planned configuration. It was noted that the airport's ultimate configuration provided 600 feet of RSA at the Runway 31 approach end by adding additional fill into Dutch Harbor and relocating both Ballyhoo Road and the airport's perimeter fence (see figure 8). Similarly, the ultimate planned configuration showed 600 feet of RSA at the Runway 13 approach end that was obtained by adding additional fill to Unalaska Bay. According to ADOT&PF there was no timetable for the construction of the airport's ultimate configuration shown in the ALP.

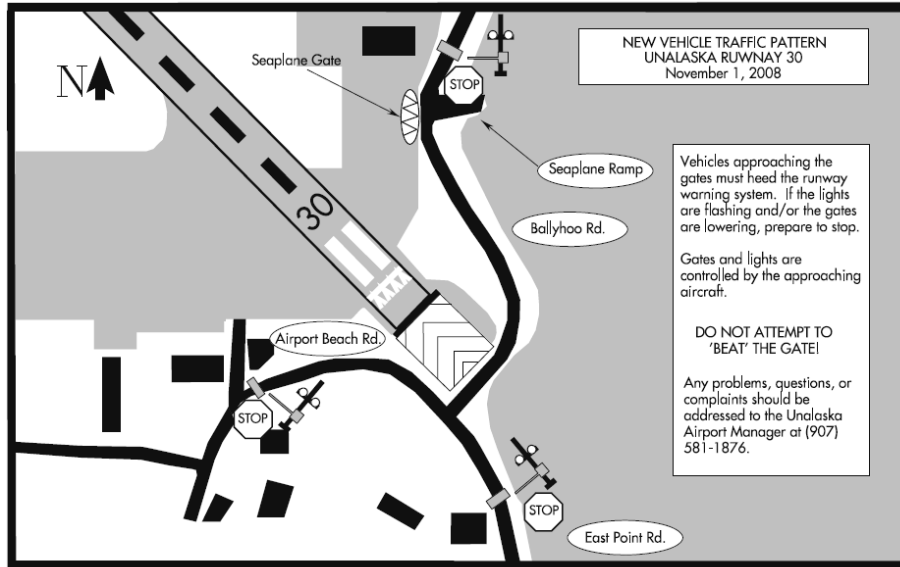
**Figure 9. Locations of DUT’s traffic control gates.**

DUT had three traffic control gates on Airport Beach Rd., Ballyhoo Rd., and East Point Rd. near the airport. According to ADOT&PF the gates could be lowered by approaching aircraft via the pilot-controlled lighting system (PCL) with 7 clicks on the frequency 122.6. Seven clicks also brought the lighting system to its highest intensity and turned on the runway end identifier lights (REIL). After the aircraft landed, 3 clicks were used to raise the gates, which was generally done while the airplane was taxiing. If the pilot forgot, the system’s internally default raised the gates after 15 minutes.

According to ADOT&PF, there had been some issues with the gates opening on their own when transmission traffic on 122.6 was broken up (usually when airplanes were on the other side of Mt. Ballyhoo) and interpreted by the system as 3 clicks. In response, the PenAir’s vehicle (Mobile 1) was equipped with a garage-door-like remote opening system. Once lowered by the remote, the gate could only be raised by the remote. Mobile 1 was also equipped with an aircraft radio which could raise/lower the gates on 122.6.
