VEHICLE FACTORS GROUP CHAIRMAN'S

Vehicle Attachment – Motorcoach Steering Gear Inspection Report

Mount Pleasant, Pennsylvania

HWY20MH002

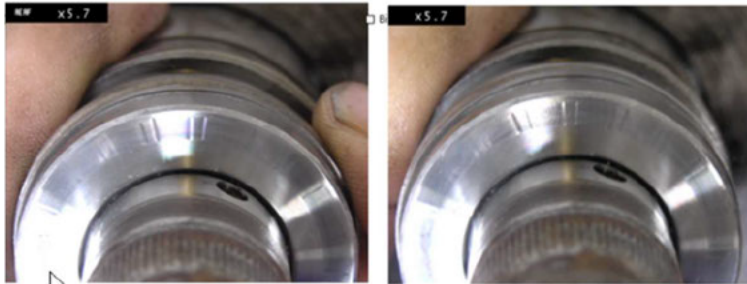
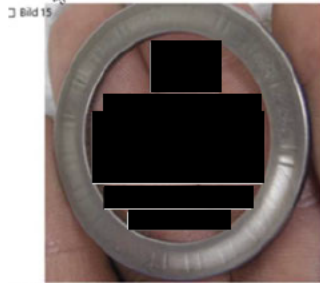
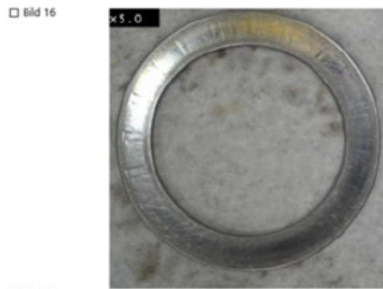
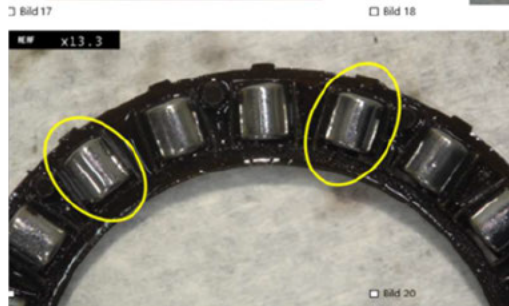
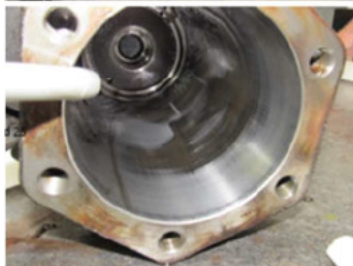
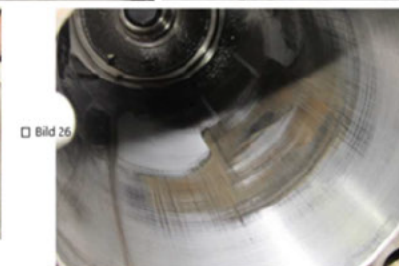
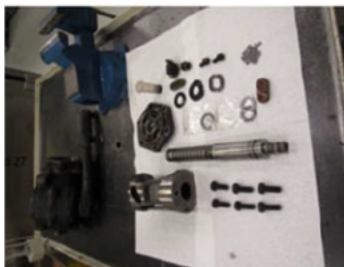
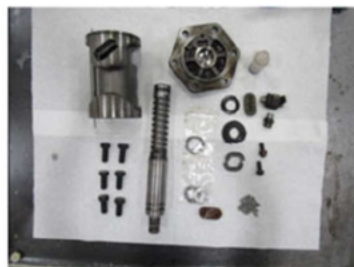
Following the Bosch AS test and detailed inspection, we find no defects with the performance of the steering gearbox.

Based on the measurement taken during tear-down (from the end of the worm to the impact damage in the ball circuit of the worm (109 mm), the piston was 18 mm out of middle position in direction to the input shaft.
