## Victory 2 Work report 15.1.2025

**CUSTOMER:** Victory Cruise lines  
**VESSEL:** Victory 2  
**MAIN ENGINE:** CATERPILLAR 3516 B  
**ENGINE LOCATION:** STDB  
**Engine serial no:** 9AN00185  
**Engine hours:**

## Work report block and crankshaft replacement

Work performed September 2<sup>nd</sup> -14<sup>th</sup> 2024 in Portland Maine

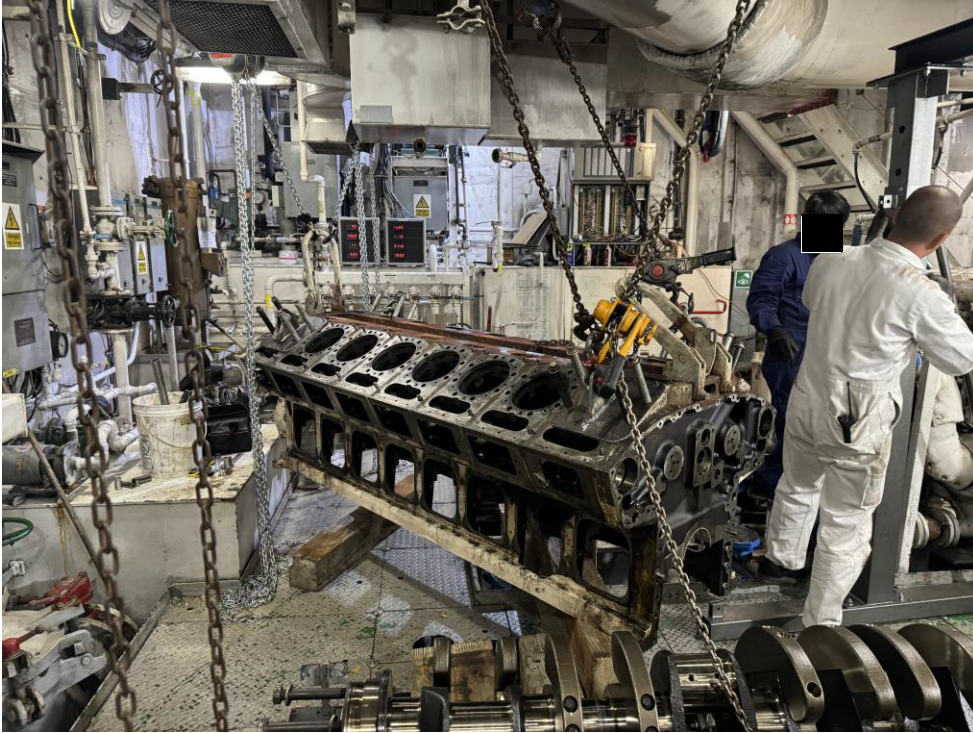
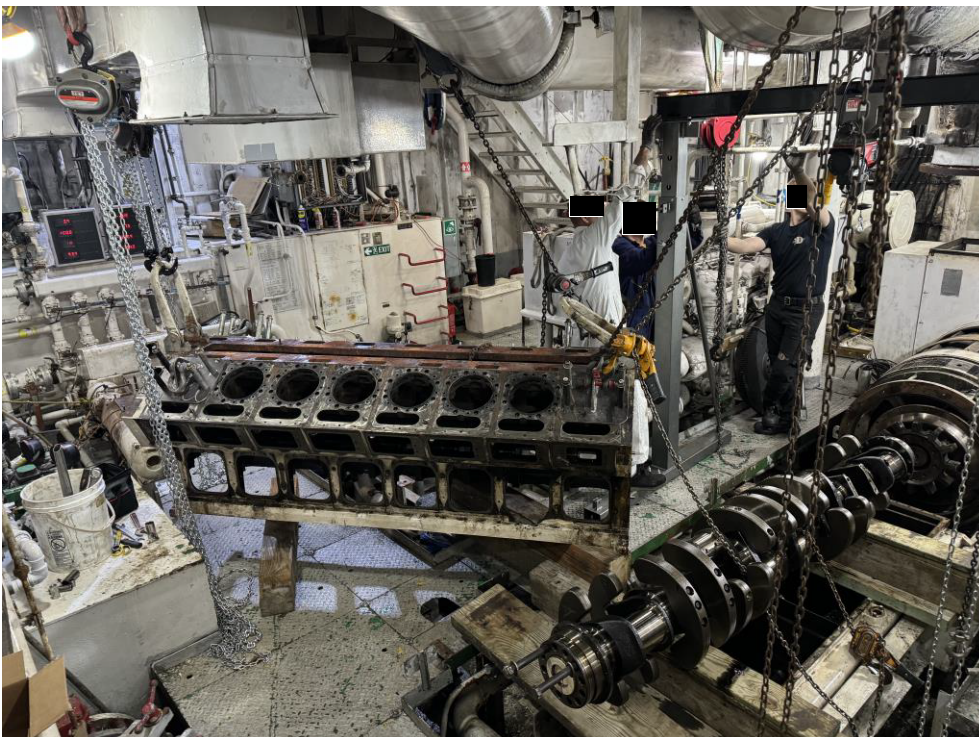
## Cylinder block:

The cylinder block was lifted up.

Total 4. lifting points and 4pcs 5T chain hoists.

Removed all necessary roof plates from engine room.

All needed pipes, hoses and wires was dismantled before block was lifted up
