National Transportation Safety Board

Memorandum

Date:	November 28, 2018				
To:	Stephen Stein Air Safety Investigator, Western Pacific Region WPR18MA087 Investigator in Charge (IIC)				
From:	John O'Callaghan National Resource Specialist – Aircraft Performance WPR18MA087 Aircraft Performance Specialist				
Subject:	Plots of Appareo Vision 1000 data for May 4, exemplar Papillon flight from KBVU to QMB; testimonies of Papillon pilots re: winds on approach to QMB; Airbus Helicopters yaw control simulations				
References:	 Appareo Vision 1000 electronic data files from May 5, 2018 flight of N836GC from KBVU to Quartermaster Base, provided by Papillon on May 10, 2018.

WPR18MA087: Airbus Helicopters EC-130 B4, N155GC, Peach Springs, AZ, 02/10/2018

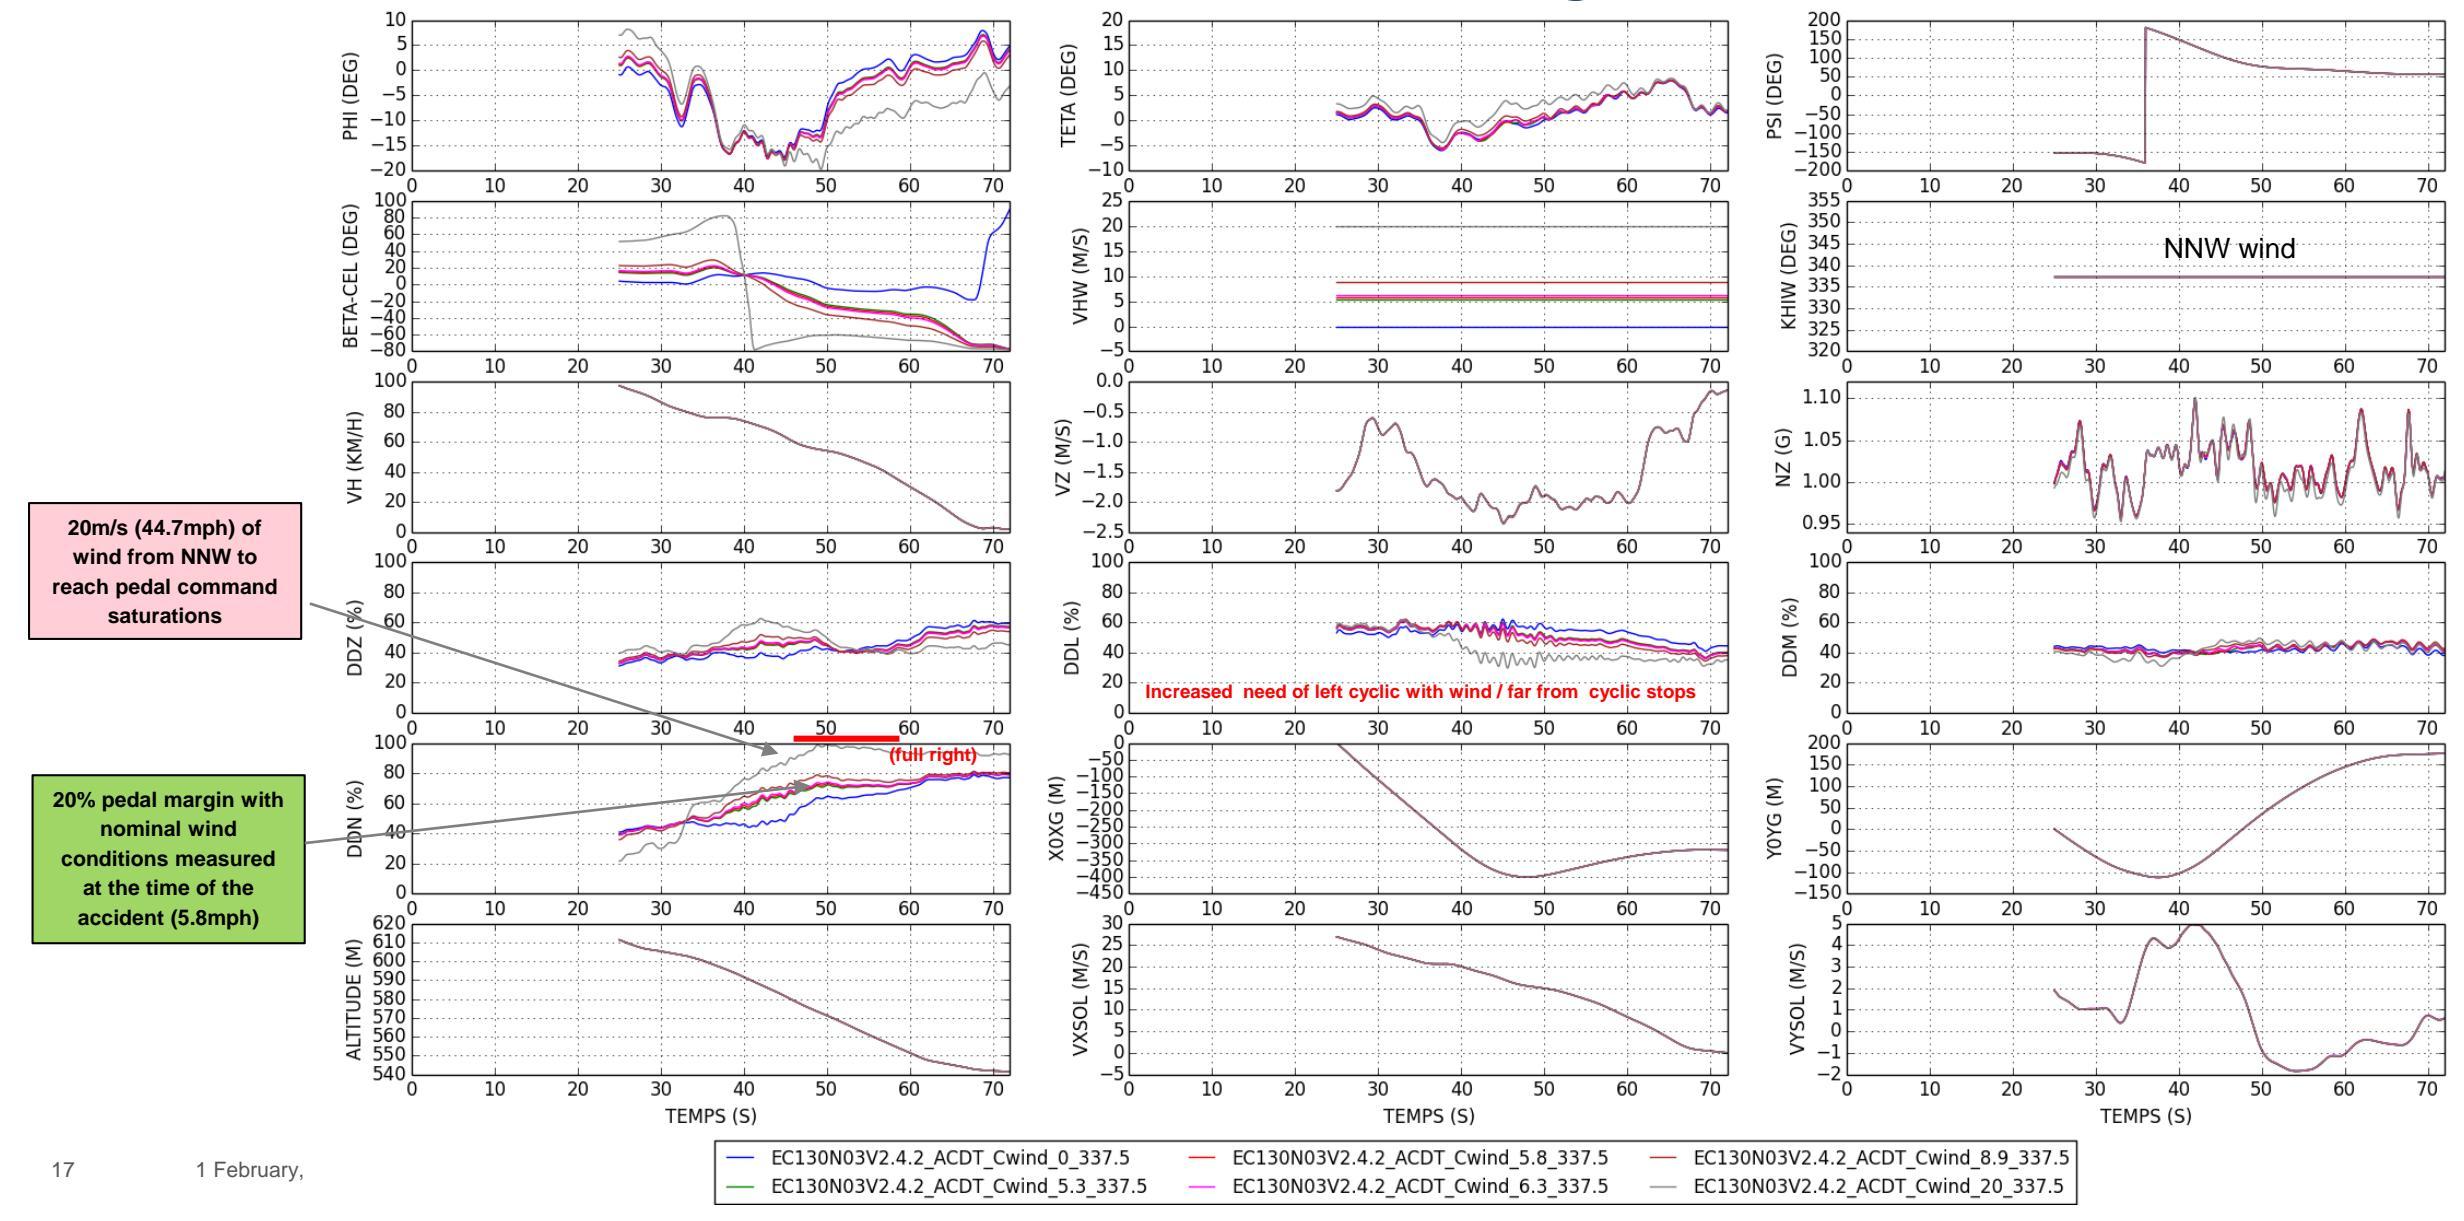
Simulations with constant horizontal wind – magnitude variations

- Considering a wind azimuth of 337.5 NNW, a pedal margin of around 20% appears with the wind conditions extracted from KAZFREDO4 & KAZPEACH2. The azimuth considered is also the worst in terms of pedal margin
- Considering a wind azimuth of 337.5 NNW, a wind of around 45mph is required to reach the pedal stop.
- The margin on the others axis (collective, cyclic) is important
- VRS conclusions: No important pitch attitude nor important rate of descent during the flight of the 4th of May. Hence even with important rearward wind, the VRS area is not reached in simulations.
