Date of Accident:	February, 3, 2019
Location:	Yorba Linda, CA
NTSB File No.:	WPR19FA079
Aircraft:	Cessna 414A
Registration No.:	N414RS
Serial No.:	414A0821 (Year of Manufacture 1982)
Operator:	(Per registration certificate found in aircraft, FAA database indicates registration not valid) AIR 20 CORP Gardenville, NV 89410-7327
Written by:	Les Doud - Air Safety Investigator
Report Date:	March 11, 2019
Contents:PagePropeller Examination Report2Accident Synopsis2Summary and Analysis of Findings3Conclusions4General Information7Propeller Examination Factual Findings8Left Propeller8Right Propeller22Photo List37

PROPELLER EXAMINATION REPORT

Date of Examination:	February 6-8, 2019	
Location:	Air Transport	
	Phoenix, AZ 85034	
Propeller Model(s):	PHC-C3YF-2UF w	ith FC7693DFB blades
Representatives:	Les Doud Maja Smith Eliott Simpson Ricardo Asensio	Hartzell Propeller Inc. ASI NTSB Investigator in Charge NTSB Sr. Air Safety Investigator Textron Air Safety Investigator

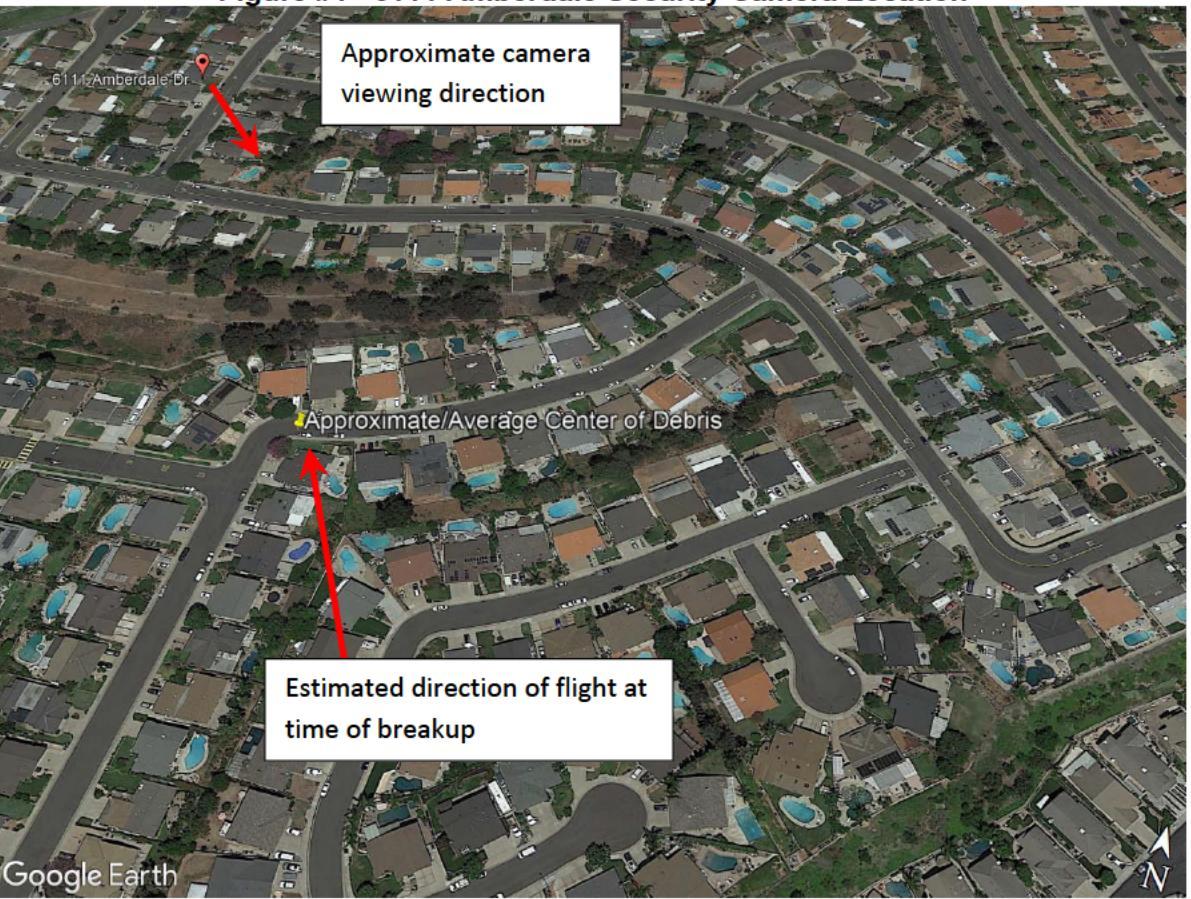
Figure #1 –6111 Amberdale Security Camera Location

Audio analysis of several security cameras was completed to discern propeller noise signatures that may provide aircraft airspeed estimates. As mentioned previously, the Nest camera video at 6111 Amberdale Drive recorded the impact sequence of the left engine/propeller and fuselage. This camera location appeared to be closely in line with the aircraft flight path (see Figure 1). The audio spectrums from that video are provided in Figure 2 and Figure 3. The 414A engines are rated for 2700 RPM. For a 3-blade propeller without Doppler shift, 2700 RPM equates to a blade passage frequency of 135 Hz. Frequencies above or below that may indicate Doppler shift due to aircraft velocity, either approaching (higher frequency) or moving away (lower frequency) from the camera. The propeller blade passage frequency at the start of the Amberdale video is approximately 137 Hz, with distinct harmonics at 2x, 3x, 4x, etc. blade passage frequencies as shown in Figure 2. Figure 3 shows the audio spectrum just before the inflight breakup occurred. Due to Doppler shift the propeller blade passage frequency increased to approximately 257 Hz as the aircraft accelerated toward the camera microphone. The spectrogram in Figure 4 shows this increasing frequency over time. Assuming the pilot had 2700 RPM set, the velocity necessary to generate that Doppler shift is approximately 310-315 knots. All the security camera videos that were reviewed indicated that after the inflight breakup, engine and propeller noise diminished guickly and was no longer detectable before impact with terrain.

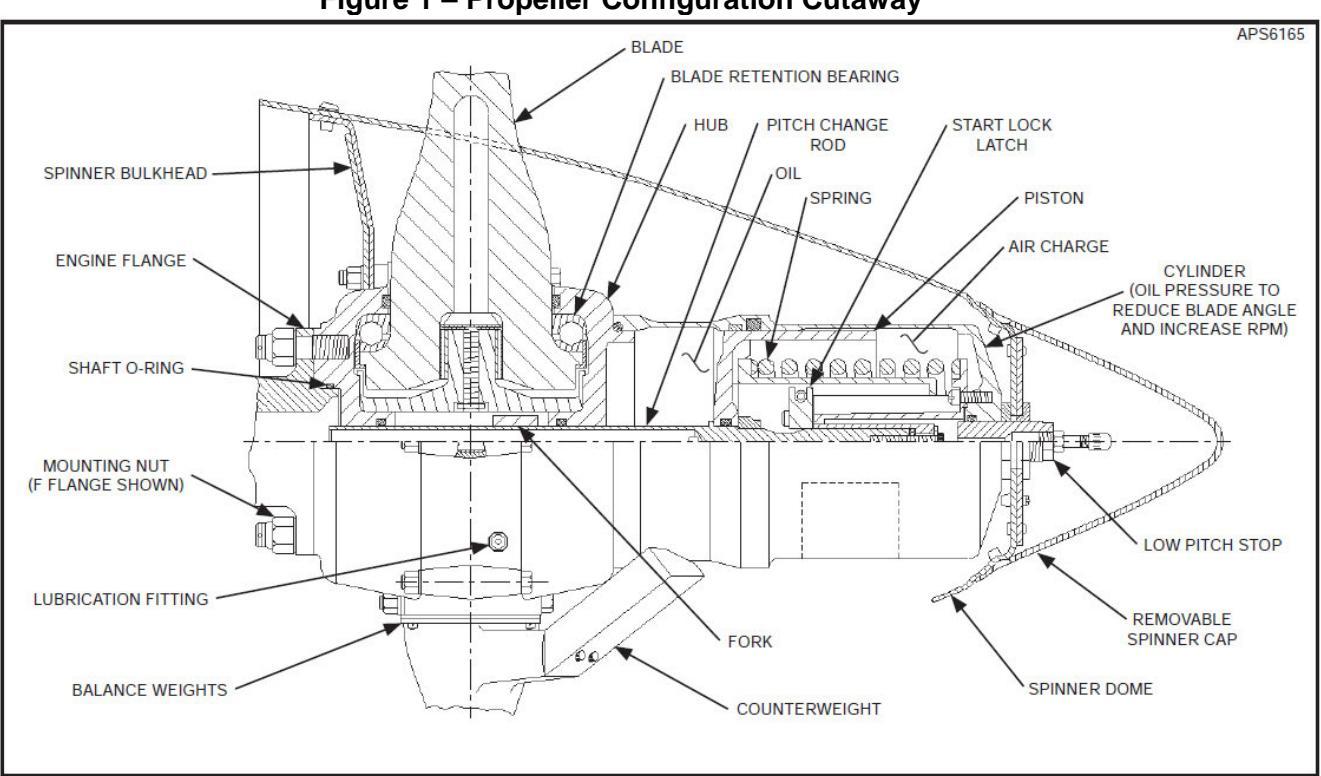
Figure 1 – Propeller Configuration Cutaway

Propeller Description: The Cessna 414A propellers examined are 78" diameter, 3-blade single-acting, hydraulically operated, constant speed model with feathering capability. Oil pressure from the propeller governor is used to move the blades to the low pitch (blade angle) direction. A spring, counterweights, and an air charge move the blades to the high pitch/feather direction in the absence of governor oil pressure. The propeller incorporates start locks to keep propeller blade angle low to minimize the starting torque. The blades and hub are of aluminum construction. Propeller rotation is clockwise as viewed from the rear.

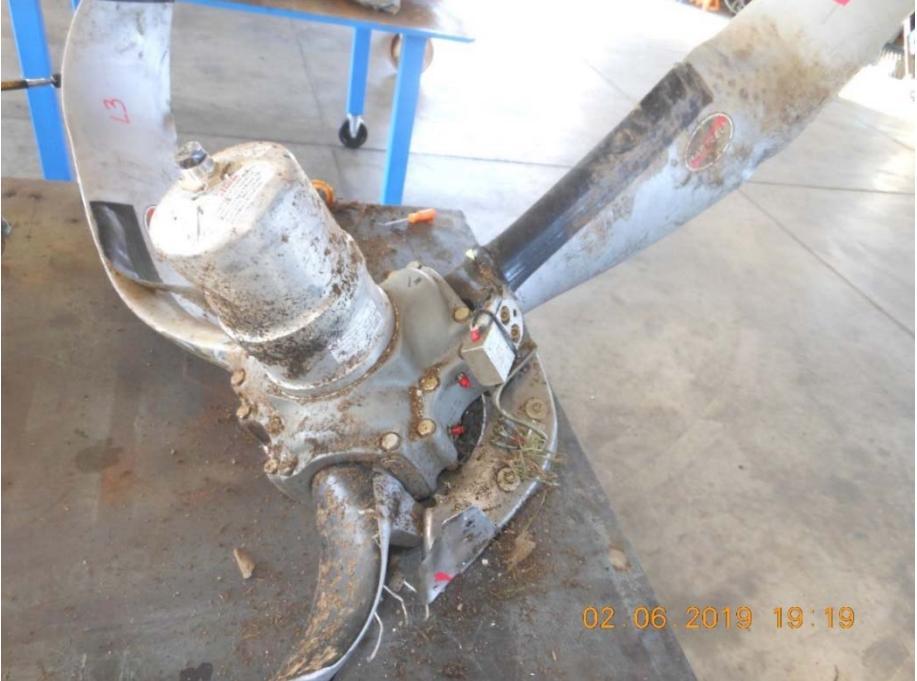
Photo #2 – Left propeller as-presented for examination

As Received Condition: The left propeller fractured-separated from the engine during the impact sequence and was found lodged into the soil behind the residence at 19912 Canyon Dr. (near where fuselage came to rest) as shown in Photo #1. The propeller was presented for examination as shown in Photo #2. The spinner dome was crushed and torn but remained attached to the propeller assembly. The engine crankshaft fractured behind the flange which remained attached to the propeller; one of the six studs fracture-separated and was missing. All three blades remained attached to the propeller assembly. Blade L1 had a large wave-bend in the mid-blade area and was at a high pitch, almost feathered position. Blade L2 was bent aft and rotated in the high pitch direction approximately 180° from a normal operating position; it was beyond the feather stop and the counterweight was on the aft side the propeller assembly. Blades L3 was bent forward and in a normal operating blade angle range. Blades L2 and L3 rotated by hand force suggesting fractured pitch change knobs. There was distinguishable chordwise/rotational scoring on the camber side of blade L1. Blades L2 and L3 exhibited some chordwise/rotational scrapes on the face side. There were varying degrees of dents, gouges and tears in the trailing edges of all three blades. The propeller had various amounts of dirt and vegetation in and around the hub including pine needles. leaves, grass and wood pulp. Photo #3 shows the propeller with the spinner dome removed prior to disassembly.

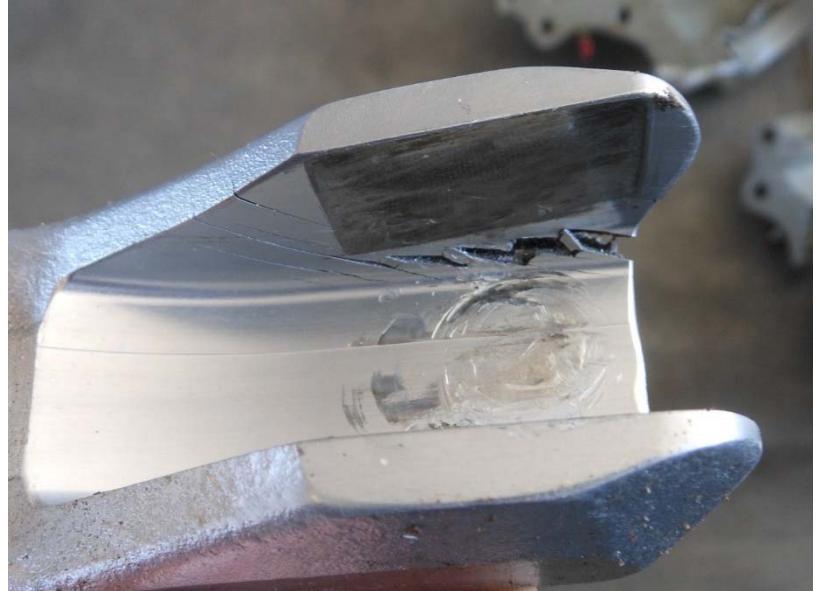
Photo #12 – Left fork fracture

The piston was intact with a dent adjacent to the location of the dent in the cylinder. The pitch change rod was intact but bent in the area that threads into the fork (Photo #9). The fork had one forward tank fractured due to forceful rotation of the blade in the low pitch direction (Photo #12).

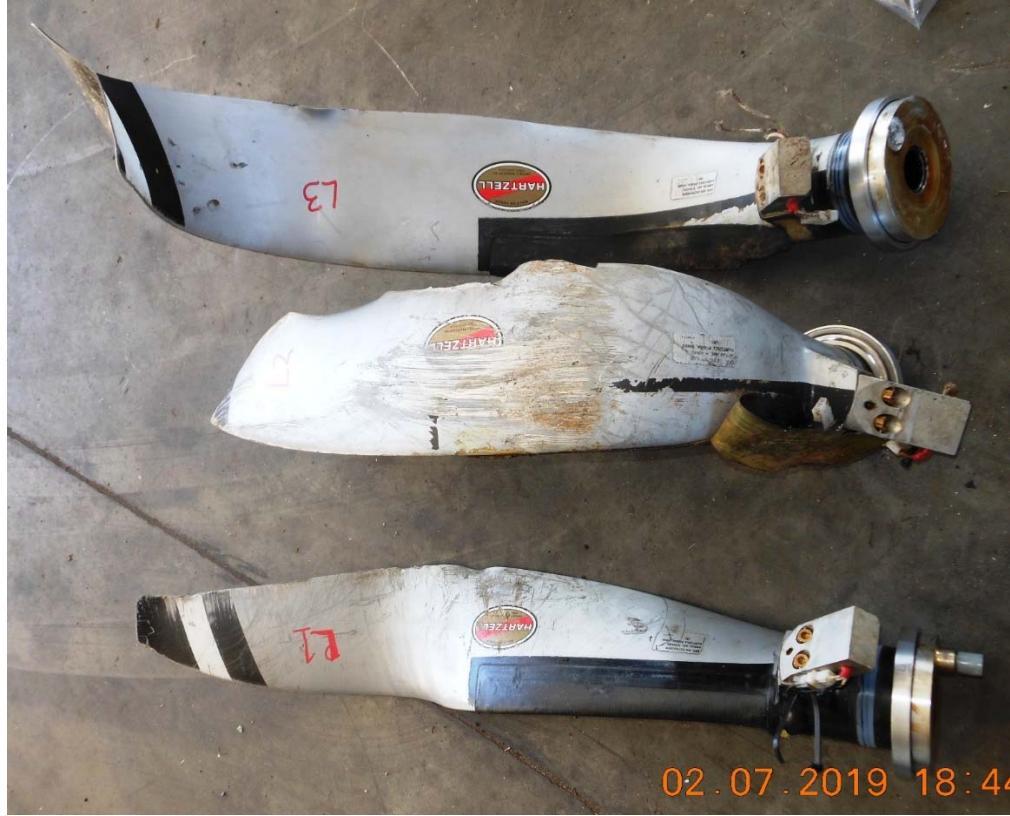
Photo #16 – Left blades camber side view

Propeller Blade Properties: (Photos #16 through #20)

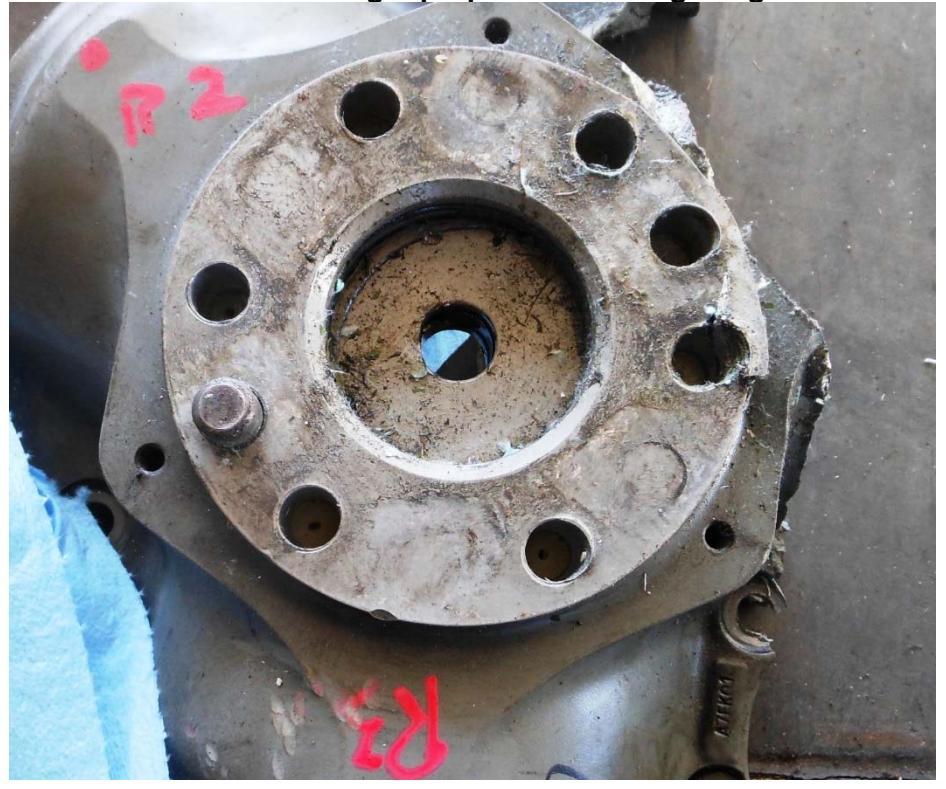
Photo #30 – Right propeller mounting flange

Engine/Propeller Mounting: All six propeller mounting studs were pulled from the hub/mounting flange during the impact sequence. One of the drive dowel pins was also pulled from the hub and is missing. Several stud holes had deformation in the same direction indicating impact forces towards R1 and aft. There were no indications of fretting/galling on the mating surfaces (Photo #30). The crankshaft fractured inside the engine case and the fracture surface as shown in Photo #32.

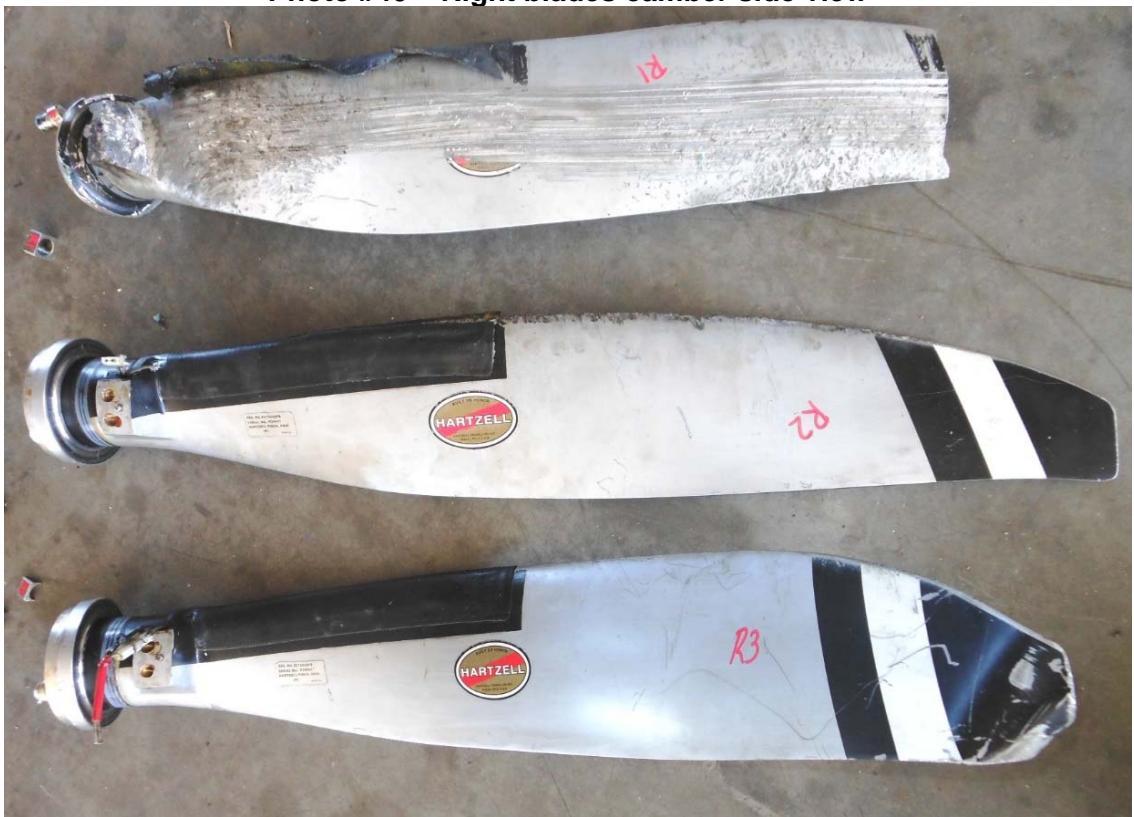
Photo #40 – Right blades camber side view

Propeller Blade Properties: Photos #40 through #44
