NTSB File No. WPR19FA079 Cessna 414A N414RS, Yorba Linda, CA 2/3/19

Hartzell Engine Technologies Turbocharger Examination Field Notes

Turbocharger Examination

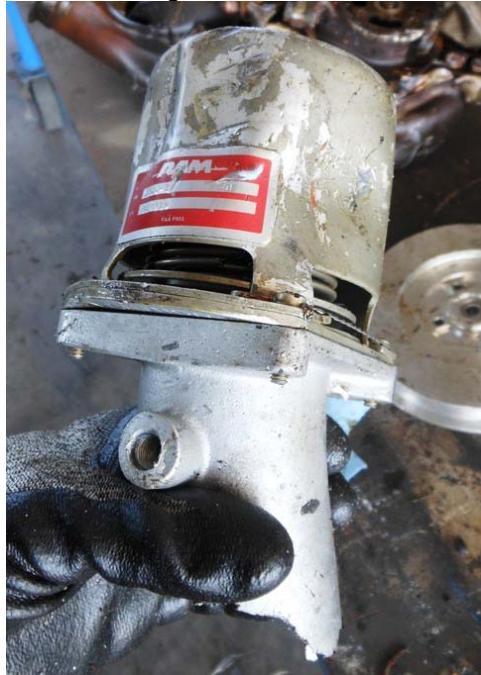
Photo #10 – Left wastegate and actuator

<u>Wastegate actuator</u> (Photo #10) RAM data tag – Red color, "OH" P/N: 470908-9012 S/N: IK0153

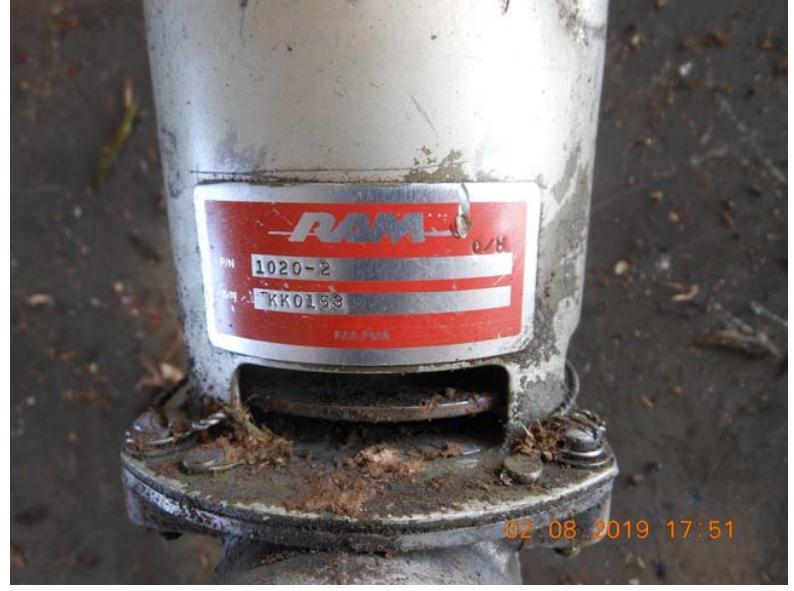
Photo #11 – Left Pressure Relief Valve

Pressure Relief Valve (Photo #11) RAM data tag – Red color, "OH" P/N: 1020-2 S/N: KK0153

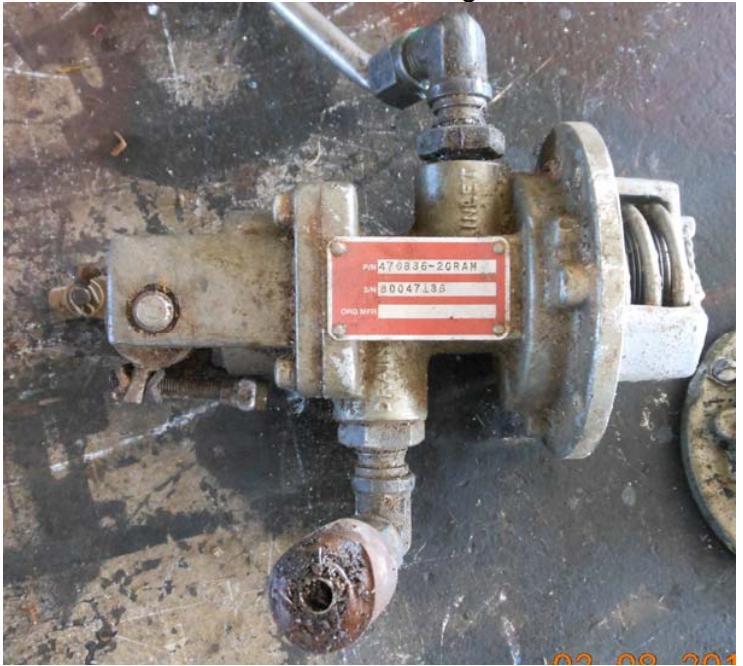
Photo #12 – Left Turbocharger Controller

<u>Turbocharger Controller (Photo #12)</u> RAM data tag – Red color P/N 470836-20RAM S/N BD047136
