NATIONAL TRANSPORTATION SAFETY BOARD
Office of Aviation Safety
Washington, D.C. 20594

Unmanned Aircraft System (UAS) Aerial Imagery Report

A. ACCIDENT WPR19FA109

Location: Fort McDowell, Arizona

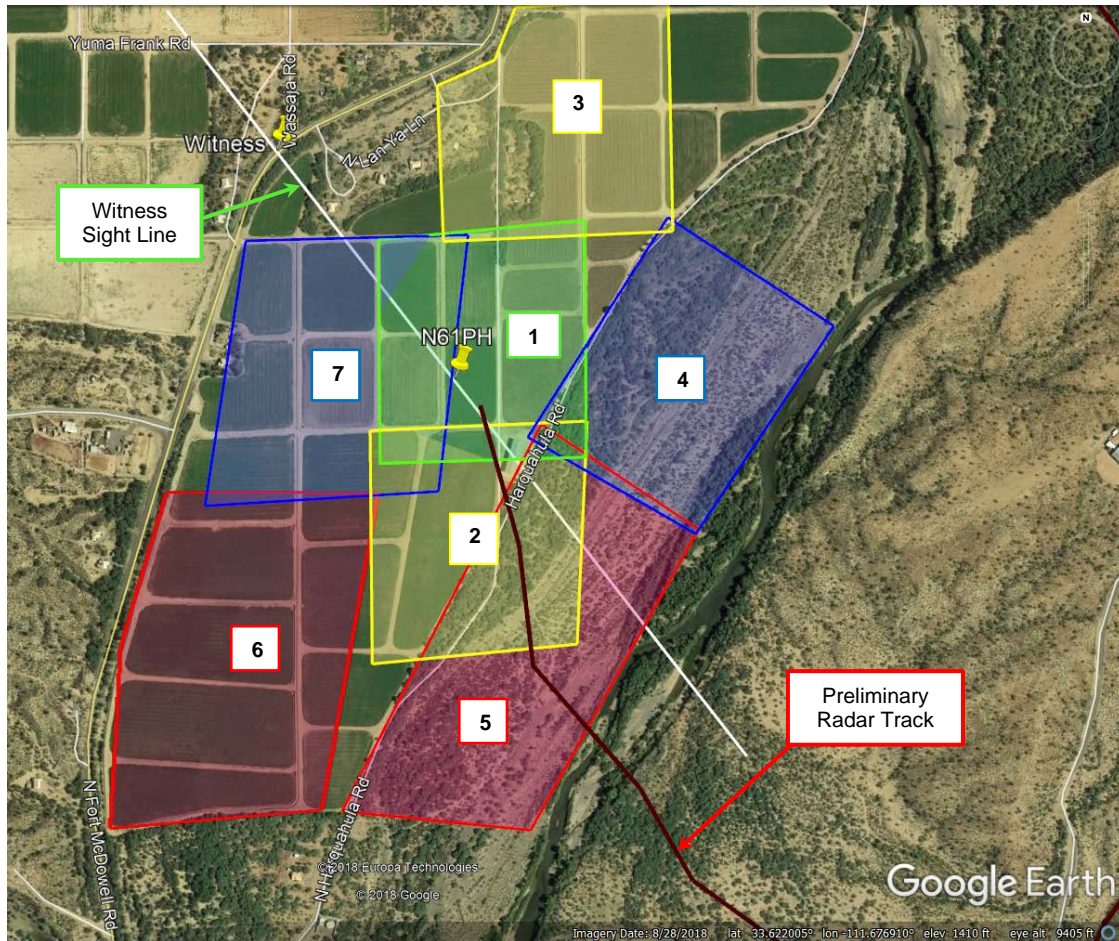
The UAS was deployed to assist in a search for a missing section of the main rotor blade from the helicopter. During preliminary discussions with the NTSB investigator-in-charge (IIC), information was provided regarding a witness video and initial an initial impact point and locations of wreckage found around the site. Using this information, seven areas were planned for conducting visual search patterns, see Figure 1. The search patterns were flown at an altitude of 260 ft above ground level (agl).

Figure 1 - Planned search areas

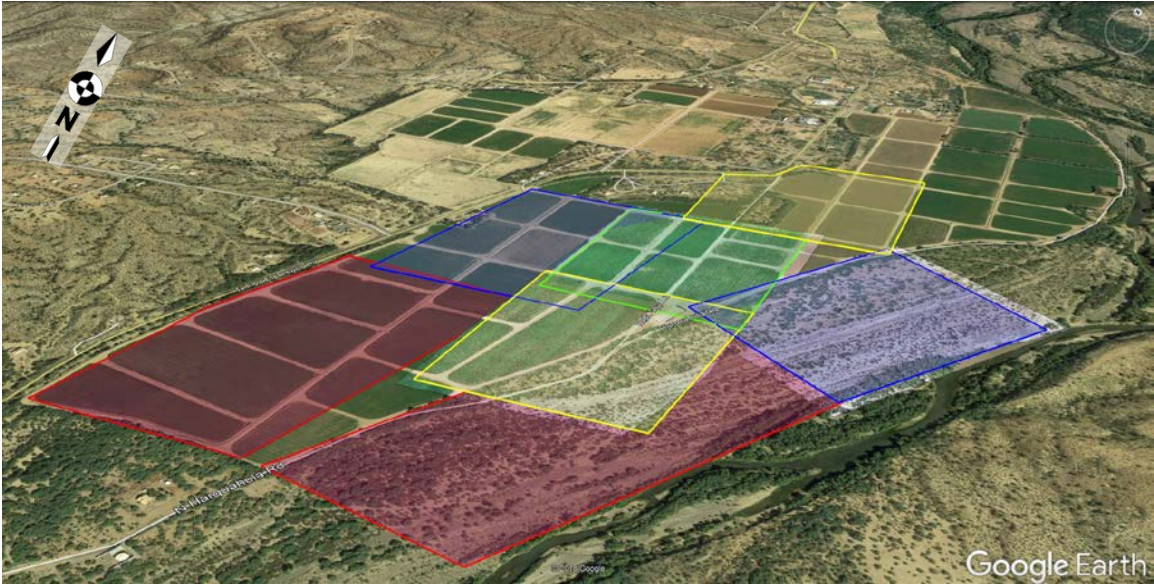
Figure 5 contains multiple orthomosaics generated by Pix4D overlaid on a Google Earth image. A green pushpin indicates the location of the missing main rotor blade, while yellow pushpins indicate the accident site, the witness location, and other recovered main rotor blade sections. Figure 6 contains the search areas extents overlaid on the Google Earth image along with the processed orthomosaics.

Figure 6 - Orthomosaic with search areas overlaid

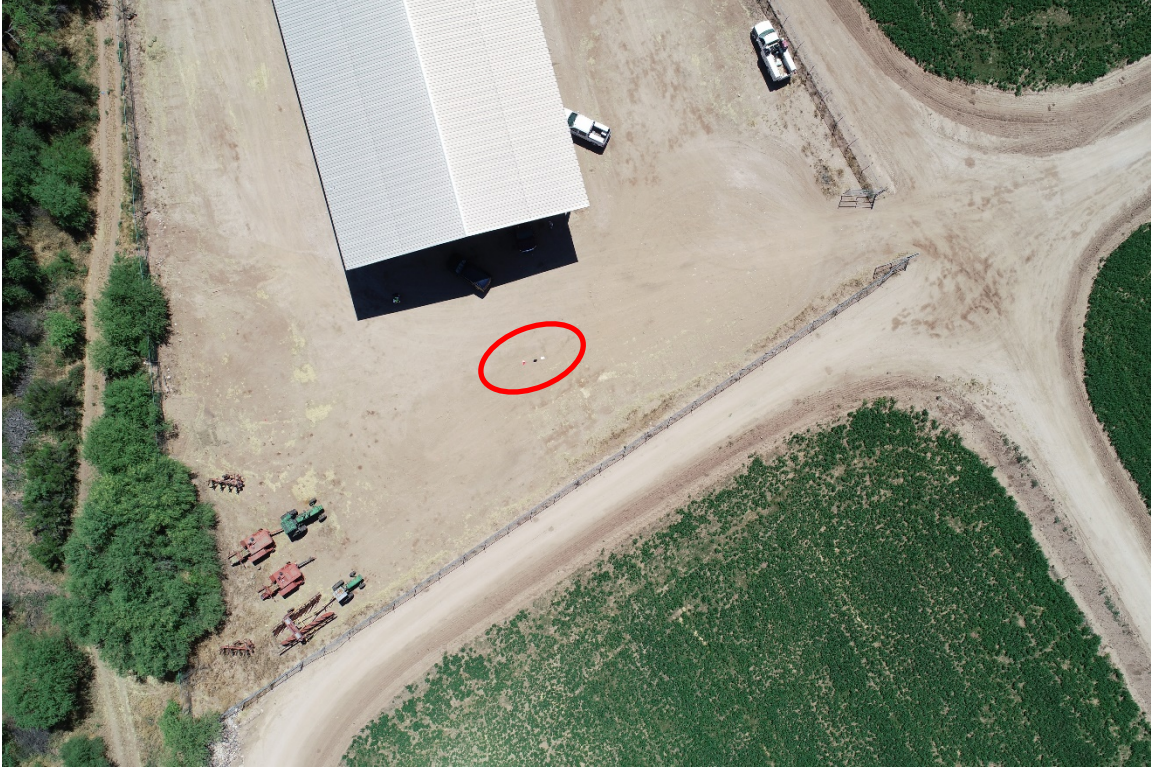
Figure 7 and Figure 8 contain still images with exemplar wreckage pieces placed on the gravel road adjacent to the hay barn taken from overhead at an altitude of about 260 ft above ground level and at a lower altitude.

Figure 7 – Exemplar wreckage (highlighted) on road from about 260 ft agl

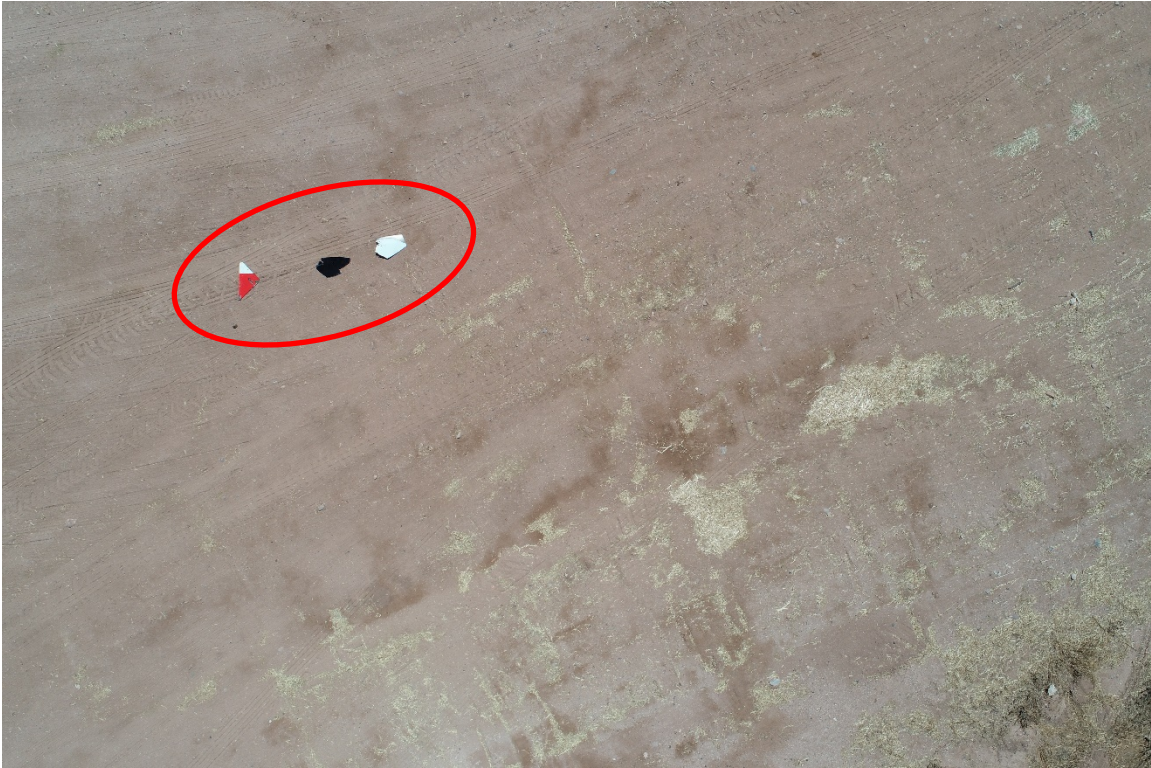
Figure 8 - Exemplar wreckage (highlighted) on road from low altitude

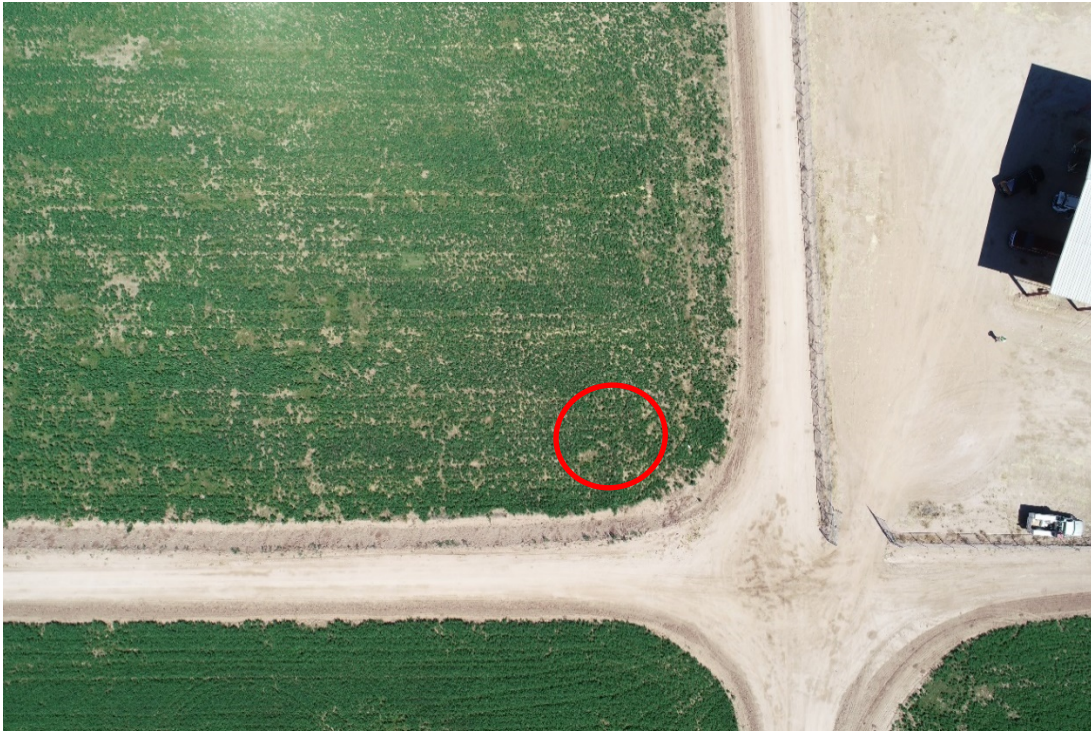
Figure 9 and Figure 10 contain still images with exemplar wreckage pieces placed in the alfalfa field adjacent to the hay barn taken from overhead at an altitude of about 260 ft agl and at a lower altitude.

Figure 9 - Exemplar wreckage (highlighted) in alfalfa field from about 260 ft agl

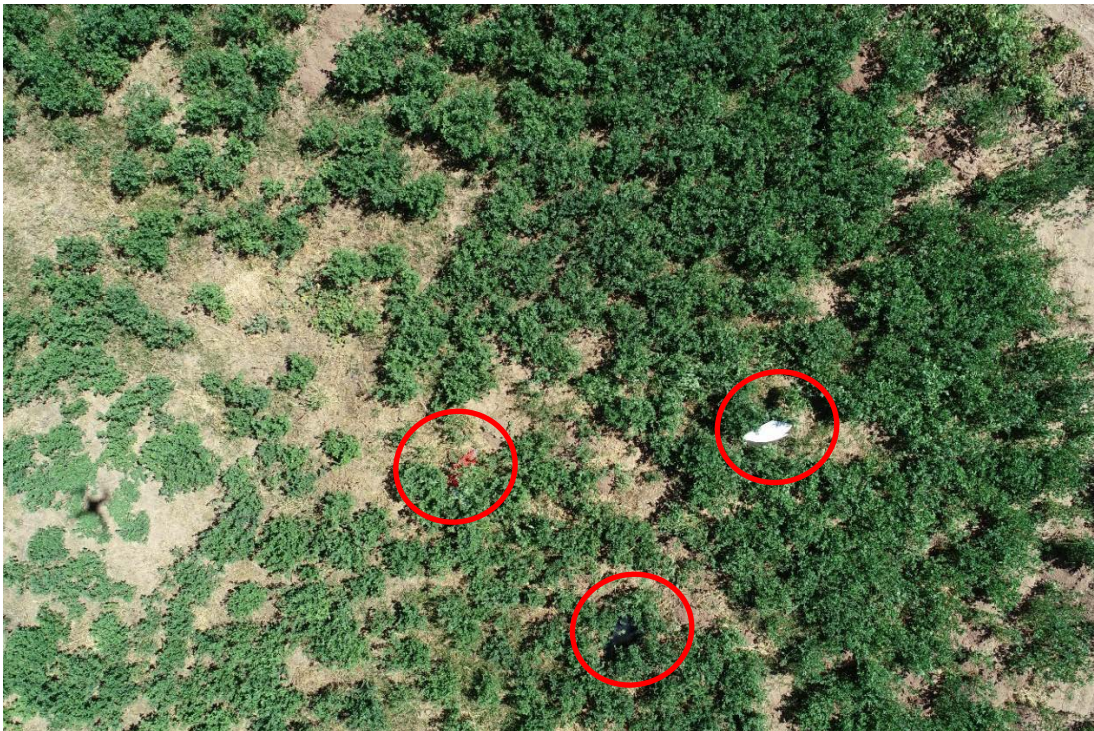
Figure 10 - Exemplar wreckage (highlighted) in alfalfa field from low altitude
