National Transportation Safety Board
Office of Research and Engineering
Washington, D.C. 20594

Airplane Performance Study

Specialist Report Timothy Burtch

Location: Mokuleia, Hawaii
Date: June 21, 2019
Time: 0422 GMT (1822 HST)
Airplane: Beechcraft 65-A90, King Air, N256TA
NTSB Number: WPR19MA177

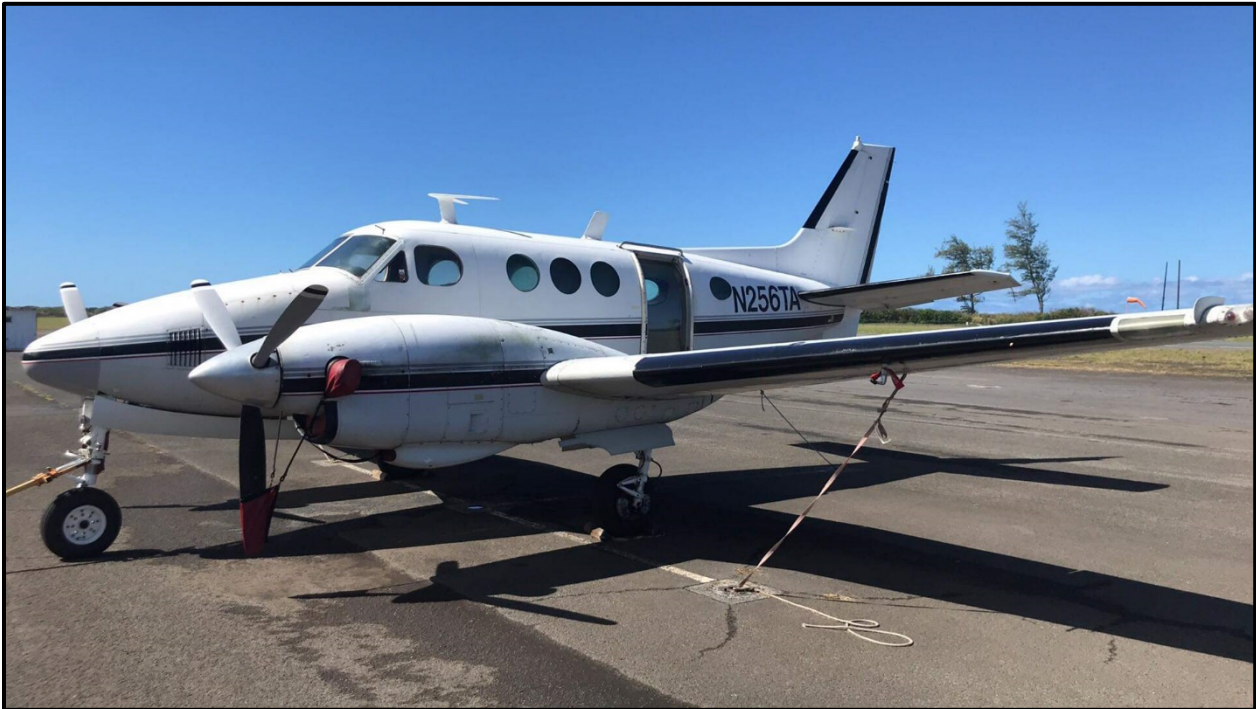
Figure 1: Accident Airplane, N256TA, a Beechcraft 65-A90

A picture of the accident airplane, a Beechcraft 65-A90, King Air, is shown in Figure 1. The airplane was manufactured by Beechcraft in 1967.

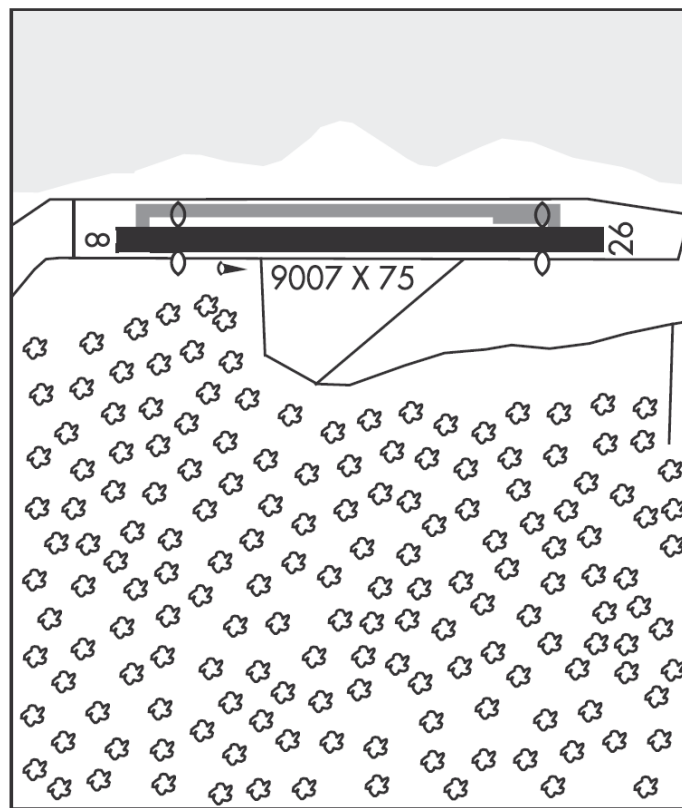
Figure 2: Dillingham Airfield Runway Diagram

A runway diagram for Dillingham’s runway 8/26 from the Federal Aviation Administration (FAA) Chart Supplement is shown in Figure 2. There were no radar or Automatic Dependent Surveillance – Broadcast (ADS-B) data recovered for the accident. The lack of radar data was likely because the airplane remained below coverage after take-off from runway 8, and the airplane was not equipped with ADS-B equipment. As such, take-off performance data provided by the airplane manufacturer were used to assess the accident flight.

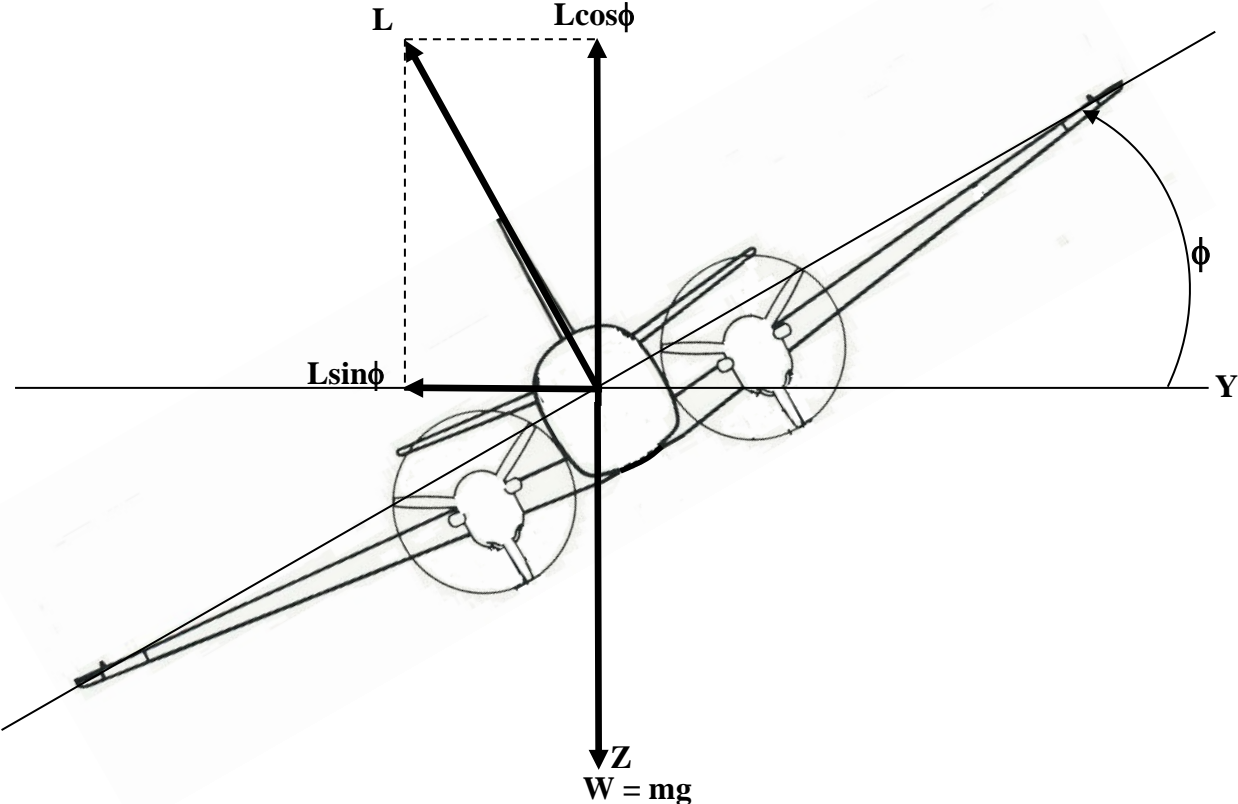
Figure 13: Forces Acting in a Steady, Coordinated Turn

The conditions associated with a steady, coordinated turn⁹ shortly after lift-off until the final impact were considered in the accident. The purpose was to approximate the airplane state during the accident sequence. While the accident airplane was climbing, the calculations provide an approximation.

The forces acting on the airplane in the turn are shown in Figure 13. Summing forces in the vertical direction:
