## **NATIONAL TRANSPORTATION SAFETY BOARD**

### **Specialist's Factual Report**

# **METEOROLOGY**

WPR21FA143

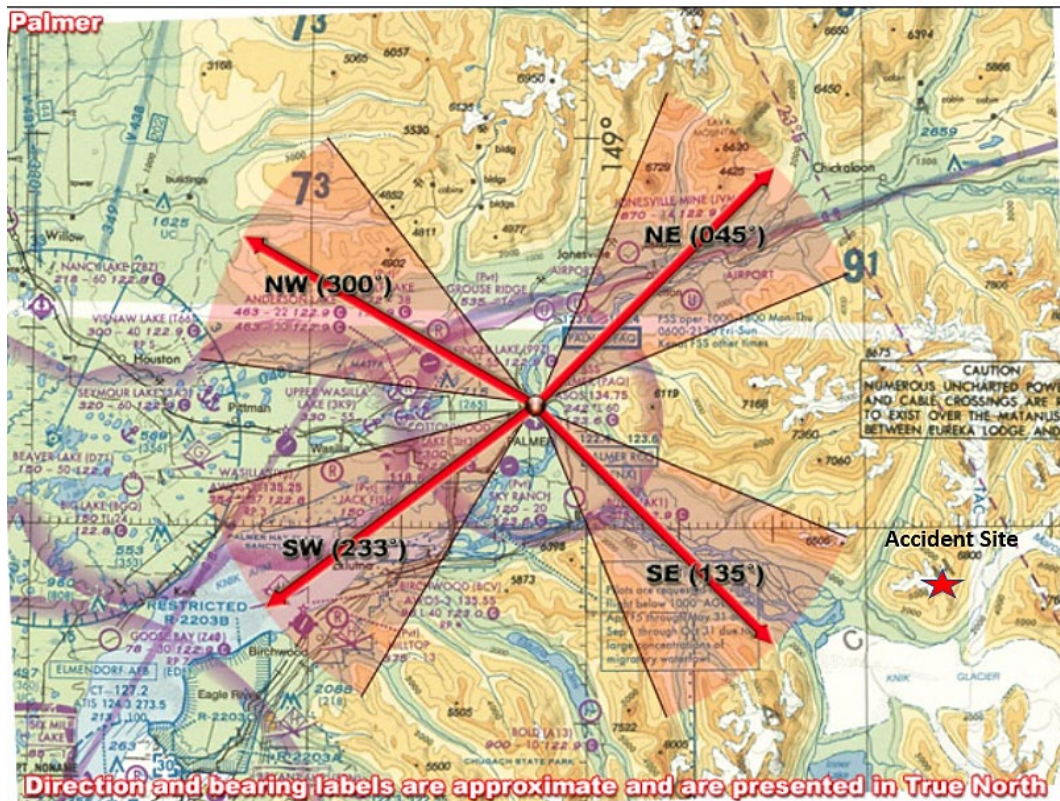
The FAA Weather Camera images from the Palmer, Alaska, southeast camera view were also obtained for the period surrounding the time of the accident. The sectional chart with the Palmer camera views is included as figure 11 highlighting the southeast (135°) camera's view looking down the Knik River Valley towards the Knik Glacier with the approximate accident site marked by the red star. Figure 12 is an image of the FAA Palmer southeast camera view on a clear day with landmarks identified. The accident site was located at an azimuth of 112° and 23 miles from the PAQQ camera site and would have been blocked by the mountains on the extreme left side of the image.

Figure 11 - FAA Palmer Cameras on a sectional chart with the approximate accident site marked

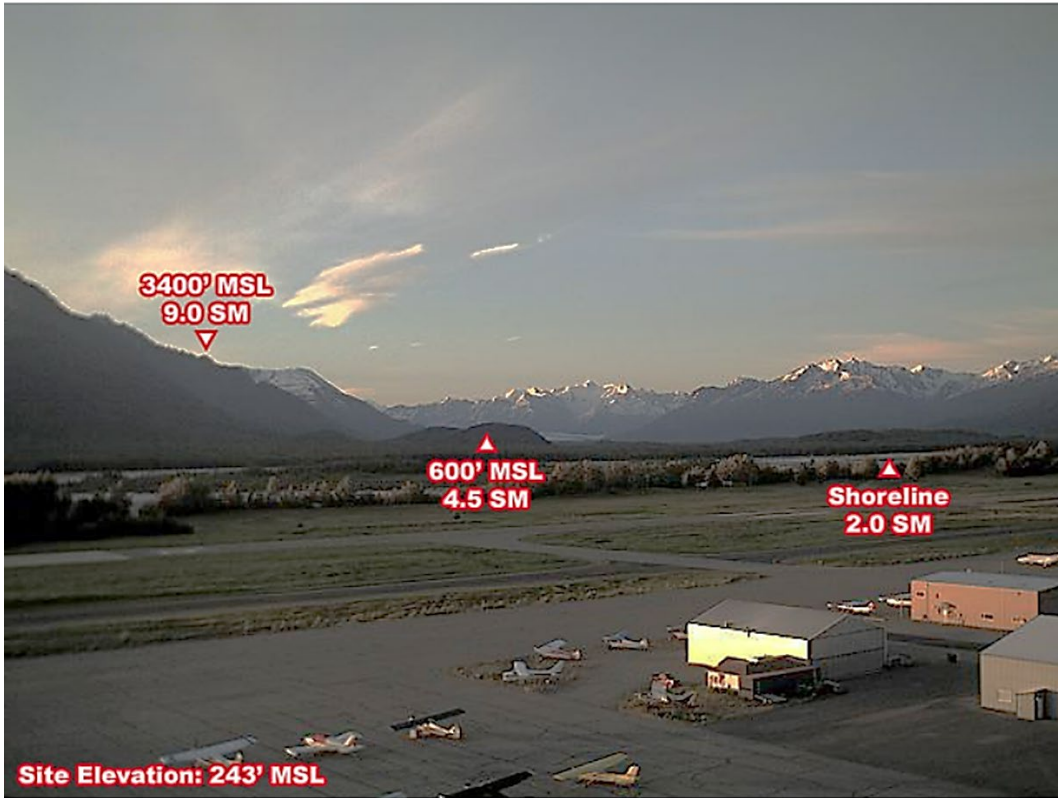
Figure 12 - FAA Weather Camera for Palmer southeast view on a clear day
