NATIONAL TRANSPORTATION SAFETY BOARD

Specialist's Report

SURVIVAL FACTORS

WPR21FA143

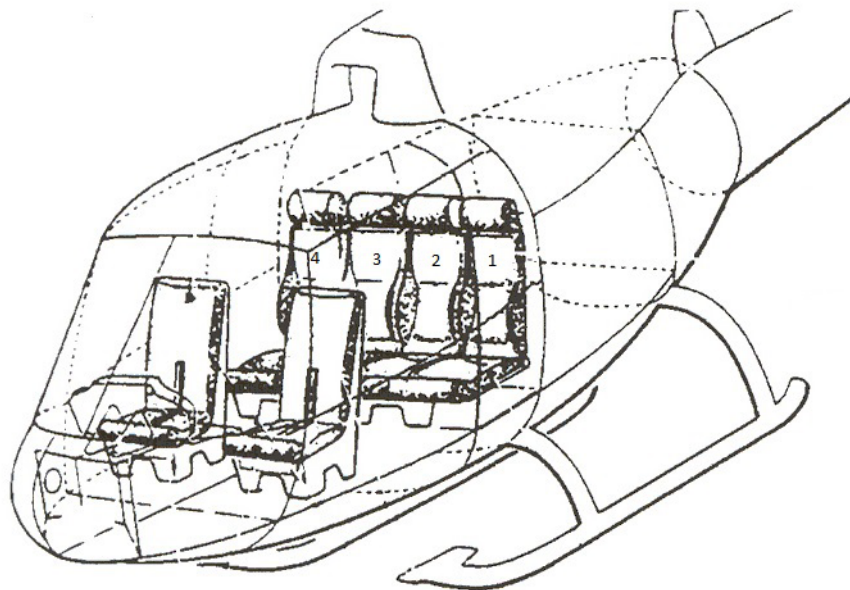
The accident helicopter was configured in a standard 6-place AS350 seating configuration (as shown in figure 1). The pilot sat in the front, right seat and one of the Third Edge Heli guides (front, left passenger) sat in the front, left seat. The second guide (aft passenger 1) sat on the aft, far left seat. The other passengers (aft passengers 2, 3, and 4) sat from left to right across the back of the helicopter. The only surviving occupant was aft passenger 3.

Figure 1. Interior configuration of accident helicopter N351SH.

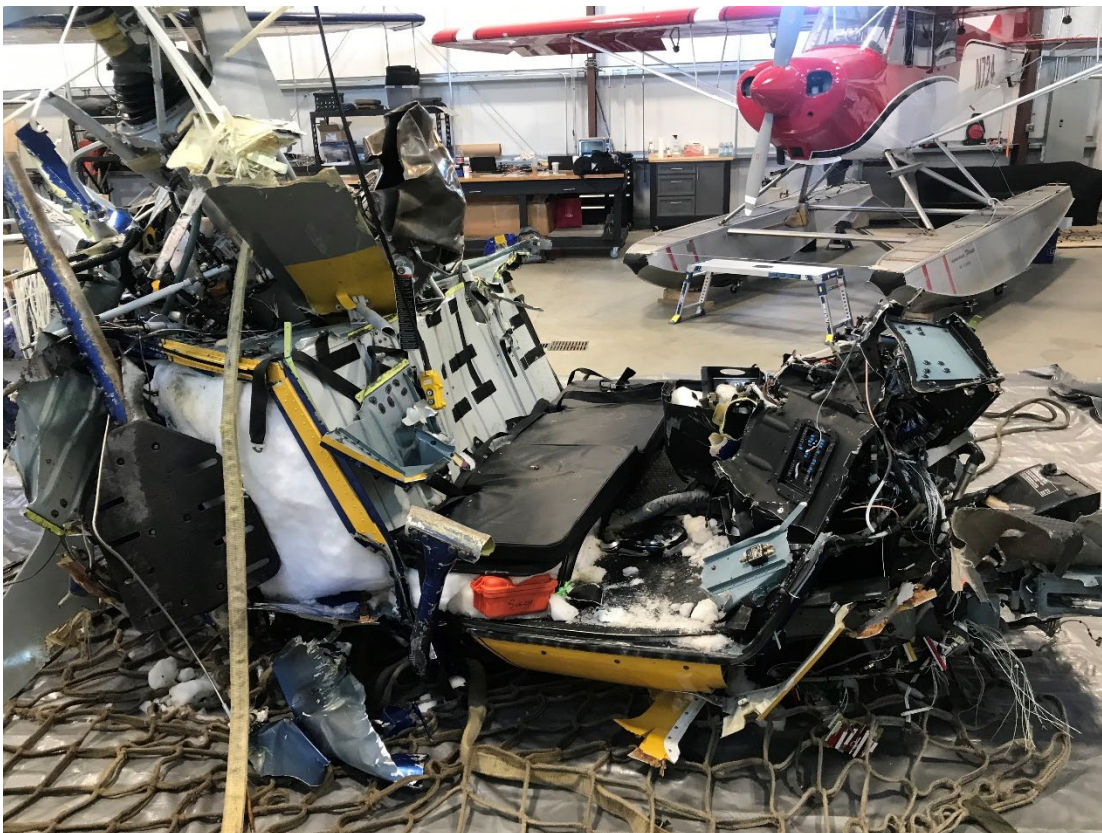
Figure 2. Cabin interior of N351SH.

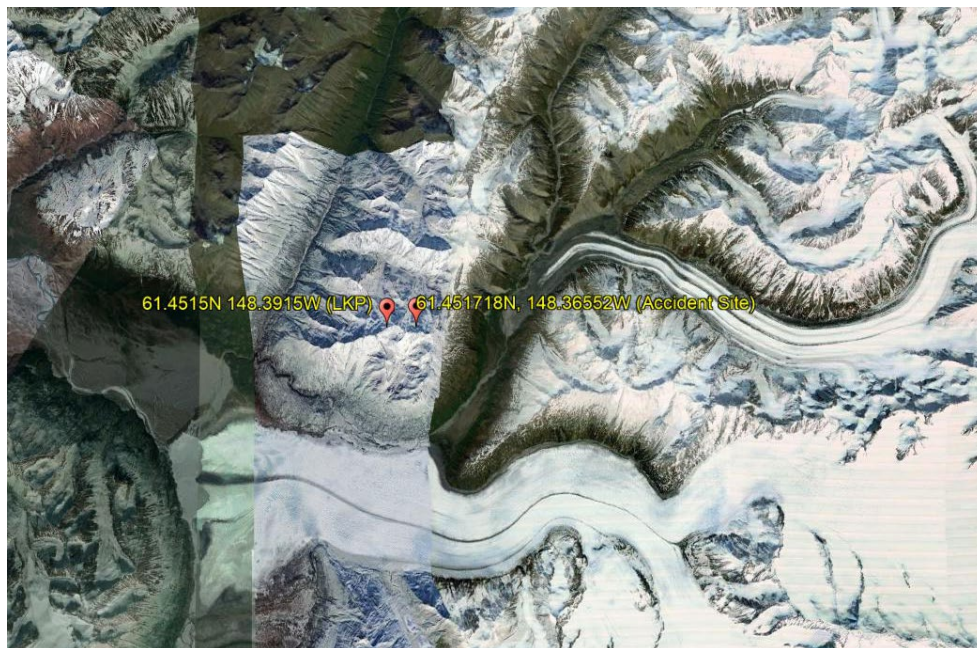
Figure 10. Locations of the original LKP and accident site.

⁵ The accident site was 0.86 miles due east of the originally reported LKP.
