NATIONAL TRANSPORTATION SAFETY BOARD

Onboard Image Recorder

Specialist's Factual Report By Sean Payne

Location: Angwin, CA
Date: July 16, 2021
Aircraft: Beech V35, N112TW
Operator: Private
NTSB Number: WPR21FA273

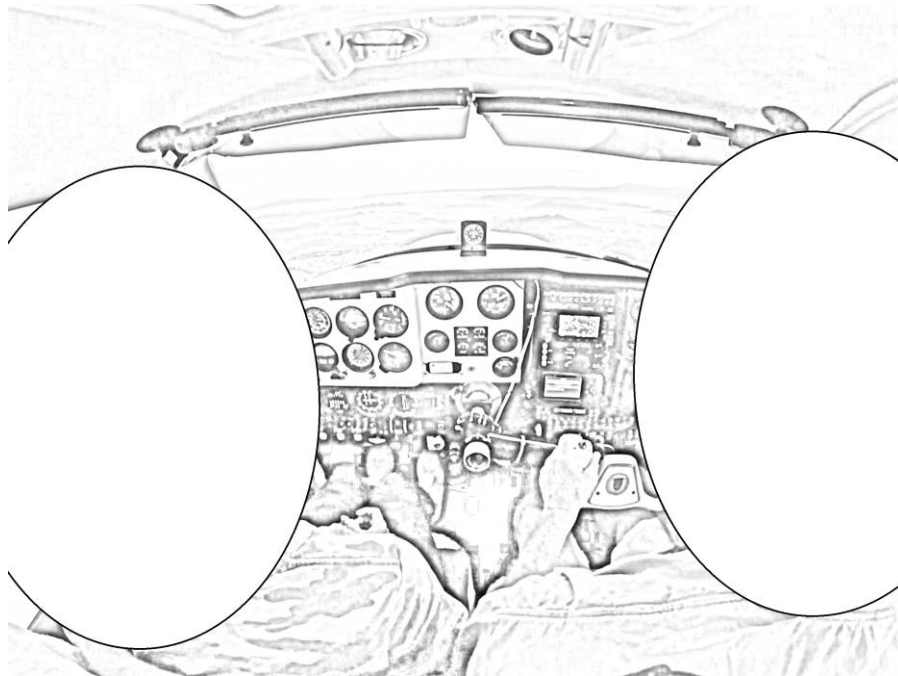
Figure 2. A digital illustration of the GoPro's POV as installed in the accident aircraft.

The GoPro was installed on the headliner of the aircraft and was set up to provide an over the shoulder view of both the LSP and RSP. Figure 2 is a digital sketch made from a frame in the recording that illustrates the point of view of the camera. The pilots have been redacted. In general, the GoPro captured both the LSP and RSP's actions and a view of most of the aircraft's instrument panel. At times, the pilots' torsos and extremities may have obscured portions of the instrument panel. At other times, lighting conditions in combination with the resolution of the video made it difficult to read indications on the aircraft's instruments.
